**CONTRACT NO. DC/2013/10 - DESIGN,  
BUILD AND OPERATE SAN WAI  
SEWAGE TREATMENT WORKS –  
PHASE 1**

**MONTHLY EM&A REPORT  
NO. 52  
(For Construction Phase)**

**(01 AUGUST – 31 AUGUST 2021)**

Report No.: ENA14370

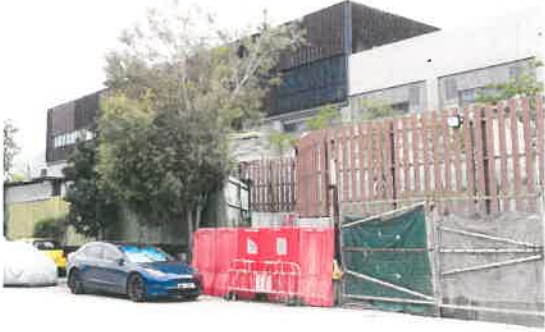
| Figure 1 | Figure 2 |
|---|---|
| <p>Works are almost completed at the eastern boundary</p> | <p>Planting works are carried out at the western end of the site</p> |

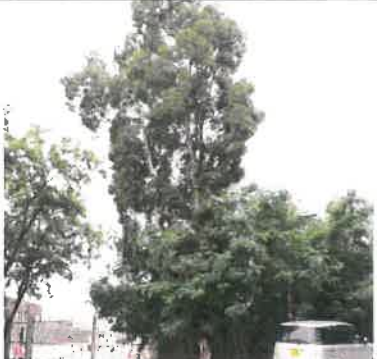
| <p><b>Condition of trees at the entrance of the existing treatment plant</b></p> | <p><b>Existing trees at the site entrance</b></p> |

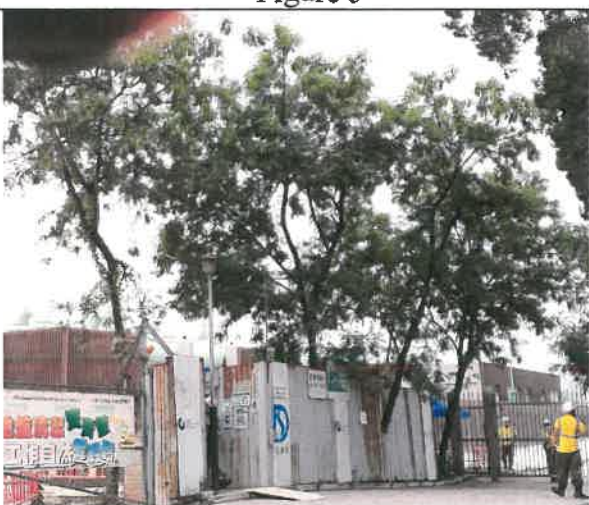
| <p><b>Figure 5</b></p> | <p><b>Figure 6</b></p> |

| <p><b>Existing trees at the site entrance near the hoarding fence</b></p> | <p><b>Tree planting works near site boundary</b></p> |

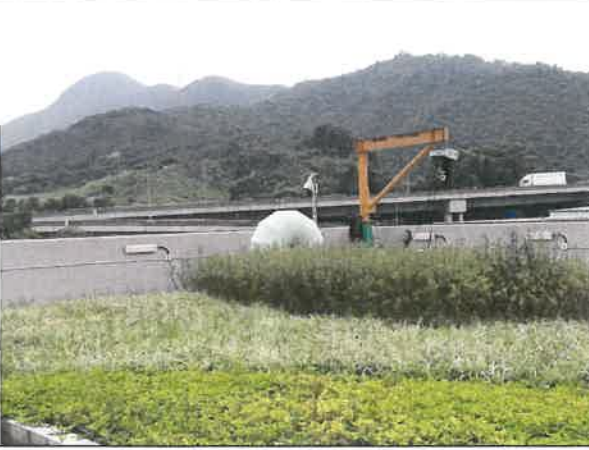
| <p><b>Figure 7</b></p> | <p><b>Figure 8</b></p> |

| <p><b>Planting works at SDB</b></p> | <p><b>Planting works at roof garden</b></p> |

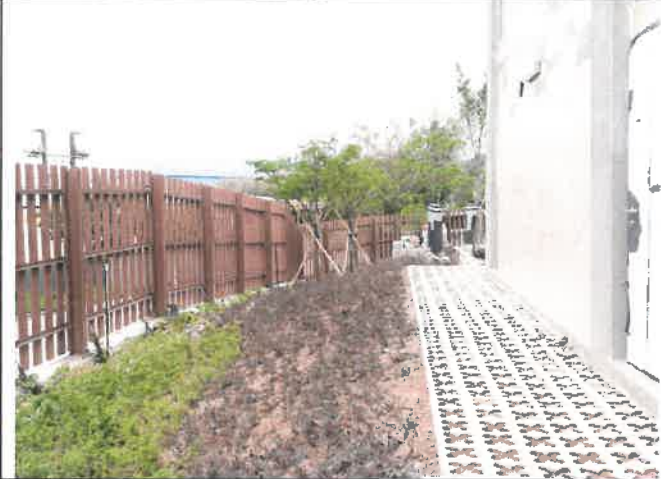
Figure 9

Planting condition along boundary require  
rectification

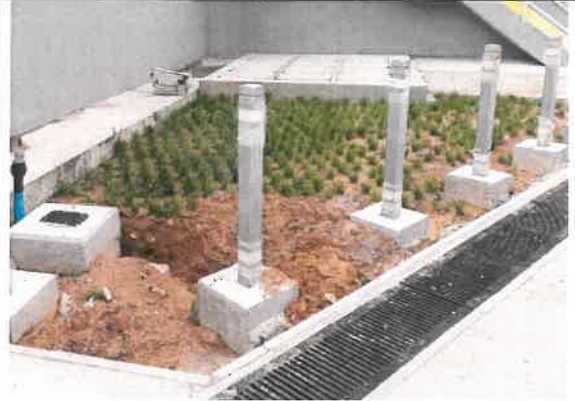
Figure 10

Planting works affected by other works  
require reinstatement

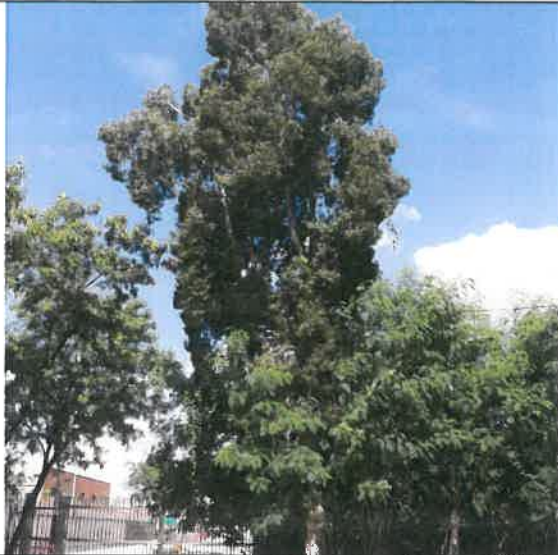
**Figure 3**

Condition of trees at the entrance of the existing treatment plant

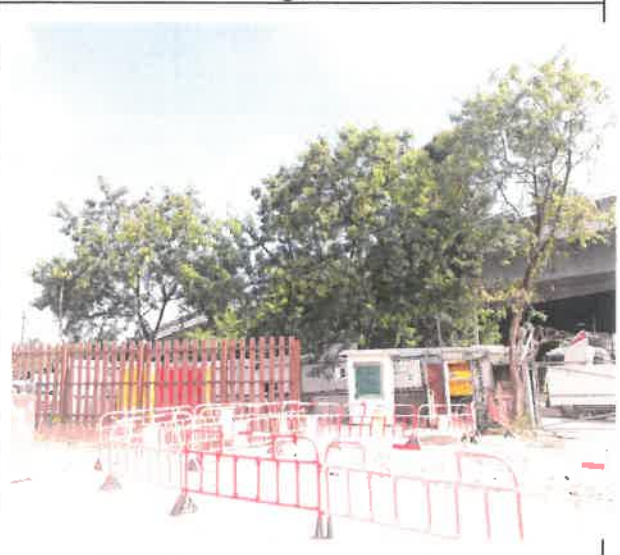
**Figure 4**

Existing trees at the site entrance

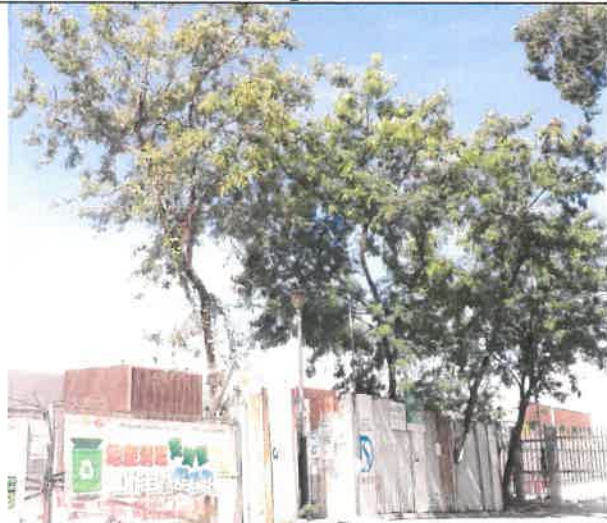
**Figure 5**

Existing trees at the site entrance near the hoarding fence

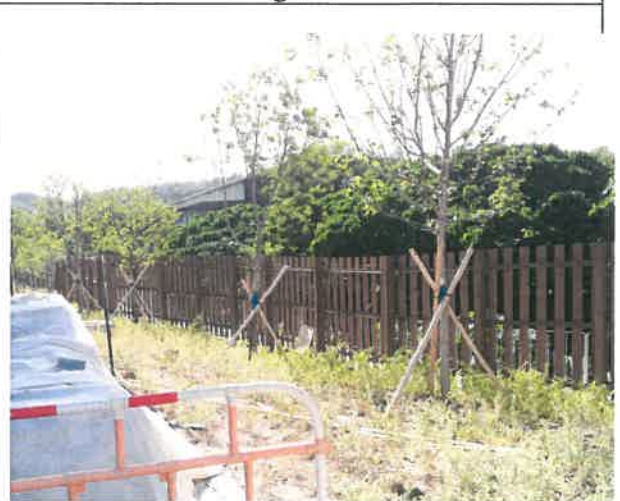
**Figure 6**

Tree planting works near site boundary

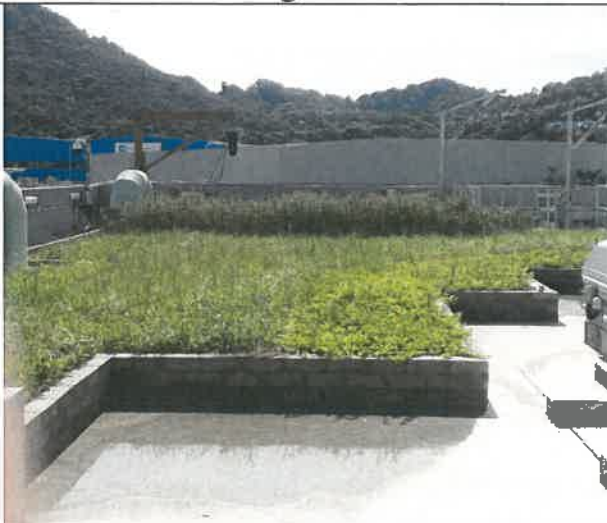
**Figure 7**

Planting works at SDB

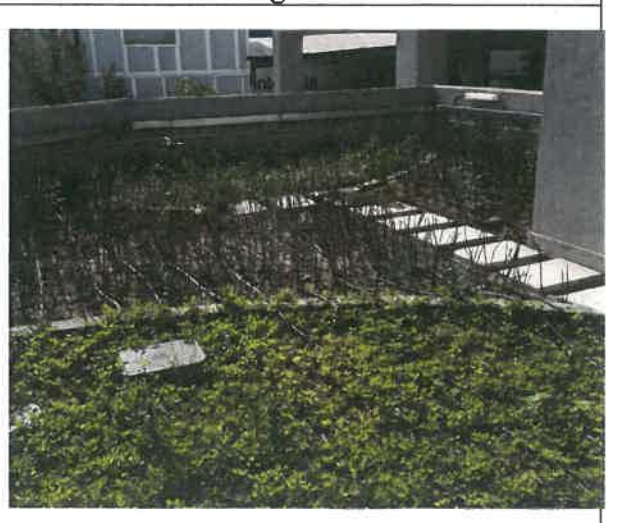
**Figure 8**

Planting works at roof garden

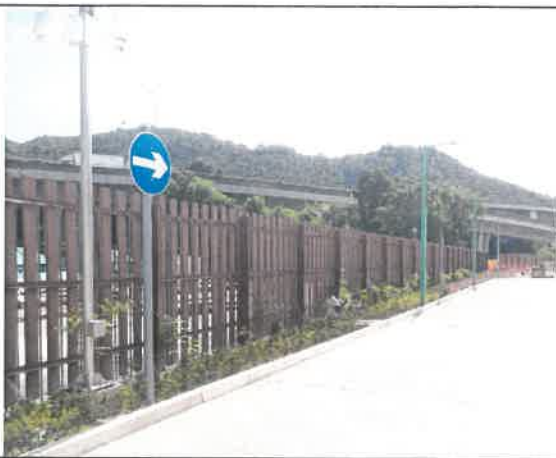
**Figure 10**

| Planting condition along boundary adjacent to the existing plant | Planting works affected by other works still require reinstatement |
