## **ATAL-DEGREMONT-CHINA HARBOUR JOINT VENTURE**

**CONTRACT NO. DC/2013/10 - DESIGN,  
BUILD AND OPERATE SAN WAI  
SEWAGE TREATMENT WORKS –  
PHASE 1**

**QUARTERLY EM&A REPORT  
NO. 17**

**(01 MAY 2021 – 31 JULY 2021)**

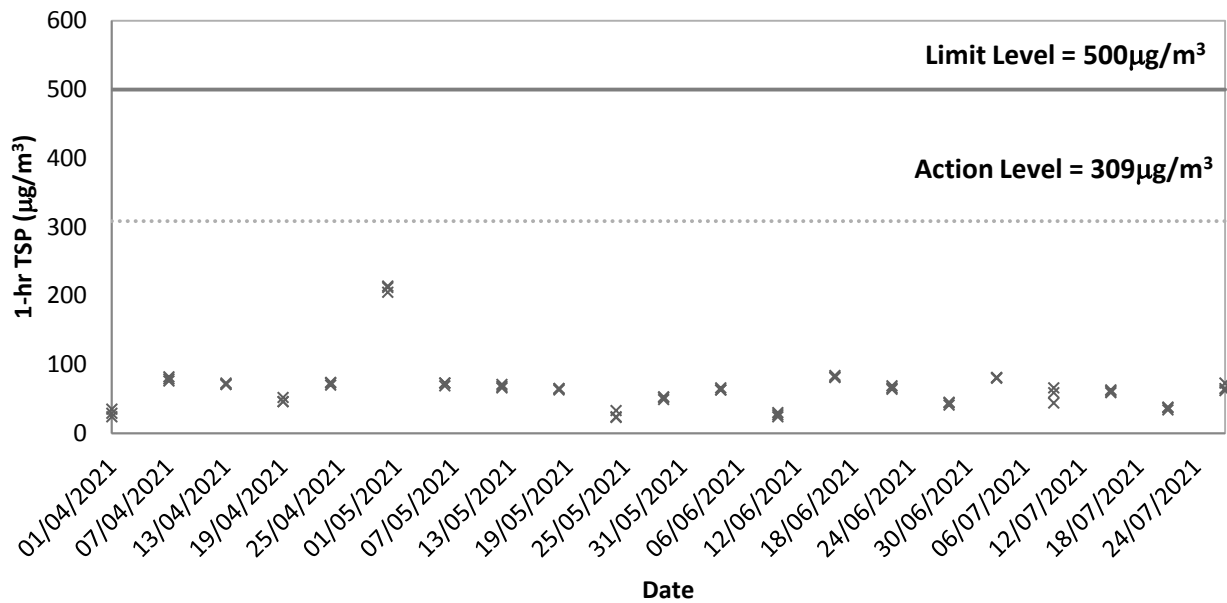
### 1-hr TSP at ASR1a

- 3.1.1. No exceedance of Action and Limit levels was recorded for 1-hr and 24-hr TSP monitoring in this quarter. Graphical presentation of 1-hour and 24-hour TSP monitoring results is shown in **Appendix D**. Wind data included wind speed and wind direction was extracted from Wetland Park Station of Hong Kong Observatory and is presented in **Appendix I**.

- 3.1.2. Generally, 1-hour TSP and 24-hour TSP monitoring results fluctuated well below the Action Level in this reporting period. The major dust source observed near the monitoring stations was mainly from vehicles passing by the container yards and general earth works. It can be concluded that the contractor implemented sufficient dust mitigation measures during this reporting quarter.

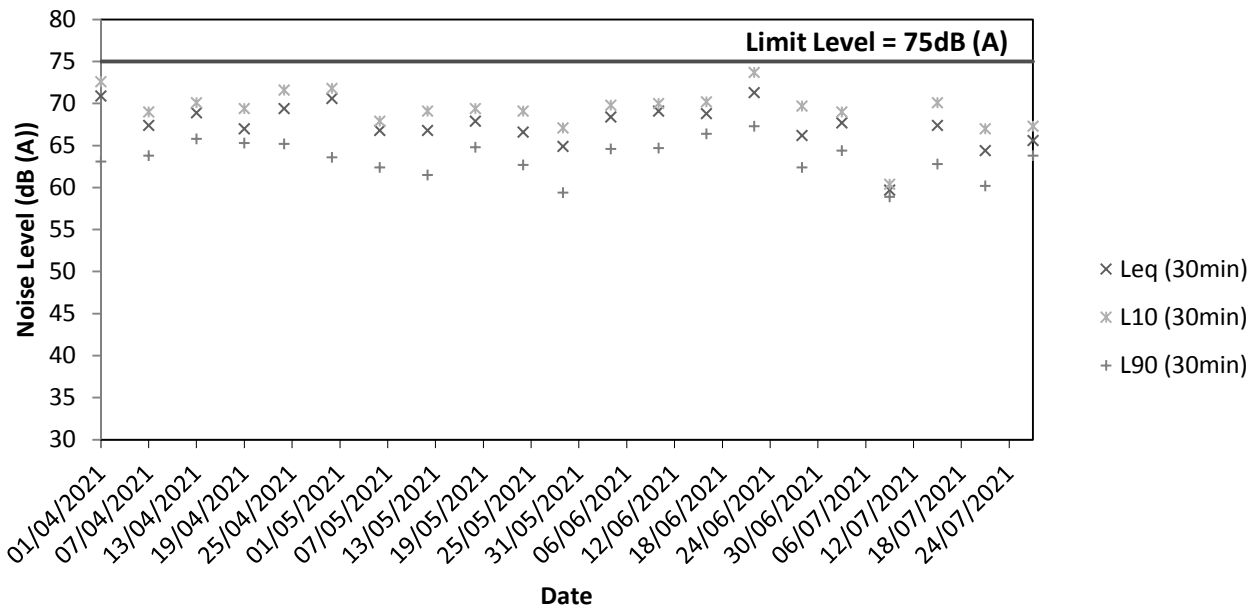
## Noise Level at NSR1a

- 3.2.1. No exceedance of Action and Limit Level of noise monitoring results was recorded during the reporting quarter. Graphical presentation of 1-hour and 24-hour TSP monitoring results for the reporting period is shown in **Appendix E**.
- 3.2.2. The noise monitoring data were found to be lower than the limit level. The major noise source during the monitoring event was the vehicles passing through the container yard entrance and the general earth works inside the construction site.
- 3.2.3. Since NSR1a and NSR2b were located inside the container yards, the frequency of vehicles moving in and out the container yards would influence the noise monitoring results.

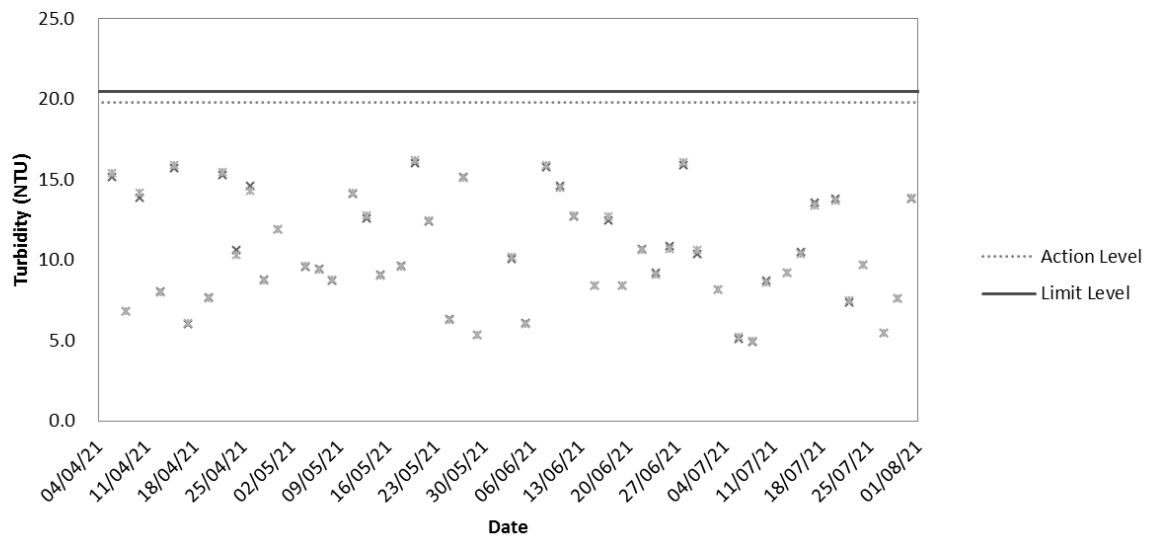
### Impact Turbidity Result

- 3.3.1. According to the summary of water monitoring results, no exceedance of Action and Limit levels was recorded in this reporting period. Graphical presentation of the monitoring results for the reporting period is shown in **Appendix F**.
- 3.3.2. Generally, the turbidity and suspended solids were found to be lower than the action level. Besides, all results of dissolved oxygen measured in this reporting period were higher than the action level.
- 3.3.3. Aside from the discharge, weather condition would be a major factor that affects the water quality in Tin Shui Wan Nallah. In rainy day, the soil and other suspended materials were flushed along the shore and entered the Tin Shui Wai Nullah. Besides, the nullah water would flow rapidly and the sand and stones in the nullah bed were upturned. Thus, the water quality would be deteriorated.

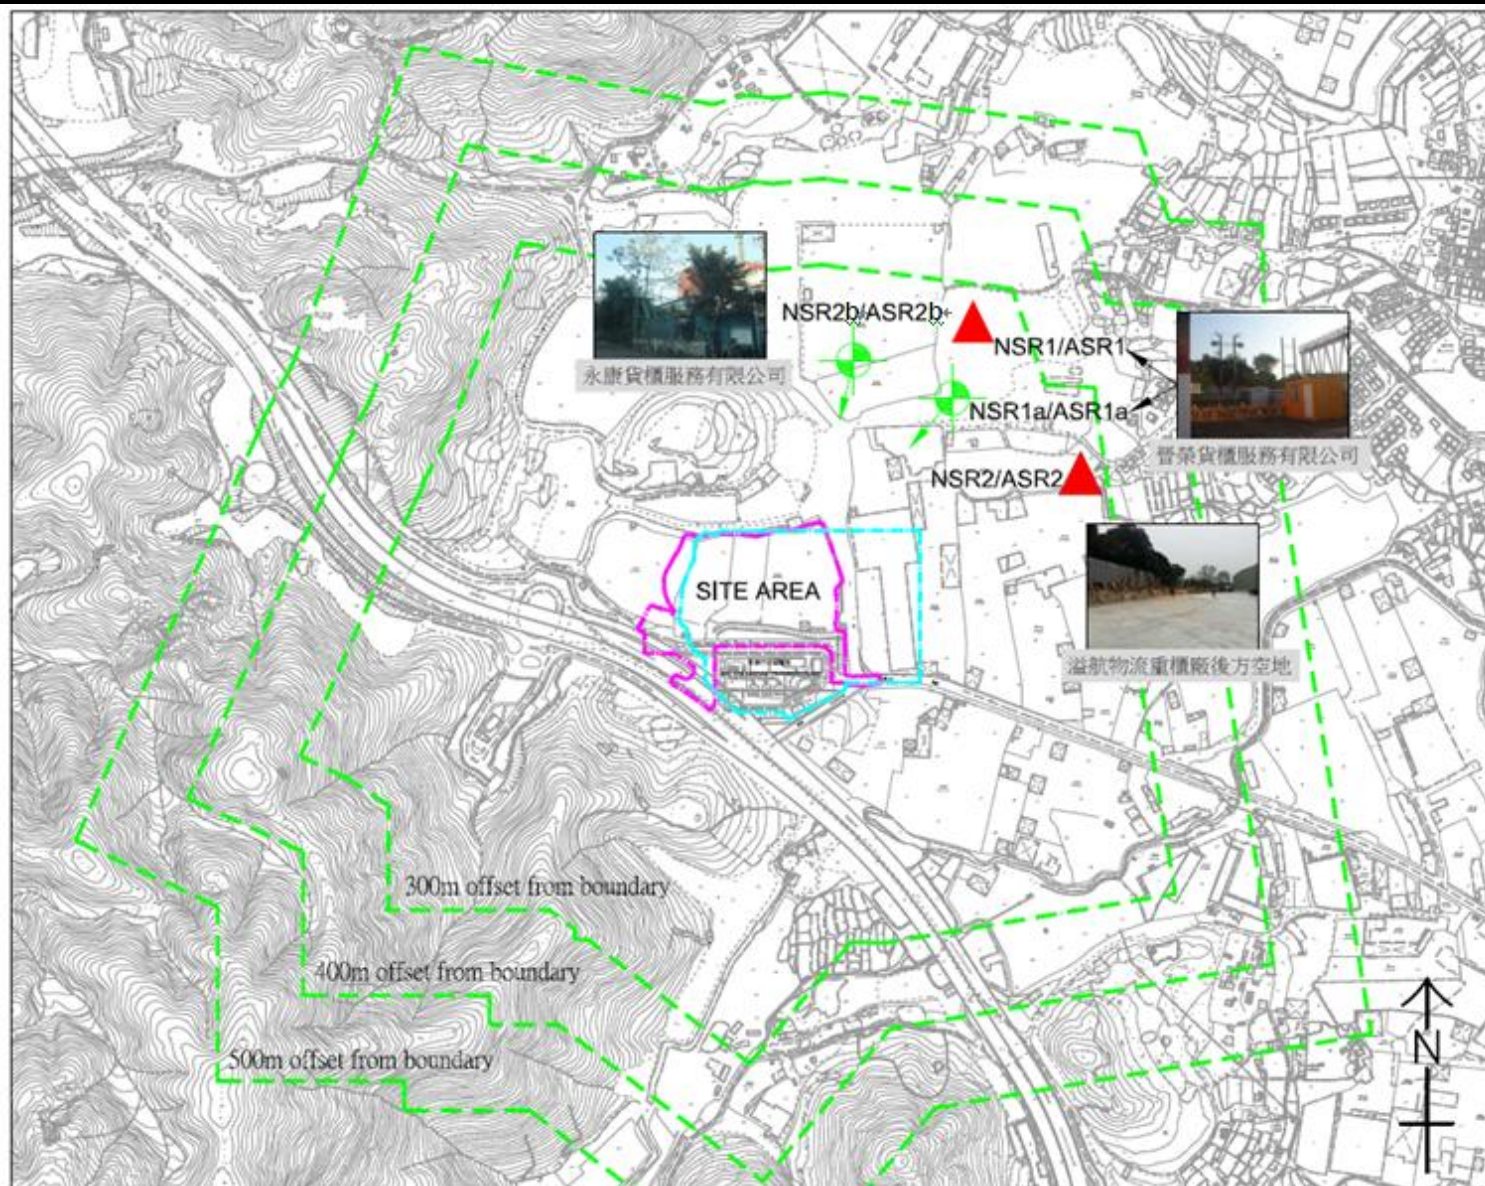
## **Figure 1**

In accordance with the EM&A Manual, 1-hr and 24-hr TSP air quality monitoring were conducted three times and once per six days correspondingly. Air quality monitoring were conducted at ASR1a (晉榮貨櫃服務有限公司) and ASR2b (永康貨櫃服務有限公司), which was shown in **Figure 1** and **Figure 2**.

Noise levels ( $L_{eq}$ ,  $L_{10}$  and  $L_{90}$ ) were monitored in the reporting period in accordance with the EM&A Manual. Noise monitoring were performed at NSR1a (晉榮貨櫃服務有限公司) and NSR2b (永康貨櫃服務有限公司), which was shown in **Figure 1** and **Figure 2**.

### **Locations of Air Quality and Noise Monitoring Stations**

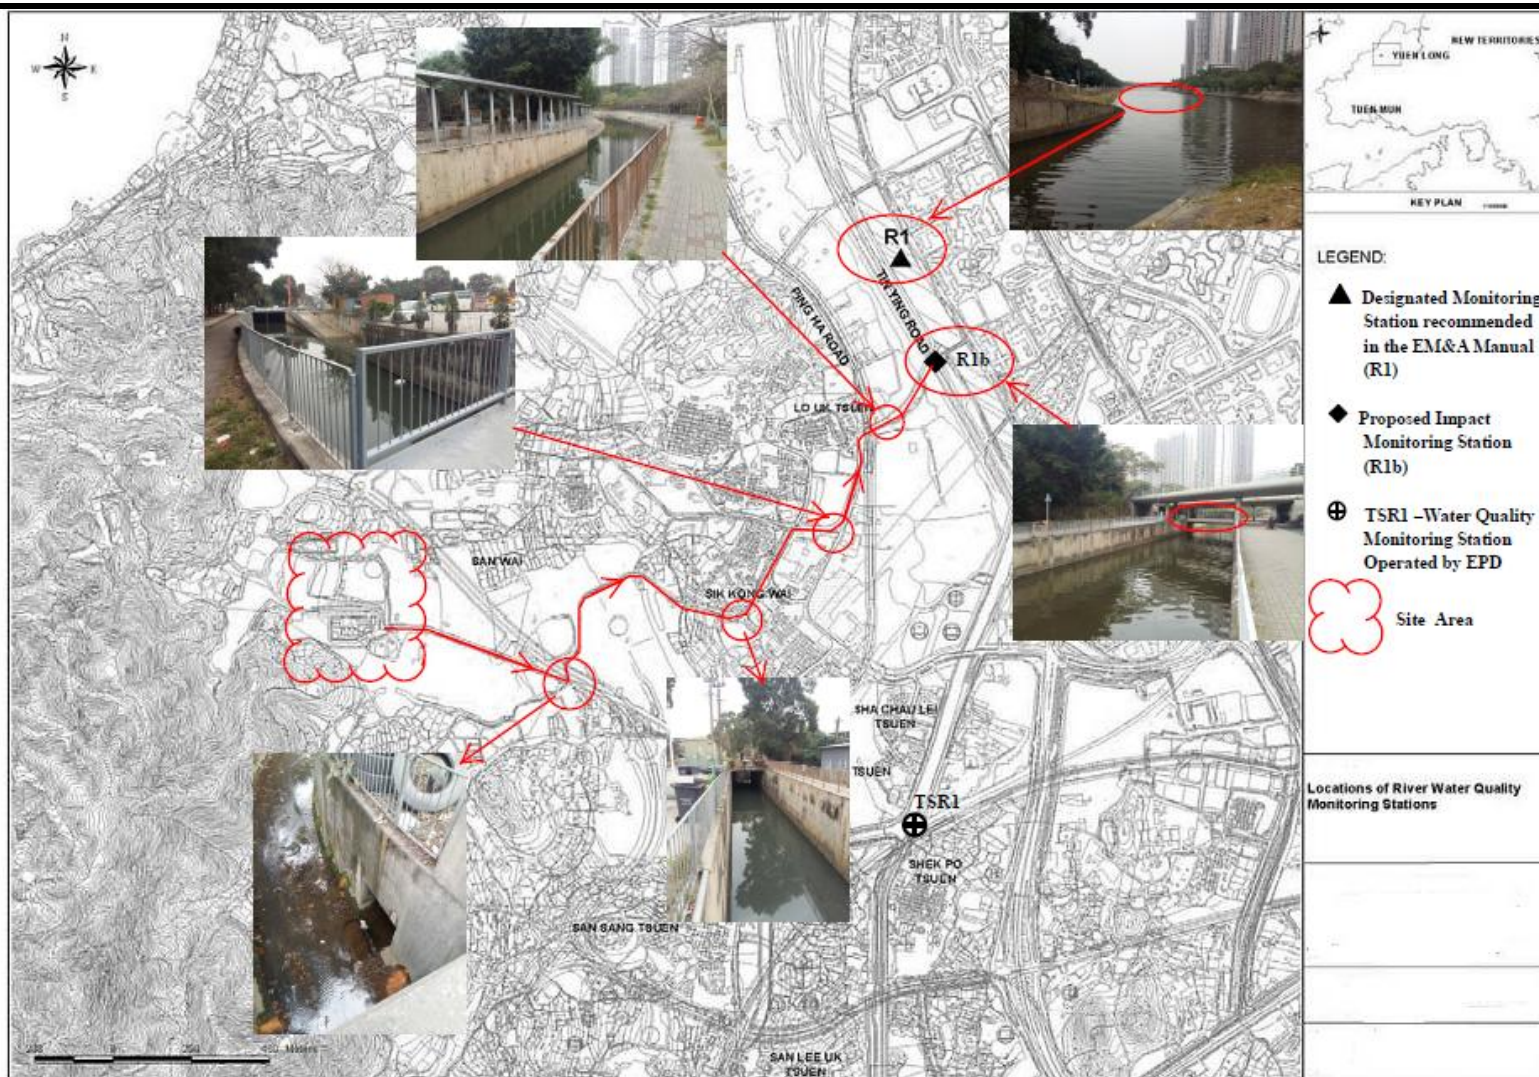
## **Figure 2**

Water quality was monitored 3 times per week in the reporting period in accordance with the EM&A Manual at the one alternative water quality monitoring station, R1b (at Tin Shui Wai Nullah) which shown in **Figure 2**.

### **Locations of Water Quality Monitoring Station**

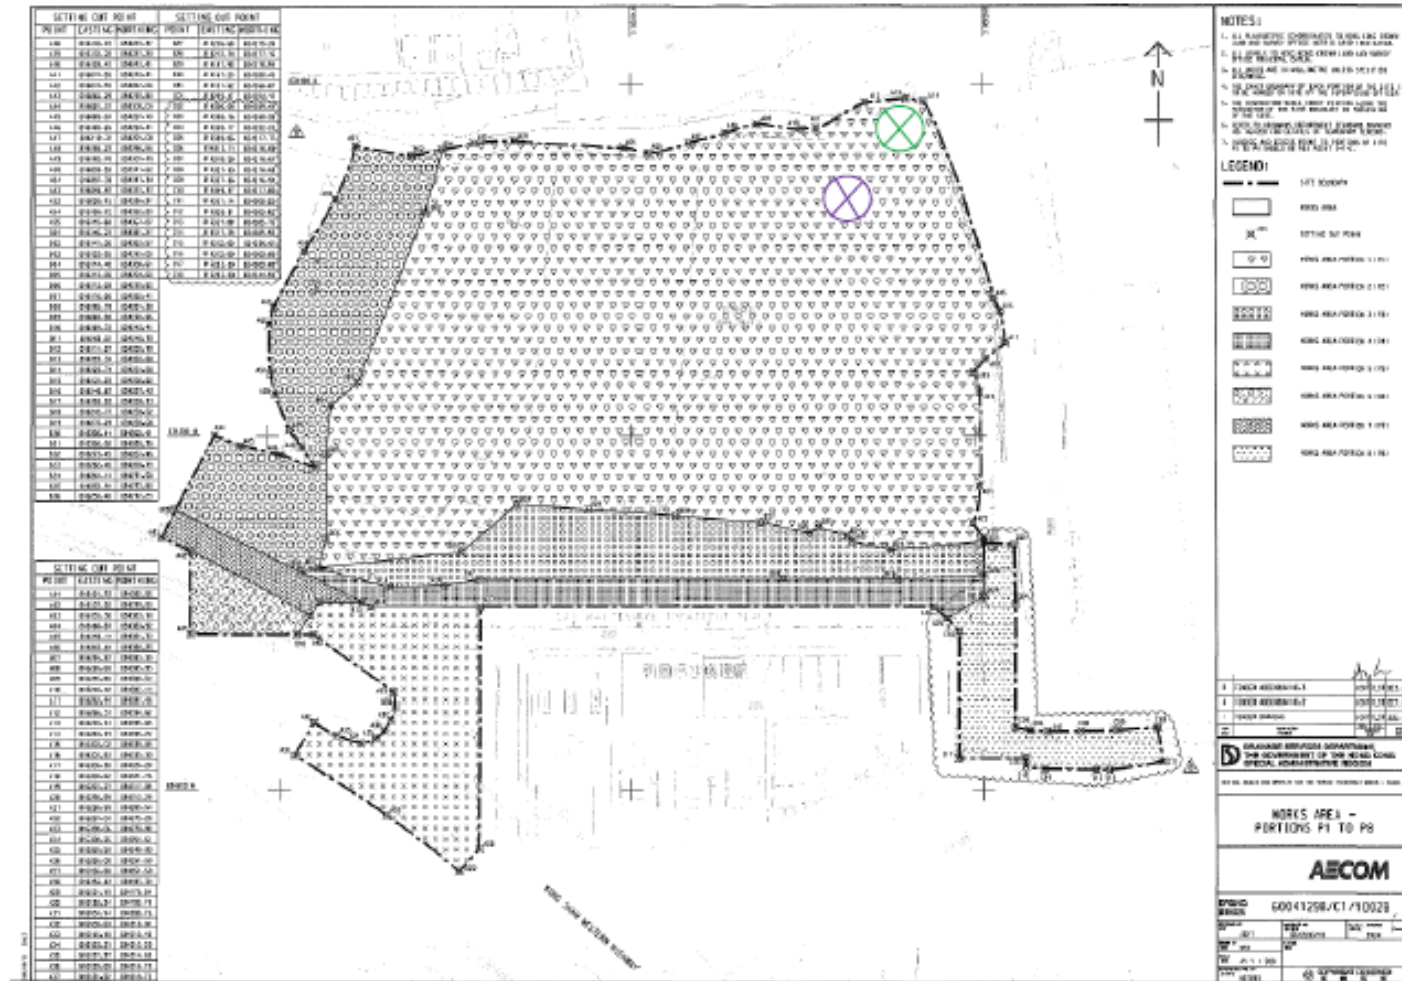
### **Figure 3**

#### **Location Plan for the Wetsep Treatment Tank**

#### 3.7.1. Effluent quality was monitored in the reporting quarter in accordance with the EM&A Manual at the discharge point. The location of Wetsep treatment tank was shown in **Figure 3**. A discharge license under Water Pollution Control Ordinance was obtained by the Contractor upon commencement of the Project. Self-monitoring would be performed as per the requirement under the discharge license. According to the EM&A Manual, pH, chemical oxygen demand and total suspended solid are required to be analysed at least once every two week.
