CONTRACT NO. DC/2013/10 - DESIGN, BUILD AND OPERATE SAN WAI SEWAGE TREATMENT WORKS – PHASE 1

> QUARTERLY EM&A REPORT NO. 18

(01 AUGUST 2021 - 31 OCTOBER 2021)

Report No.: ENA15782

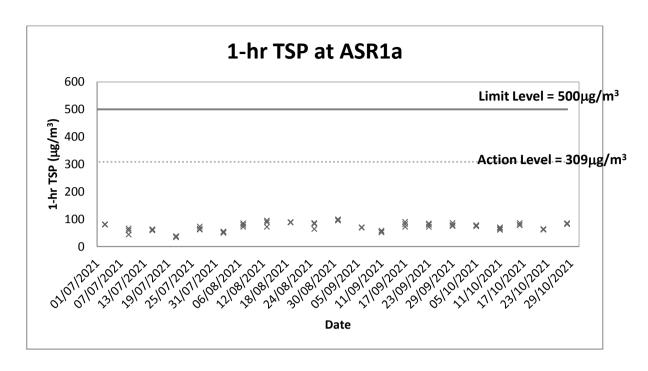
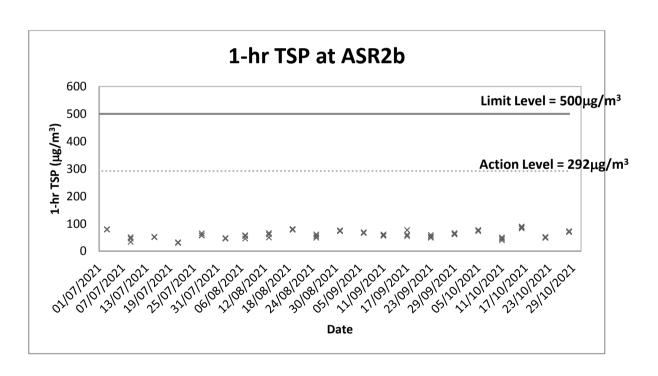
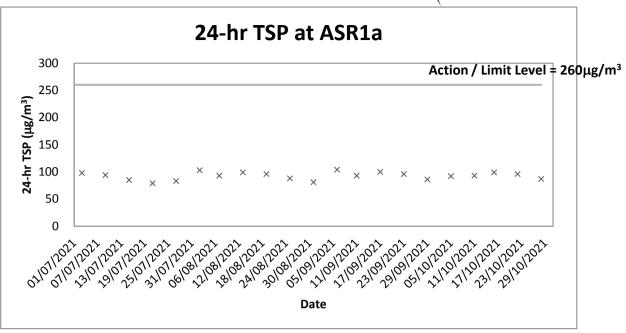
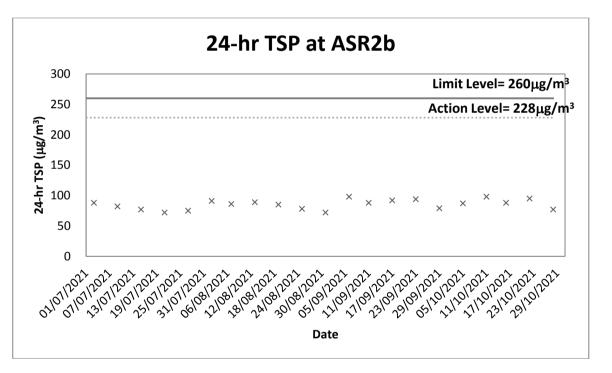
Graphical Plots of Impact Air Quality Monitoring Results

- 3.1.1. No exceedance of Action and Limit levels was recorded for 1-hr and 24-hr TSP monitoring in this quarter. Graphical presentation of 1-hour and 24-hour TSP monitoring results is shown in Appendix D. Wind data included wind speed and wind direction was extracted from Wetland Park Station of Hong Kong Observatory and is presented in Appendix I.

- **3.1.2.** Generally, 1-hour TSP and 24-hour TSP monitoring results fluctuated well below the Action Level in this reporting period. The major dust source observed near the monitoring stations was mainly from vehicles passing by the container yards and general earth works. It can be concluded that the contractor implemented sufficient dust mitigation measures during this reporting quarter.

- 3.1.3. Apart from the construction activities, the cargo trunks passing through the container yards (晉榮貨櫃服務有限公司 and 永康貨櫃服務有限公司) would also generate dust since the Ha Tsuen Road was mainly made by soil and sand. A part of 1-hour TSP and 24-hour TSP monitoring results were contributed by the cargo trunks.

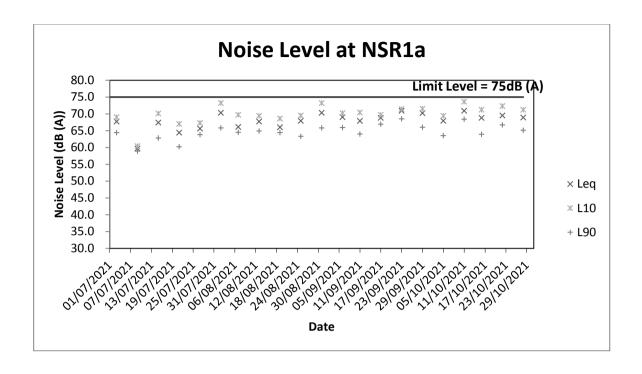
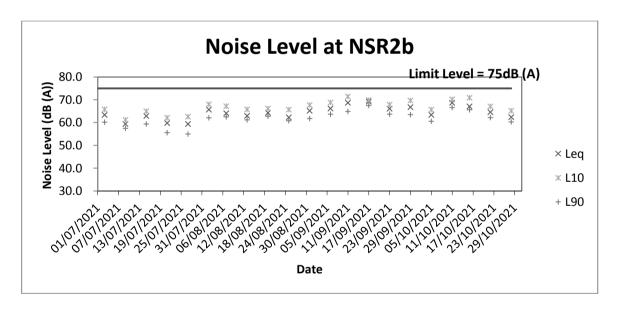
Graphical Plots of Impact Noise Monitoring Data

- **3.2.1.** No exceedance of Action and Limit Level of noise monitoring results was recorded during the reporting quarter. Graphical presentation of 1-hour and 24-hour TSP monitoring results for the reporting period is shown in **Appendix E**.
- **3.2.2.** The noise monitoring data were found to be lower than the limit level. The major noise source during the monitoring event was the vehicles passing through the container yard entrance and the general earth works inside the construction site.
- **3.2.3.** Since NSR1a and NSR2b were located inside the container yards, the frequency of vehicles moving in and out the container yards would influence the noise monitoring results.

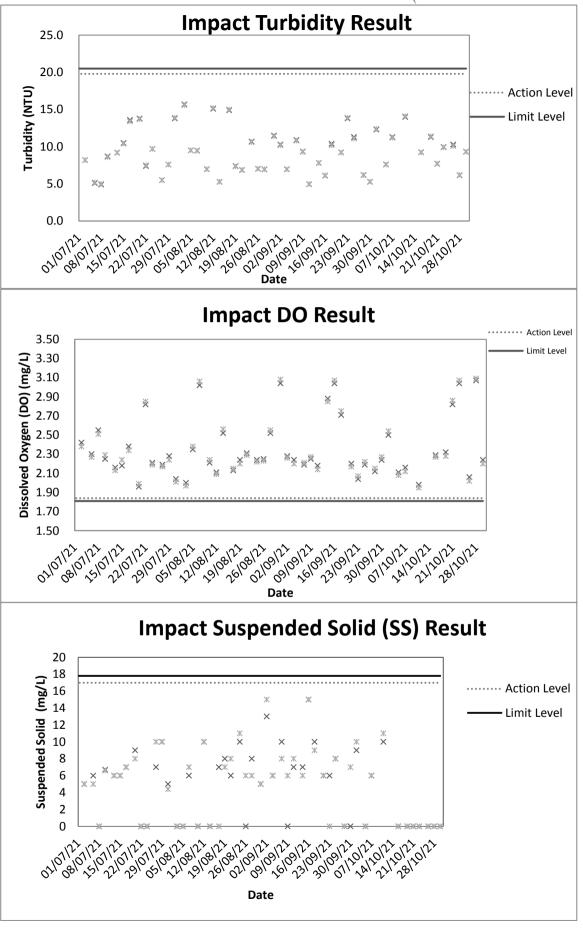
Graphical Plots of Impact Water Quality Monitoring Data

- **3.3.1.** According to the summary of water monitoring results, no exceedance of Action and Limit levels was recorded in this reporting period. Graphical presentation of the monitoring results for the reporting period is shown in **Appendix F**.
- **3.3.2.** Generally, the turbidity and suspended solids were found to be lower than the action level. Besides, all results of dissolved oxygen measured in this reporting period were higher than the action level.
- **3.3.3.** Aside from the discharge, weather condition would be a major factor that affects the water quality in Tin Shui Wan Nallah. In rainy day, the soil and other suspended materials were flushed along the shore and entered the Tin Shui Wai Nullah. Besides, the nullah water would flow rapidly and the sand and stones in the nullah bed were upturned. Thus, the water quality would be deteriorated.

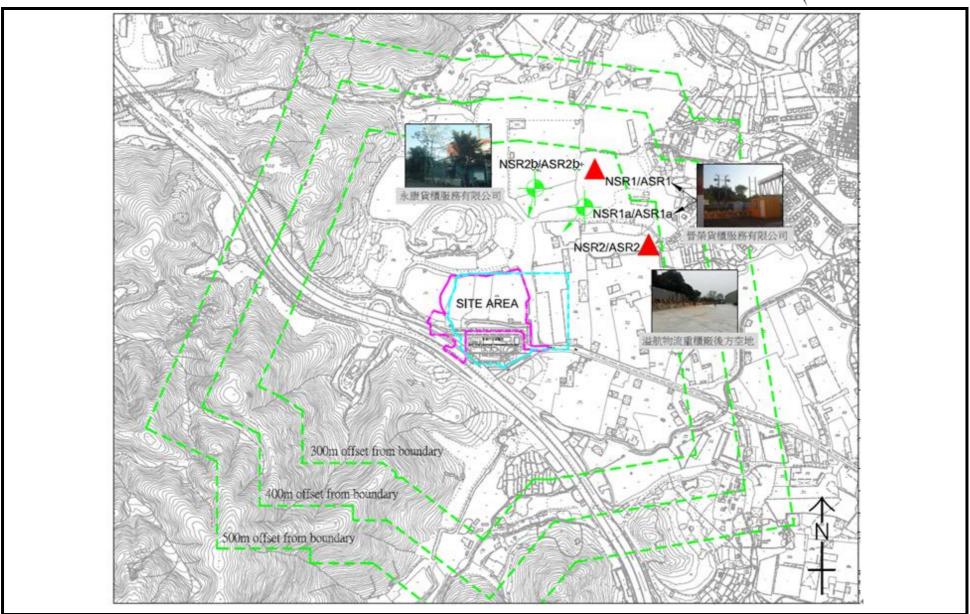
Project: Contract No. DC/2013/10 - Design, Build and Operate San Wai Sewage Treatment Works – Phase 1 Figure 1 Locations of Air Quality and Noise Monitoring Stations

Locations of Air Quality and Noise Monitoring Stations

In accordance with the EM&A Manual, 1-hr and 24-hr TSP air quality monitoring were conducted three times and once per six days correspondingly. Air quality monitoring were conducted at ASR1a (晉榮貨櫃服務有限公司) and ASR2b (永康貨櫃服務有限公司), which was shown in **Figure 1** and **Figure 2**.

Noise levels (L_{eq} , L_{10} and L_{90}) were monitored in the reporting period in accordance with the EM&A Manual. Noise monitoring were performed at NSR1a (晉榮貨櫃服務有限公司) and NSR2b (永康貨櫃服務有限公司), which was shown in **Figure 1** and **Figure 2**.

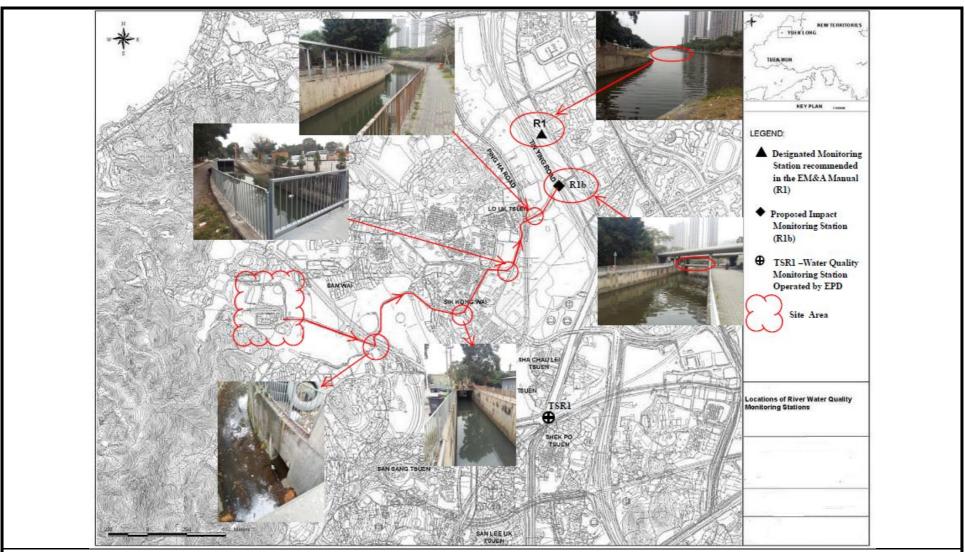
Project: Contract No. DC/2013/10 - Design, Build and Operate San Wai Sewage Treatment Works – Phase 1 Figure 2 Locations of Water Quality Monitoring Station

Figure 2 Locations of Water Quality Monitoring Station

Water quality was monitored 3 times per week in the reporting period in accordance with the EM&A Manual at the one alternative water quality monitoring station, R1b (at Tin Shui Wai Nullah) which shown in **Figure 2**.
