DSD CONTRACT No.: DC/2009/08

CONSTRUCTION OF YUEN LONG SOUTH BRANCH SEWERS AND EXPANSION OF HA TSUEN SEWAGE PUMPING STATION

6TH ENVIRONMENTAL MONITORING & AUDIT MONTHLY REPORT – JULY 2010

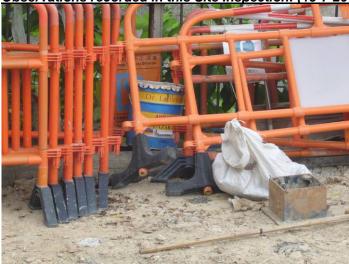
Observations recorded in this Site Inspection: (15-7-2010)

Remark 1: Chemical label and drip tray should be provided for the chemical drum

Remark 2: Sand and mud was observed at the public road, the contractor was reminded to clean and keep the public road near the site area was clean.

The chemical drum was found to be removed.

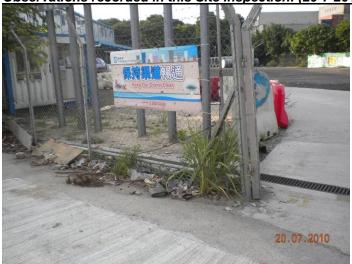
Observations recorded in this Site Inspection: (20-7-2010)

Remark 1: The contractor was reminded to clean the workfront to keep the site clean and tidy at Ha Tsuen Road

- 1. House keeping shall be further improved.
- 2. The stockpile was found to be removed/
