DSD CONTRACT No.: DC/2009/08

CONSTRUCTION OF YUEN LONG SOUTH BRANCH SEWERS AND EXPANSION OF HA TSUEN SEWAGE PUMPING STATION

7<sup>TH</sup> ENVIRONMENTAL MONITORING & AUDIT MONTHLY REPORT – AUGUST 2010

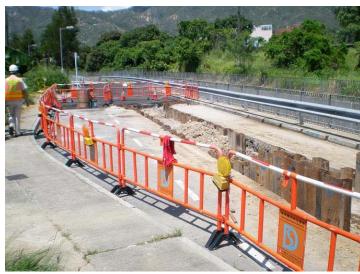
#### Follow up of last Site Inspection:

- 1. C&D wastes on site and the weed on the railing were found to be cleared. (Tai Shu Ha Road)
- 2. Housekeeping at Ha Tsuen Pumping station was improved.

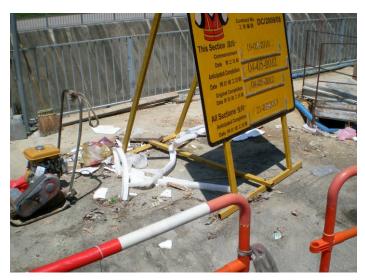
Observations recorded in this Site Inspection: (10-8-2010)

Remark 1: General refuse scattered was observed, housekeeping should be improved to maintain the site clean and tidy. (Kui Hing Road)

Remark 2: Sand and mud tail was observed at the public road, the contractor was reminded to clean and keep the public road near the site area was clean. (Tai Shu Ha Road)

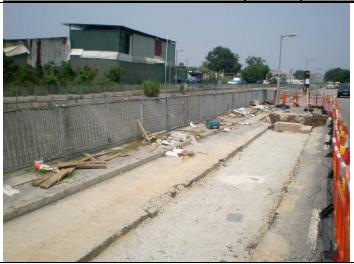
Observations recorded in this Site Inspection: (31-8-2010)

Remark 1: C&D material scattered on the site was observed, housekeeping should be improved to maintain the site tidiness. (Tai Shu Ha Road)
