**CONSTRUCTION OF YUEN LONG SOUTH BRANCH
SEWERS AND EXPANSION OF HA TSUEN SEWAGE
PUMPING STATION**

**THE FIFTH RESULTS OF LANDSCAPE AND VISUAL IMPACT MONITORING
FOR JUNE 2010 (No.5)**

Landscape and Visual Impact Assessment Site Inspection Checklist

Contract No.: DC/2009/08
Contract title: Construction of Yuen Long South Sewer and Expansion of Ha Tsuen Sewage Pumping Station
Contractor: China State Construction Engrg. (HK) Ltd.
Location: Ha Tsuen Sewage Pumping Station
Inspection Date: 30-Jun-2010

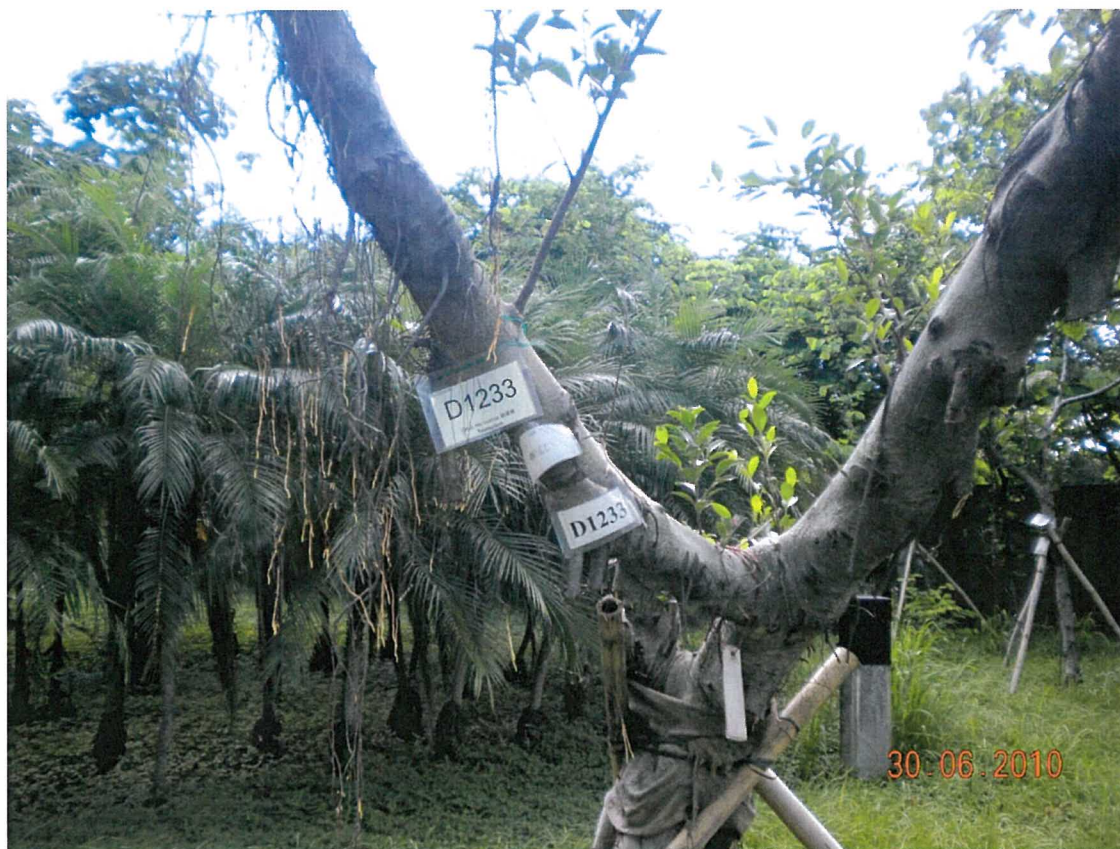
Tree Nos.	Health	Tree Form	Comments	Suggested treatment
HA245	Dying	Fair	Dying	Water more frequently
HA260	Fair	Fair	Fungi attack	Need to spray insecticide
D1233	Fair	Fair	Found dead branch	Pruning
D1240	Fair	Fair	Found dead branch and the knot of	Pruning, release knot of aerial
HA211	Fair	Fair	Die branch	Pruning
