JOB No.: TCS00491/09

DSD CONTRACT No.: DC/2009/08

CONSTRUCTION OF YUEN LONG SOUTH BRANCH
SEWERS AND EXPANSION OF HA TSUEN SEWAGE
PUMPING STATION

21ST ENVIRONMENTAL MONITORING & AUDIT
MONTHLY REPORT – OCTOBER 2011

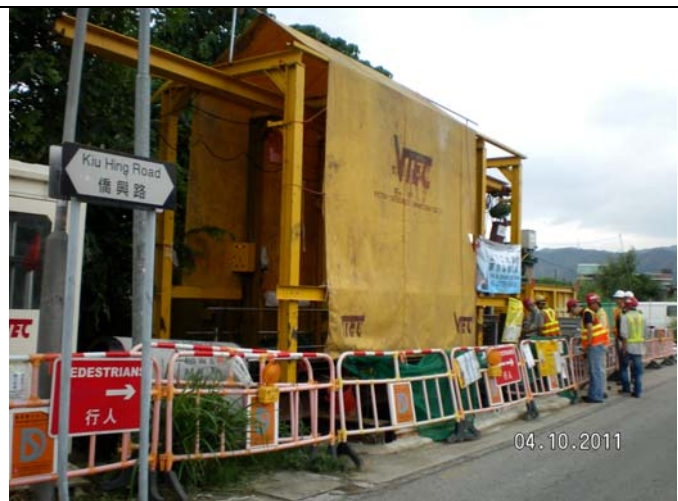
1. Oil stain was not observed on the hard paved ground at Kiu Hing Road.

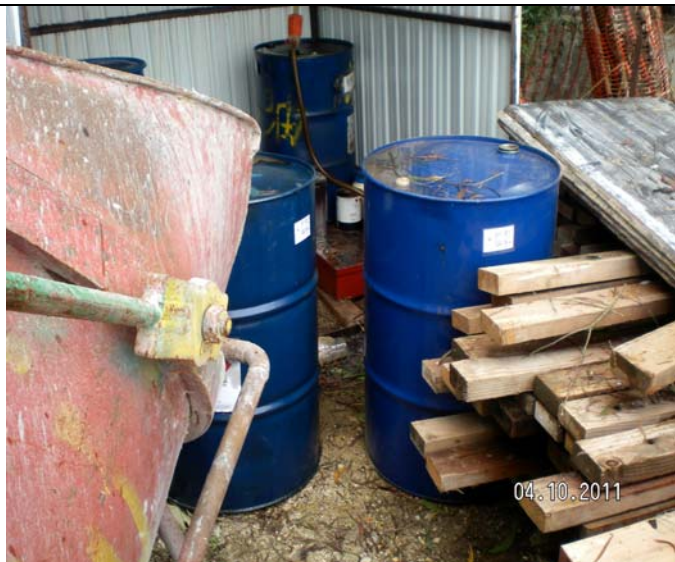
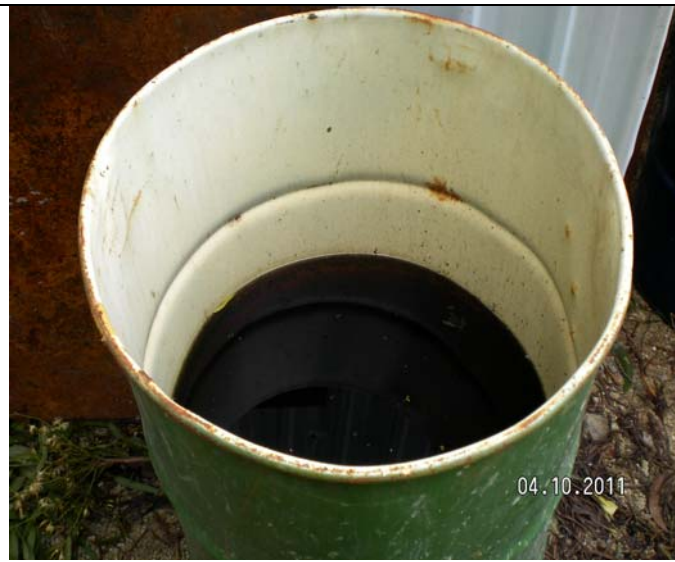
Observations recorded in this Site Inspection: (04-Oct-2011)

1. Oil drums without drip tray were observed in HT p/s site. Drip trays or removal of the oil drums are required.
2. A drum containing waste was observed without cover at Ha Tsuen Pumping Station. covering of the oil drum is required to avoid overflow to cause contamination of the environment.

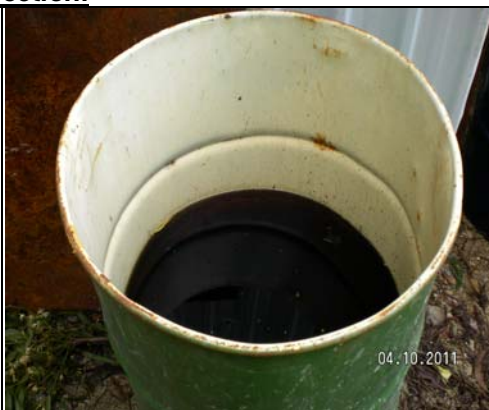
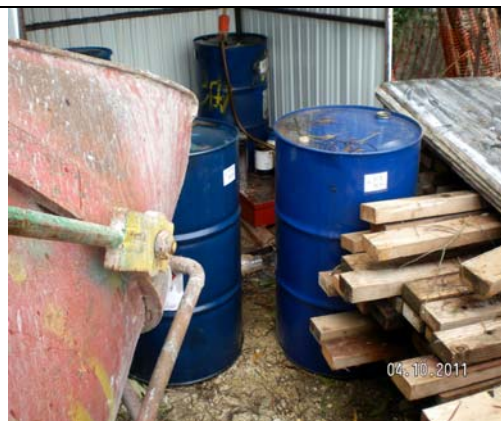
1. The deficiencies are On-Going.

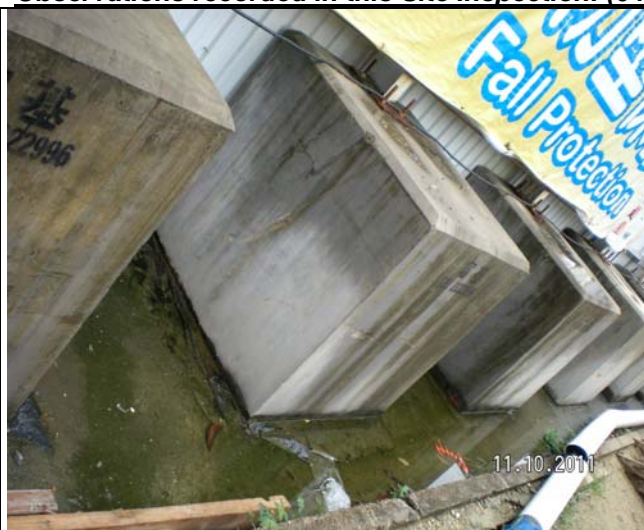
Observations recorded in this Site Inspection: (04-Oct-2011)

1. Stagnant water due to rain was observed along the site. Mosquito control is reminded.

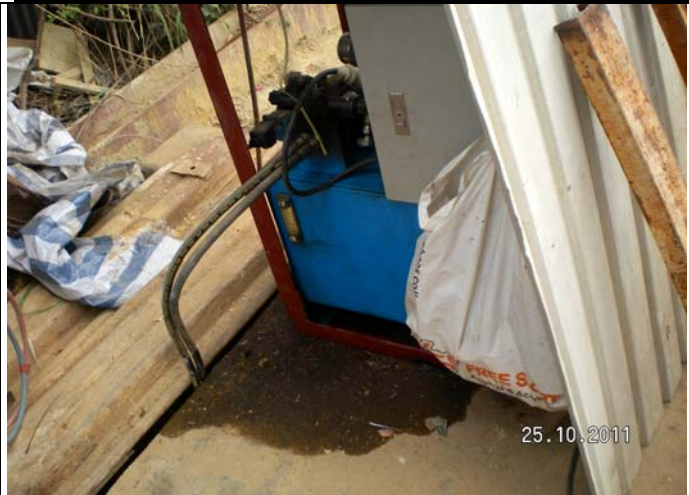
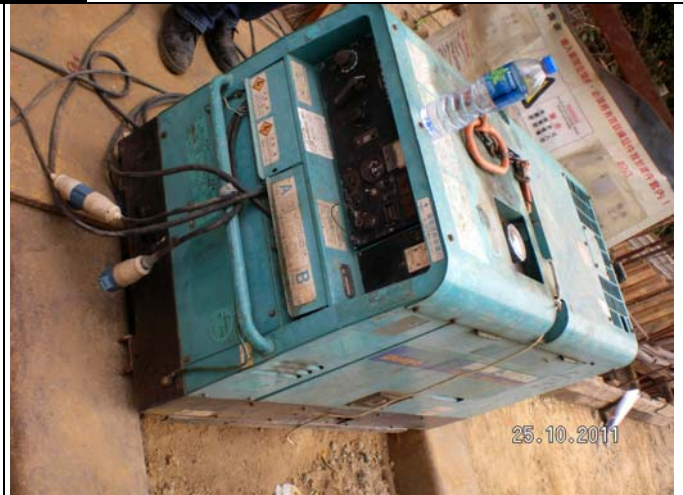
Observations recorded in this Site Inspection: (25-Oct-2011)

<p>1. Oil leakage from generator without drip tray was observed in the Ha Tsuen Rd construction site. Clearance of the oil and Drip tray or removal of the equipment from the site is required.</p>	<p>2. Generator without drip tray was observed. Drip tray or removal of the equipment from the site is required</p>
