Quotation Ref. 23-02230  
Provision of Independent Environmental Checker Consultancy Services  
for West New Territories Landfill Extension  
Decommissioning of Remaining Portion of Middle Ash Lagoon in Tsang Tsui  
Monthly Dust Monitoring Report No.11

1. This is the 11th Monthly Dust Monitoring Report for Contract No. EP/SP/186/21 “West New Territories Landfill Extension (WENTX)” at Nim Wan, Tuen Mun. This report summarized the monitoring results and audit findings of the EM&A programme in accordance with the Dust Monitoring Plan under clause 2.2 of the EP (EP/618/2022) and clause 2.2 of the FEP (FEP-01/618/2022) during the 11th reporting month covering 1 January to 31 January 2025.

***Decommissioning of Remaining Portion of Middle Ash Lagoon in Tsang Tsui***  
**Monthly Dust Monitoring Report No.11 (1 January to 31 January 2025)**

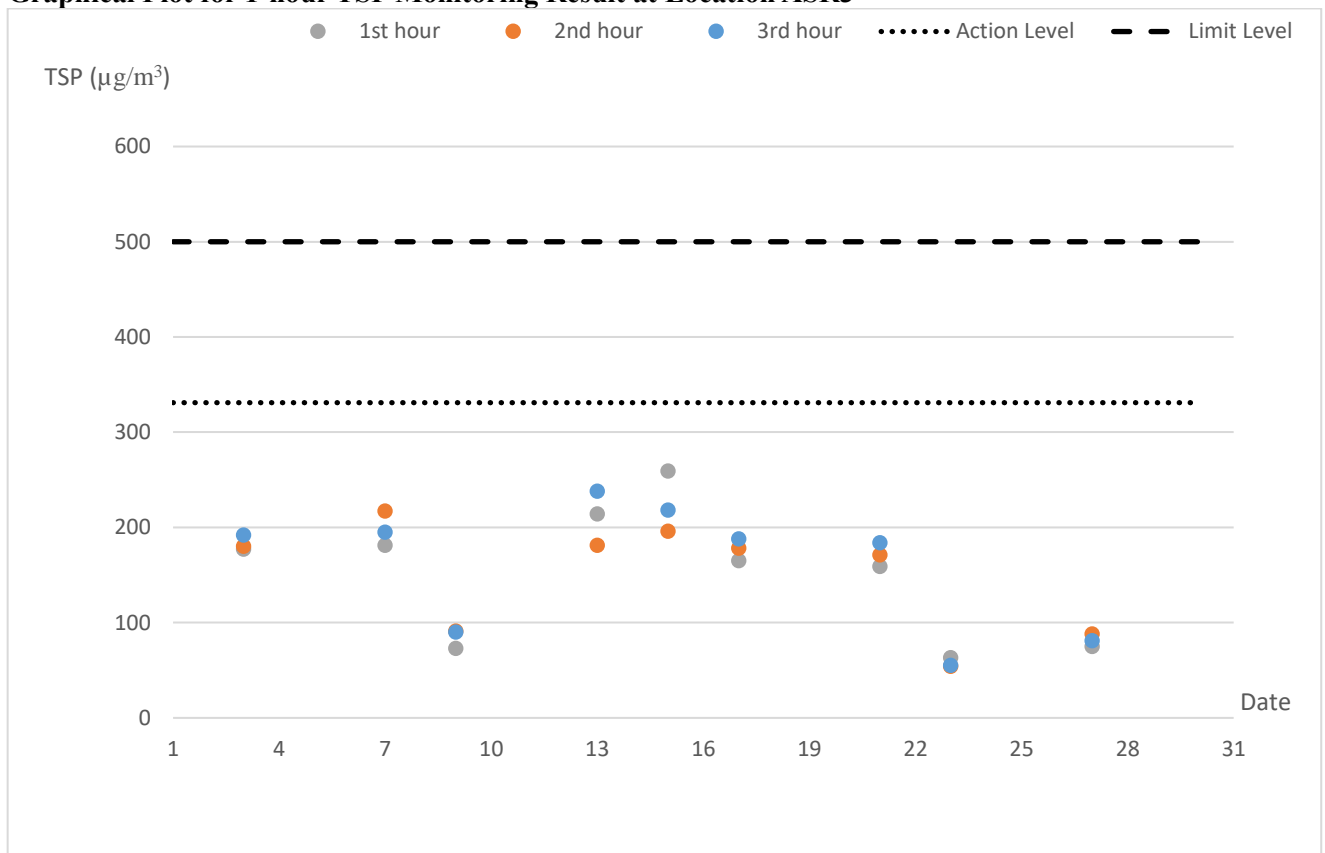
**Graphical Plot for 1-hour TSP Monitoring Result at Location ASR3**

Date	Start Time	1-hour TSP ( $\mu\text{g}/\text{m}^3$ )			Action Level ( $\mu\text{g}/\text{m}^3$ )	Limit Level( $\mu\text{g}/\text{m}^3$ )
		1 <sup>st</sup> reading	2 <sup>nd</sup> reading	3 <sup>rd</sup> reading		
3-Jan-25	09:25	177	180	192	331	500
7-Jan-25	09:40	181	217	195	331	500
9-Jan-25	09:35	73	91	90	331	500
13-Jan-25	13:31	214	181	238	331	500
15-Jan-25	09:25	259	196	218	331	500
17-Jan-25	09:35	165	178	188	331	500
21-Jan-25	09:35	159	171	184	331	500
23-Jan-25	09:35	63	54	55	331	500
27-Jan-25	09:30	75	88	81	331	500
