Quotation Ref. 23-02230  
Provision of Independent Environmental Checker Consultancy Services for  
West New Territories Landfill Extension  
Decommissioning of Remaining Portion of Middle Ash Lagoon in Tsang Tsui  
Monthly Dust Monitoring Report No.18

1. This is the 18th Monthly Dust Monitoring Report for Contract No. EP/SP/186/21 “West New Territories Landfill Extension (WENTX)” at Nim Wan, Tuen Mun. This report summarized the monitoring results and audit findings of the EM&A programme in accordance with the Dust Monitoring Plan under clause 2.2 of the EP (EP/618/2022) and clause 2.2 of the FEP (FEP-01/618/2022) during the 18th reporting month covering 1 August to 31 August 2025.

***Decommissioning of Remaining Portion of Middle Ash Lagoon in Tsang Tsui***  
**Monthly Dust Monitoring Report No.18 (1 Aug to 31 Aug 2025)**

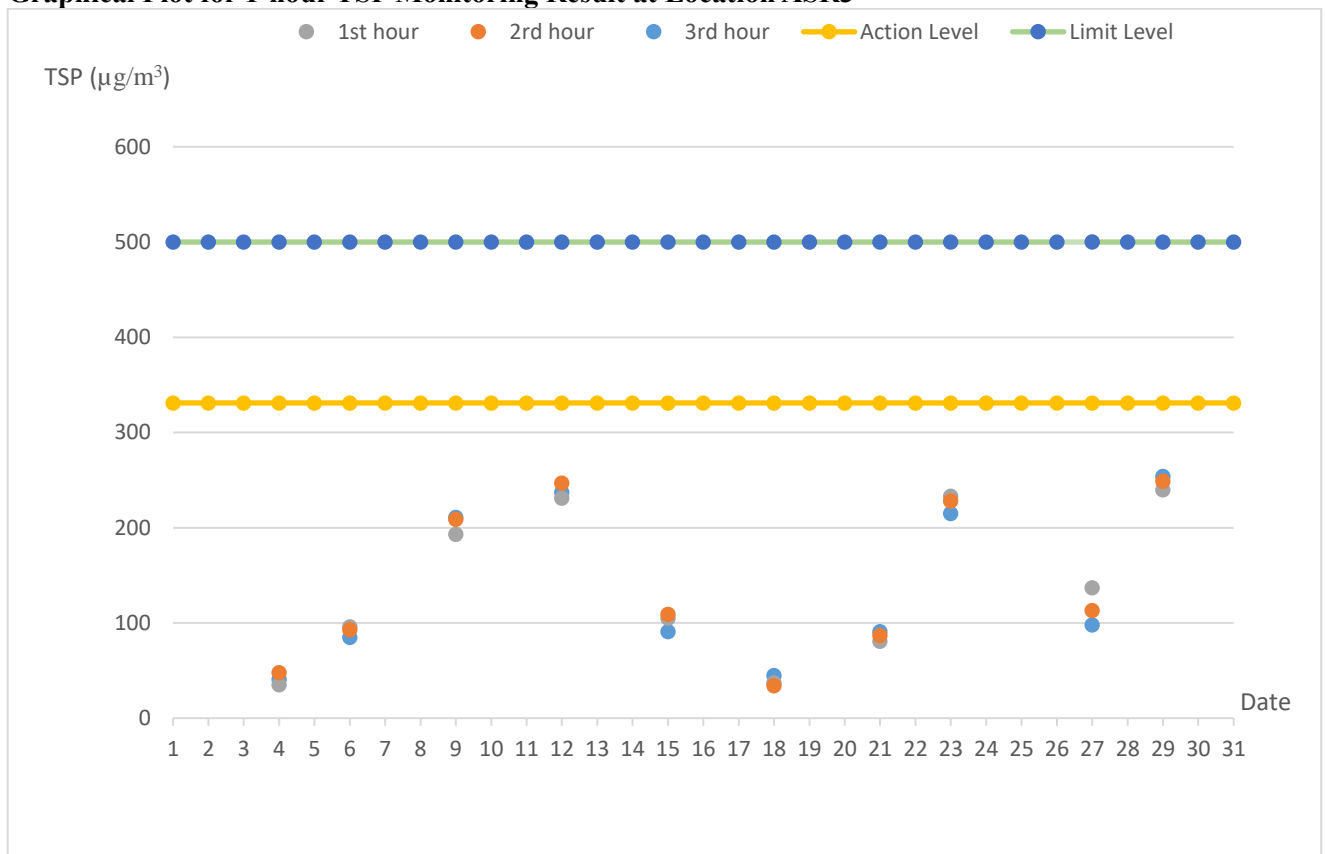
**Graphical Plot for 1-hour TSP Monitoring Result at Location ASR3**

Date	Start Time	1-hour TSP ( $\mu\text{g}/\text{m}^3$ )			Action Level ( $\mu\text{g}/\text{m}^3$ )	Limit Level( $\mu\text{g}/\text{m}^3$ )
		1 <sup>st</sup> reading	2 <sup>nd</sup> reading	3 <sup>rd</sup> reading		
4-Aug-25	10:02	41	48	35	331	500
6-Aug-25	09:55	85	93	96	331	500
9-Aug-25	10:02	211	209	193	331	500
12-Aug-25	10:00	237	247	231	331	500
15-Aug-25	10:07	91	109	105	331	500
18-Aug-25	10:02	45	34	37	331	500
21-Aug-25	10:00	91	87	81	331	500
23-Aug-25	10:05	215	228	233	331	500
27-Aug-25	10:00	98	113	137	331	500
29-Aug-25	10:05	254	249	240	331	500

2.9.3 The monitoring data and graphical presentation of 1-hour TSP monitoring results are shown in **Appendix G** respectively.

2.9.4 No Action / Limit Level exceedance was recorded for all 1-hour TSP monitoring in the reporting month.
