LIGHT PUBLIC HOUSING AT YAU POK ROAD, YUEN LONG

MONTHLY EM&A REPORT

FOR DECEMBER 2024

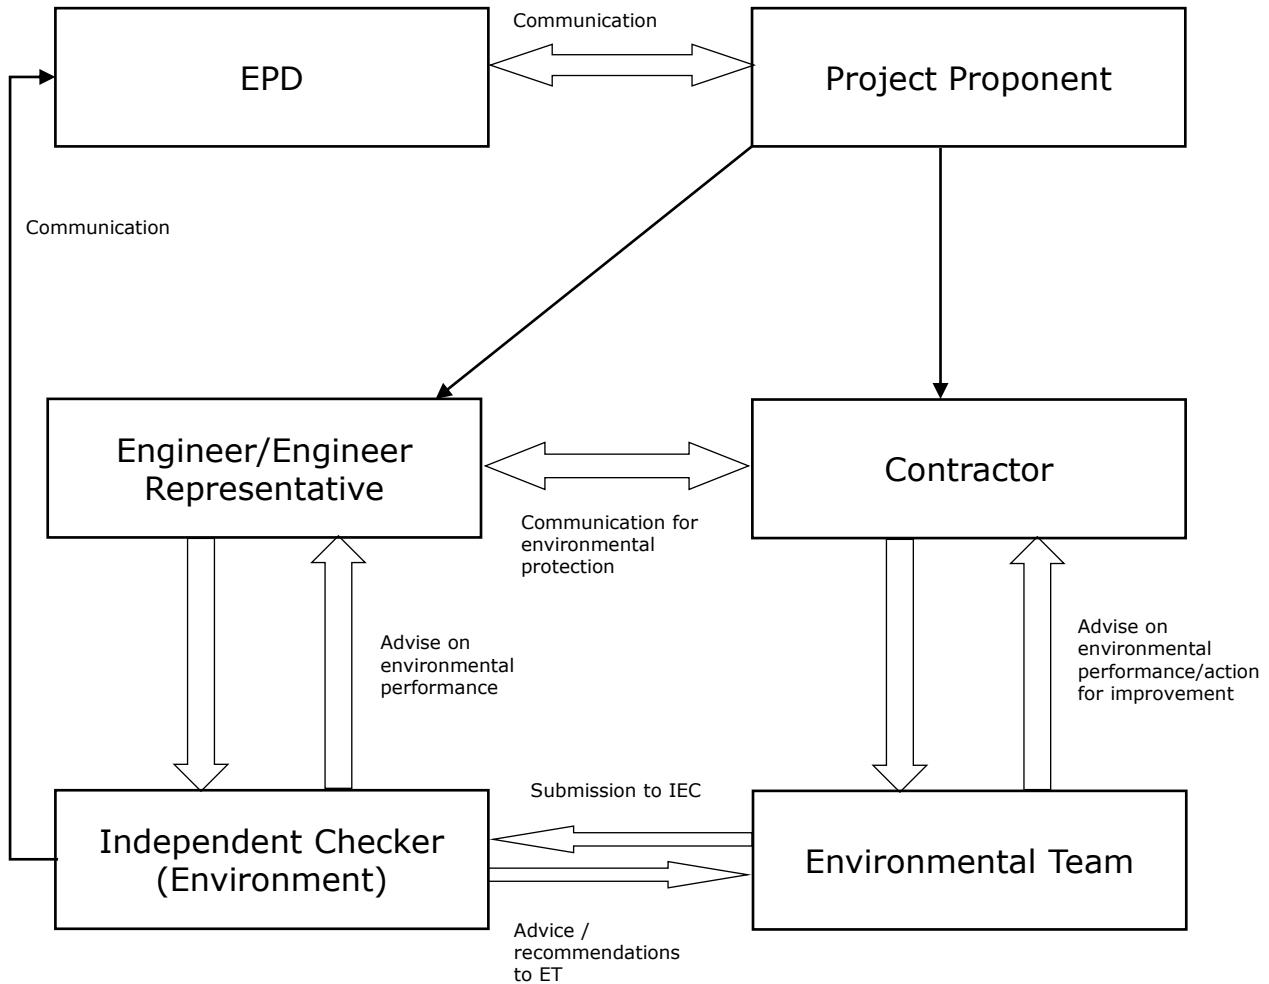
Figure 2 Typical Construction Phase Environmental Monitoring and Audit Procedure

- Implementation status proforma on mitigation action;
- Proactive environmental protection proforma for construction method alternative;
- Regulatory compliance proforma listing licenses/permit compliance;
- Site inspection proforma;
- Complaint report;
- EM&A report for endorsement;
- Effectiveness of EIA recommendations.

- Advise on environmental performance
- Return/sign off audit proformas
- Environmental concerns recommendations on construction methods

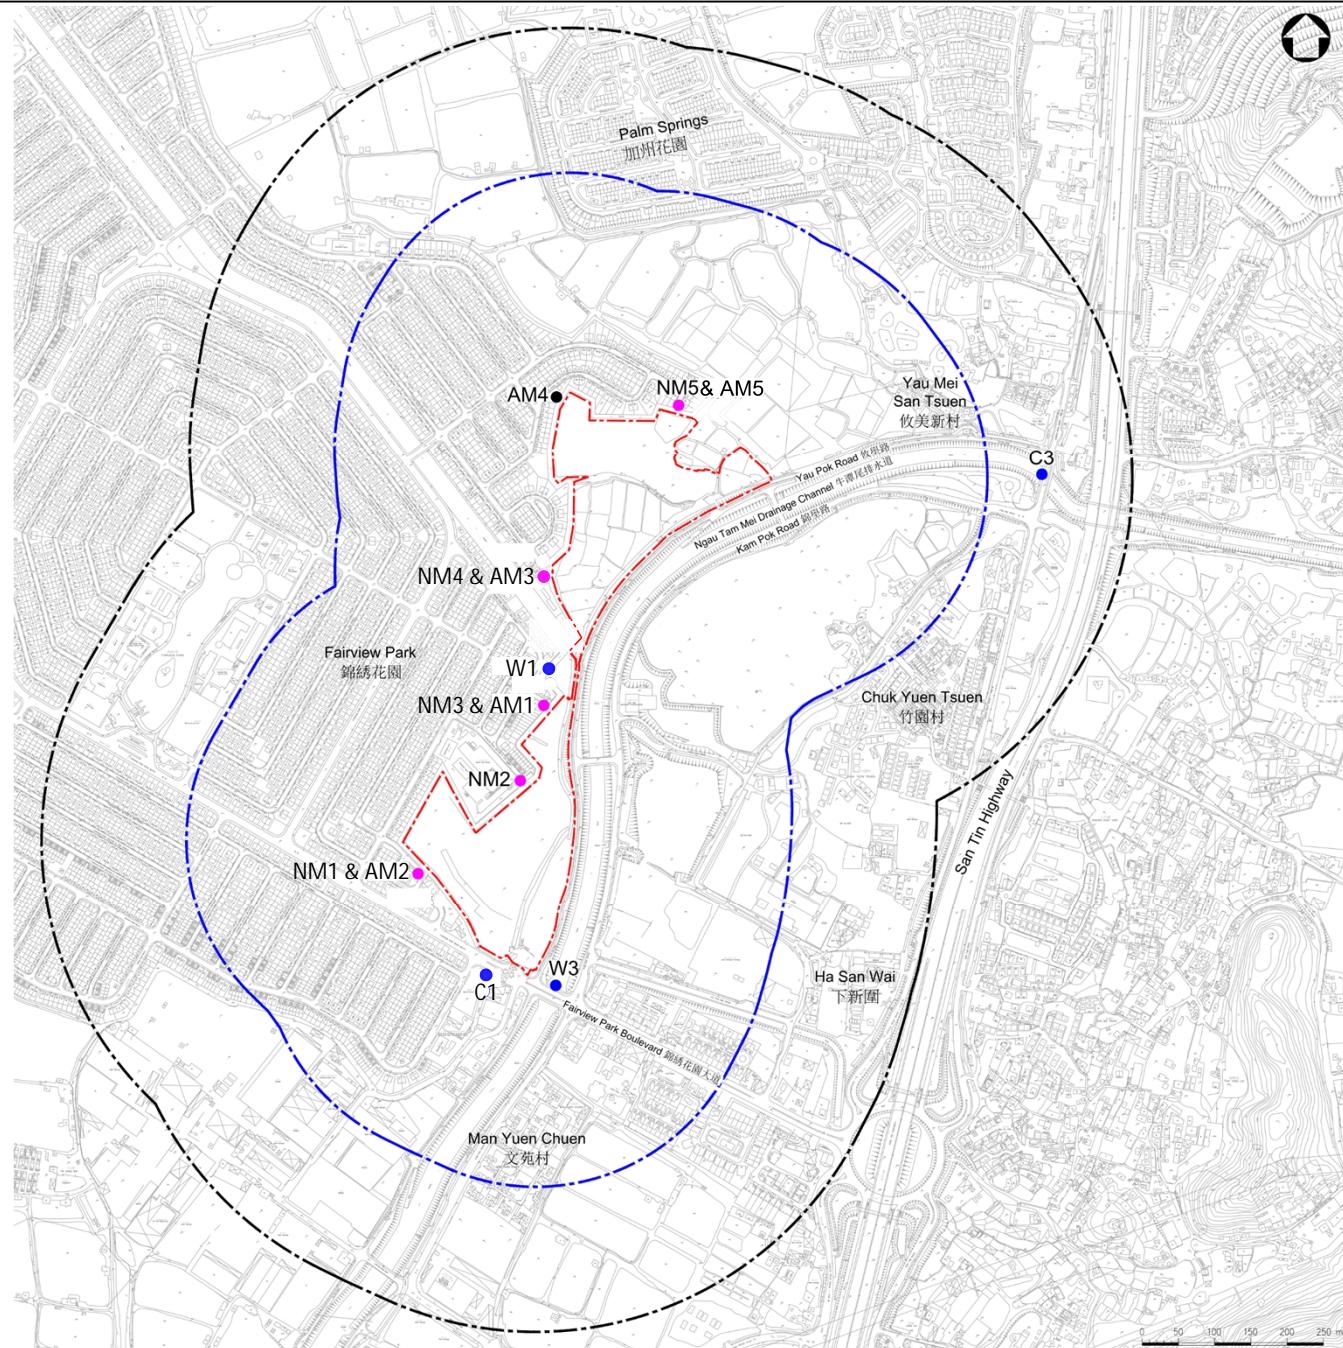
Figure 3 Locations of Air Quality, Noise and Water Quality Monitoring Stations

- PROJECT SITE 項目地點
- 500m ASSESSMENT AREA FOR AIR QUALITY AND WATER QUALITY 500米空氣質素及水質評估範圍
- 300m ASSESSMENT AREA FOR NOISE 300米噪音評估範圍
- AIR QUALITY MONITORING STATIONS 空氣質素監察站
- NOISE MONITORING STATIONS 噪音監察站
- WATER QUALITY MONITORING STATIONS 水質監察站

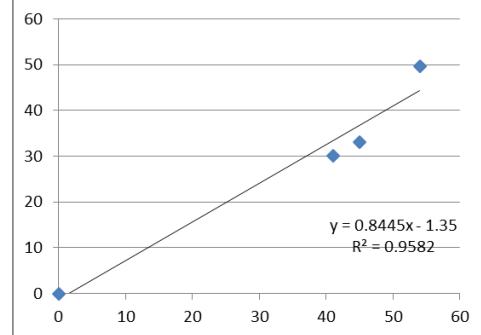
Slope (K-factor): 0.8445 (µg/m³)/CPM
Correlation Coefficient (R) 0.9789
Date of Issue 21 June 2024

- Strong Correlation ($R > 0.8$)
- Factor 0.8445 (µg/m³)/CPM should be applied for TSP monitoring

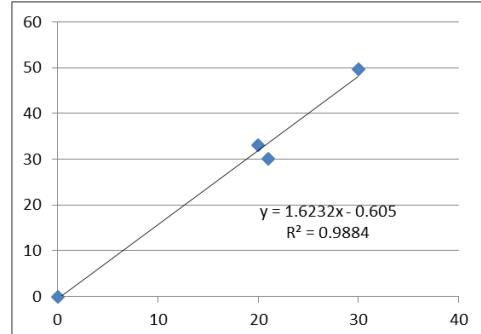
Slope (K-factor): 1.6232 (µg/m³)/CPM
Correlation Coefficient (R) 0.9942
Date of Issue 21 June 2024

1. Strong Correlation ($R > 0.8$)
2. Factor 0.9942 (µg/m³)/CPM should be applied for TSP monitoring

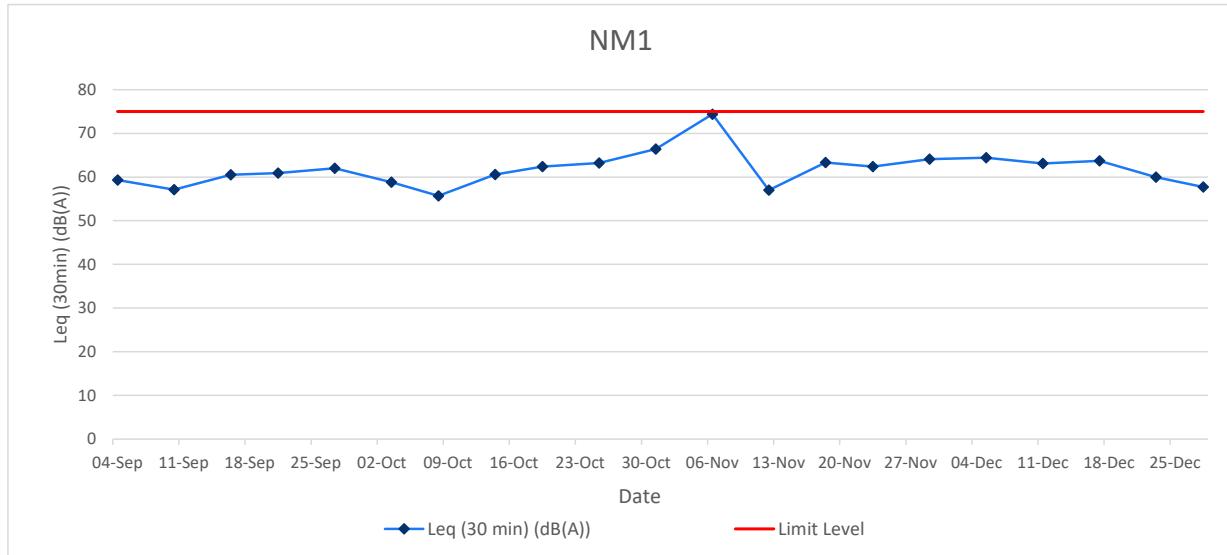
Note: +3dB for Free Field is added.

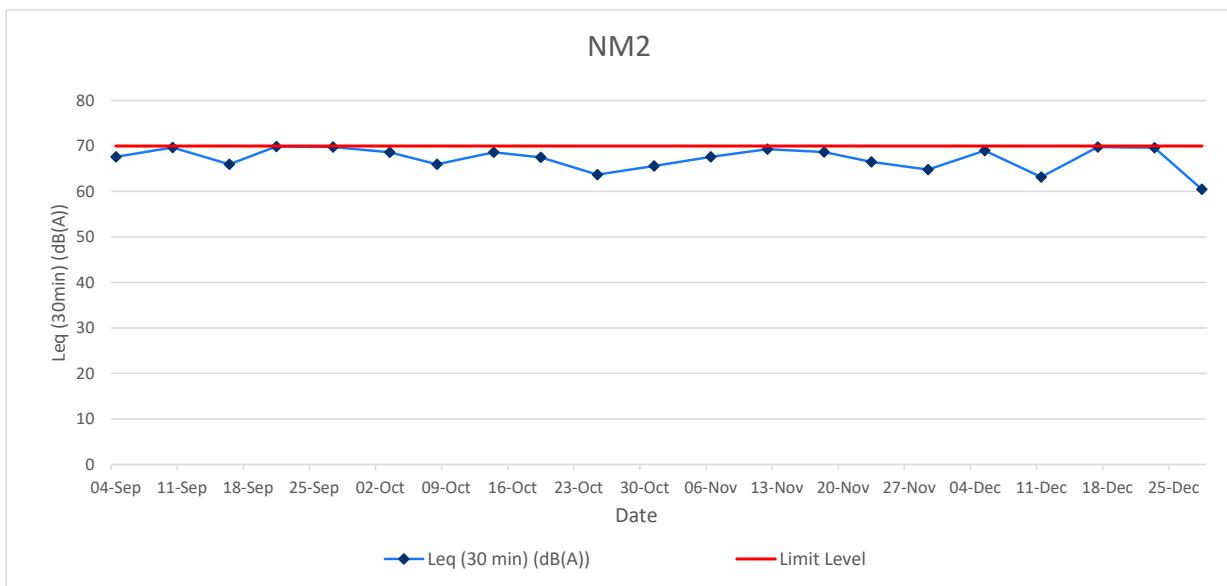
Note: +3dB for Free Field is added. Limit Level reduced to 70 dB(A) for schools.

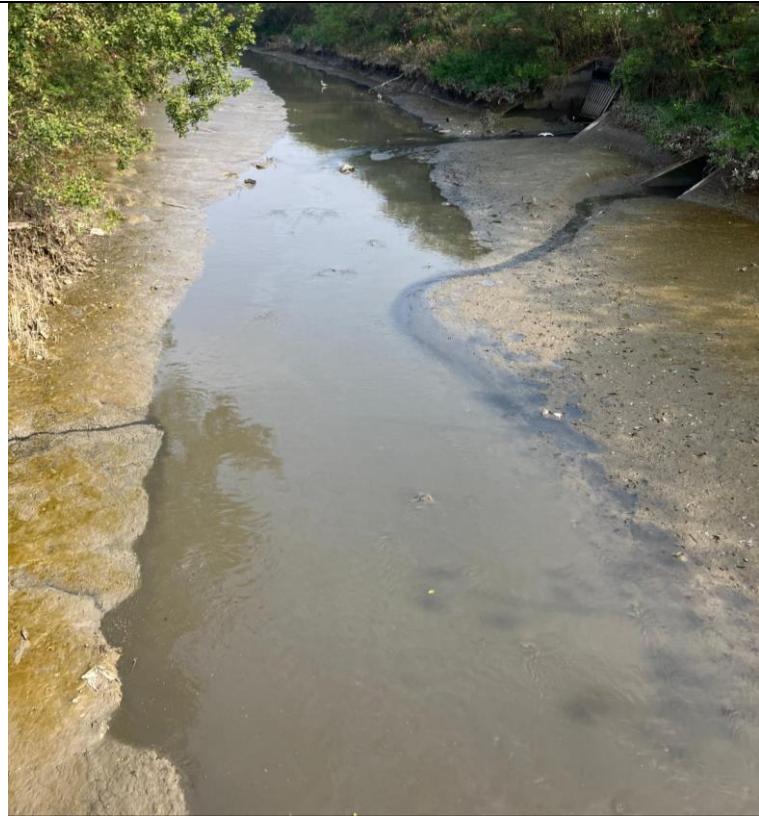
Photo 1: Very shallow water at W3 on 6 December 2024

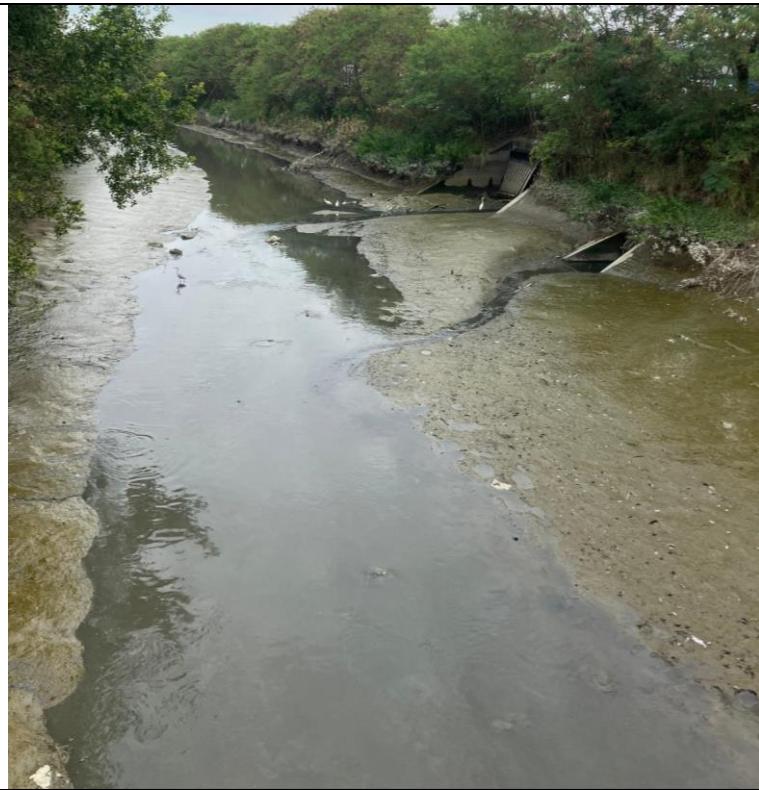
Photo 2: Very shallow water at W3 on 18 December 2024
