Sheung Shui to Lok Ma Chau Spur Line

Monthly EM&A Report for Kwu Tung Station

(January 2025)

Kwu Tung Station on East Rail Line

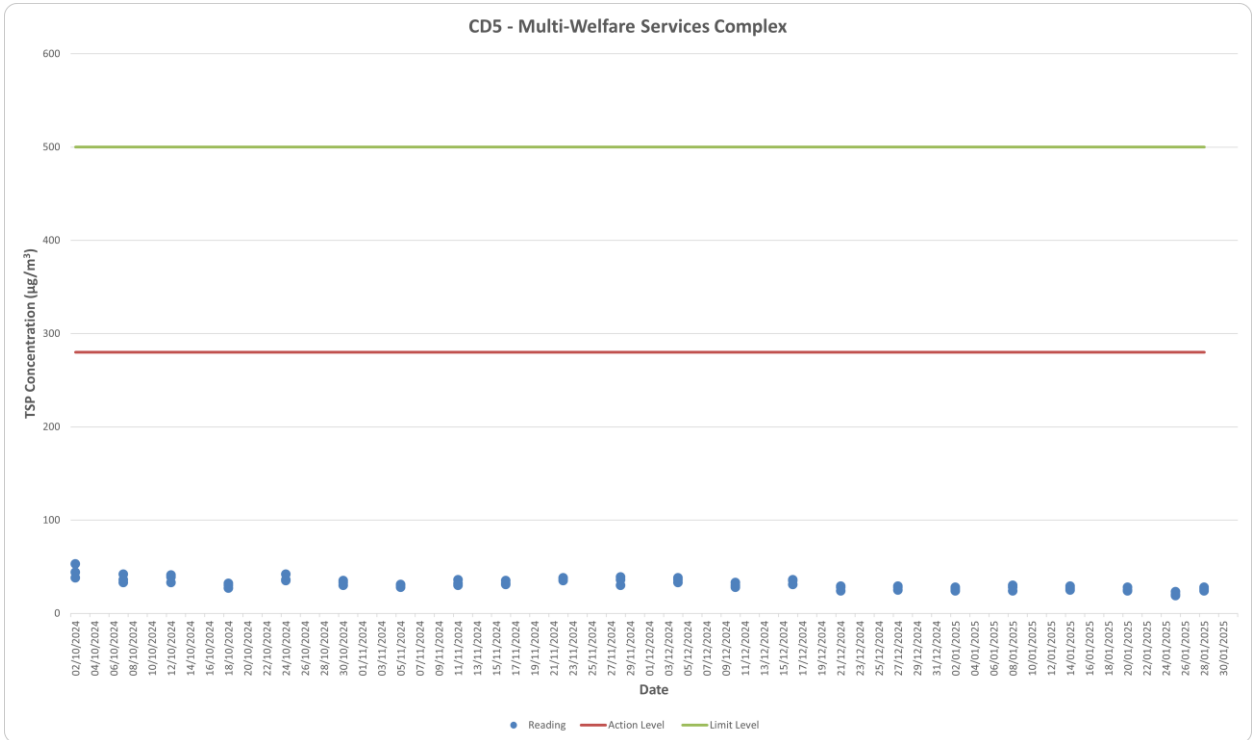
1-hour TSP Concentration Level

Location CD5 - Multi-Welfare Services Complex							
Date	Start Time	Weather	1 st Hour (µg/m ³)	2 nd Hour (µg/m ³)	3 rd Hour (µg/m ³)	Action Level (µg/m ³)	Limit Level (µg/m ³)
2025-01-02	8:56	Fine	24	28	26	280	500
2025-01-08	8:45	Fine	30	28	24		
2025-01-14	8:49	Fine	27	29	25		
2025-01-20	8:55	Fine	25	24	28		
2025-01-25	8:57	Fine	19	20	23		
2025-01-28	8:57	Fine	24	28	26		
Average			25				
Range			19 - 30

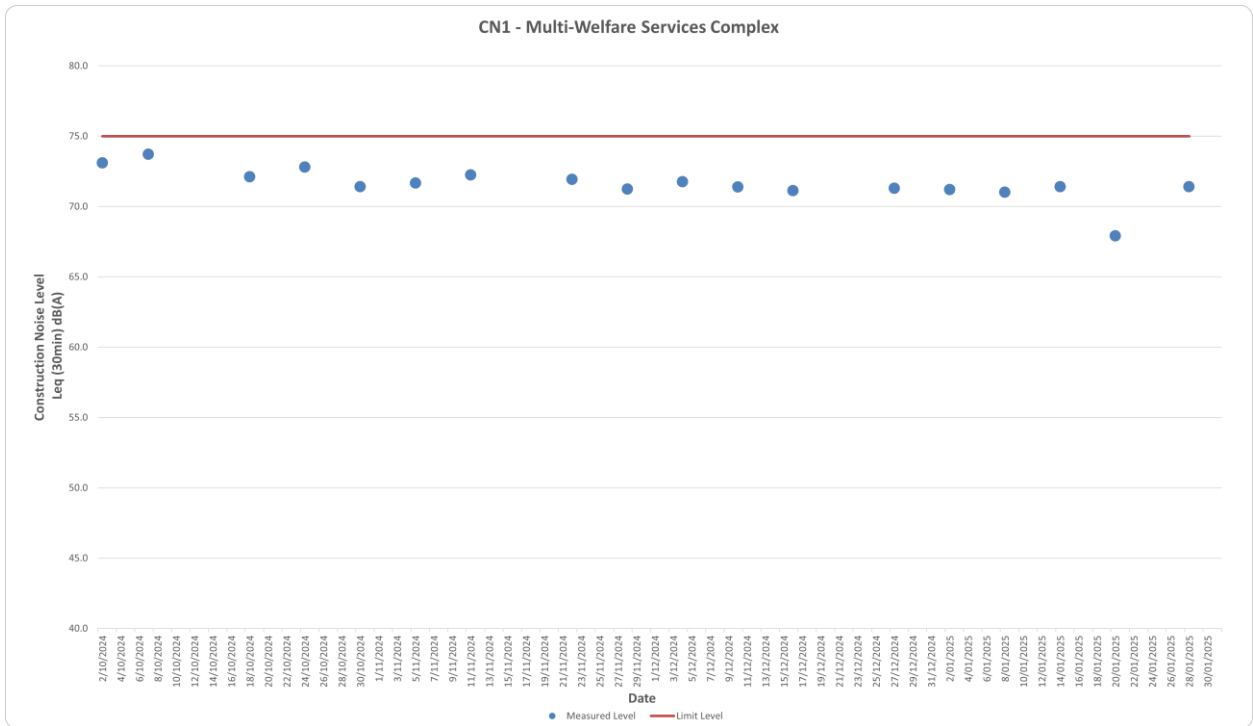
Noise Monitoring Results

10:20	71.2	73.4	70.6		
		10:25	70.0	72.7	68.5		
		10:30	73.2	75.3	70.8		
		10:35	68.4	74.0	69.2		
		10:40	72.2	73.3	70.4

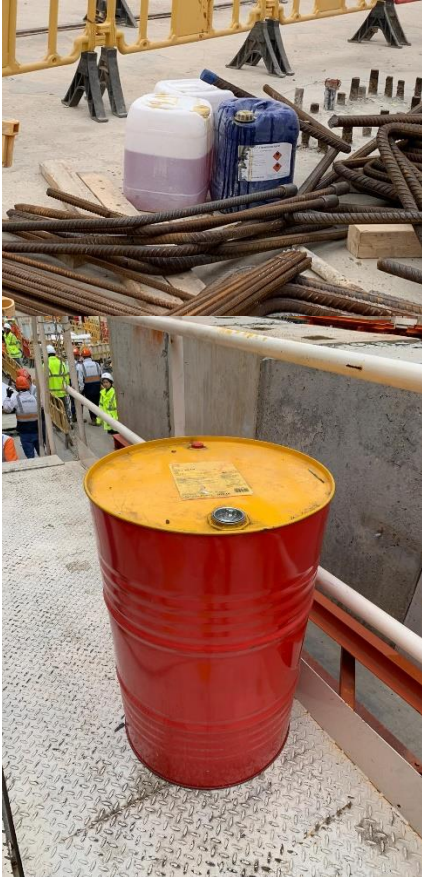
Date	Environmental Observation(s) / Recommendation(s)	Rectification Photos	Close-out Date / Status
Follow-up action of last month site observation(s)			
2024 - 12 - 18	<p>Observation:</p>

<p>1. Chemical containers and Oil drum should be placed properly on the drip tray. (Above-ground, Station tunnel box)</p>	<p>Action Taken:</p>

Date	Environmental Observation(s) / Recommendation(s)	Follow-up Status	Close-out Date / Status
Follow-up action of last month site observation(s)			
2024 - 12 - 18	Observation: 1. Chemical containers and Oil drum should be placed properly on the drip tray. (Above-ground, Station tunnel box)	Action Taken: 1. Chemical containers and Oil drum has been placed properly on the drip tray. (Above-ground, Station tunnel box)	Rectified on 15 January 2025.
2024 - 12 - 24	Observation: 1. Oil drums should be placed properly on the drip tray. (Above-ground, Station tunnel box)	Action Taken: 1. Oil drum has been placed properly on the drip tray. (Aboveground, Station tunnel box)	Rectified on 15 January 2025.
Site observation(s) in reporting month			
2025 - 1 - 02	No Major environmental issue was observed during the site inspection.	NA	NA
2025 - 1 - 08	No Major environmental issue was observed during the site inspection.	NA	NA

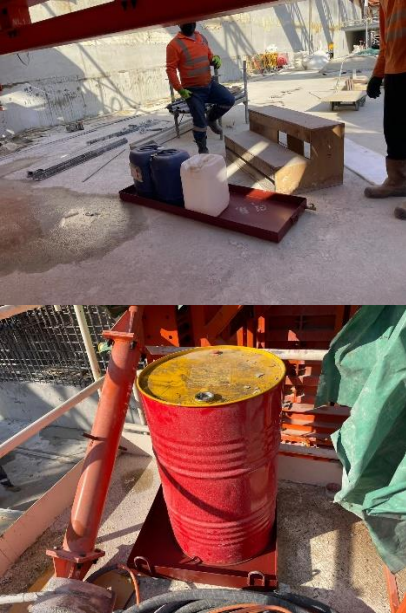
<p>1. Chemical containers and Oil drum has been placed properly on the drip tray. (Above-ground, Station tunnel box)</p>	Rectified on 15 January 2025.
2024 - 12 - 24	<p>Observation:</p>

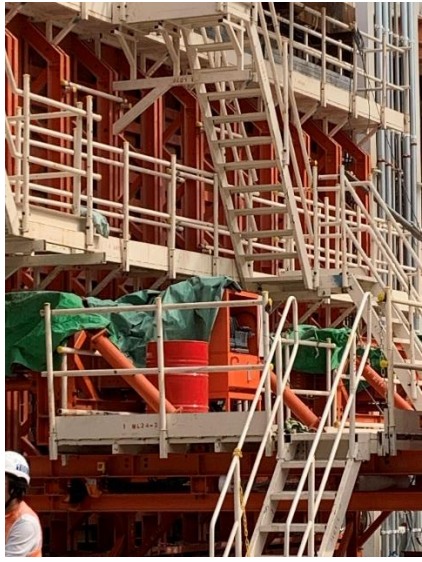
<p>1. Oil drums should be placed properly on the drip tray. (Above-ground, Station tunnel box)</p>	<p>Action Taken:</p>

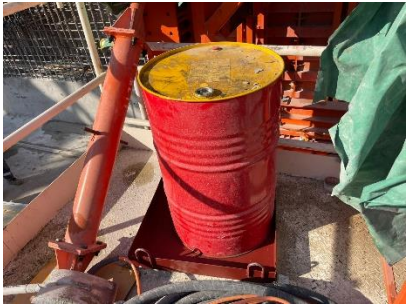
<p>1. Oil drum has been placed properly on the drip tray. (Aboveground, Station tunnel box)</p>	Rectified on 15 January 2025.
Site observation(s) in reporting month			
2025 - 1 - 02	No Major environmental issue was observed during the site inspection.	NA	NA
