**SHA TIN NEW TOWN STAGE II
CONTRACT NO. ST 86/2000
CONSTRUCTION OF ROAD T7 IN MA ON SHAN
ENVIRONMENTAL MONITORING AND AUDIT
MONTHLY EM&A REPORT - MARCH 2003**

Report No.: 23156-27

MONTHLY EM&A REPORT - MARCH 2003

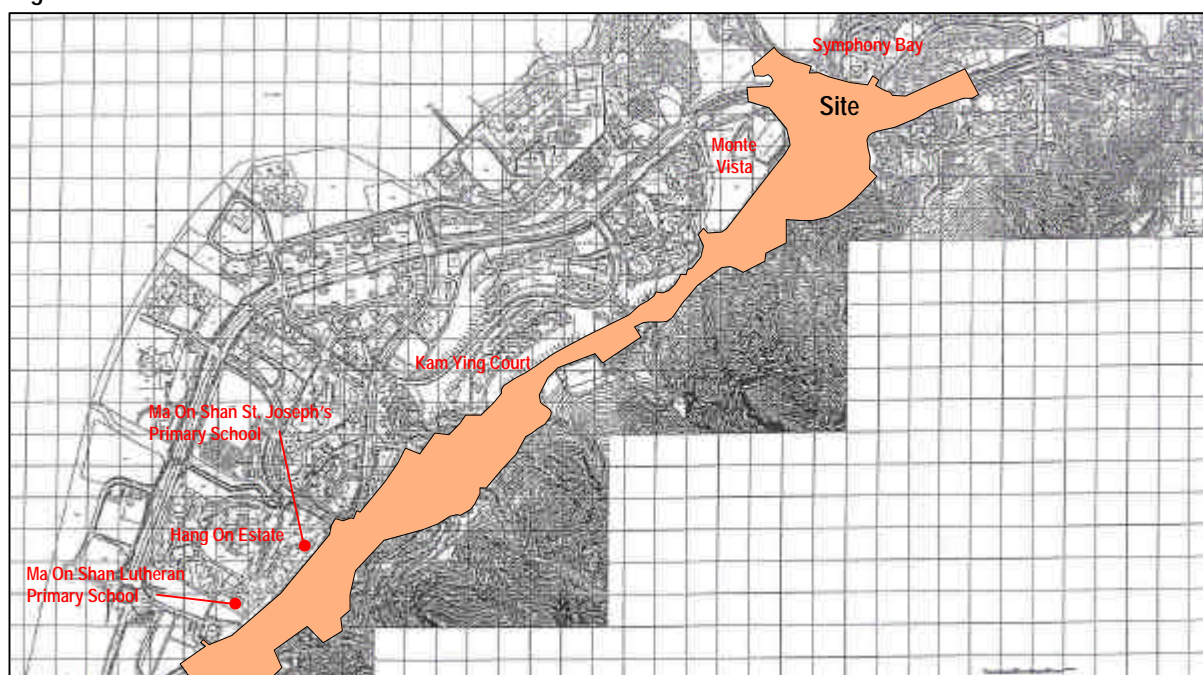
Figure 2-1 - Locations of construction site and environmental sensitive receivers.

Detailed locations of the environmental sensitive receivers are shown in Figure 2-1.

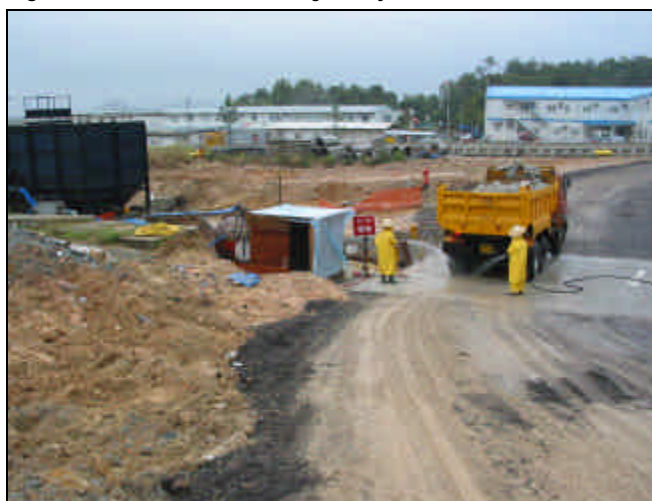
Figure 6-1 – The wheel washing facility at new access.

- The Contractor had received a Construction Noise Permit (CNP) for the construction works near Heng On Estate. Details of the permit conditions are given in CNP No. GW-TN0055-2003 issued on 3 March 2003. Copy of the CNP is given in Appendix 7.
- The access near Cheung Muk Tau Village was relocated. The wheel washing facility was provided at the new access. Photo showing the wheel washing facility at new access is given in Figure 6-1.

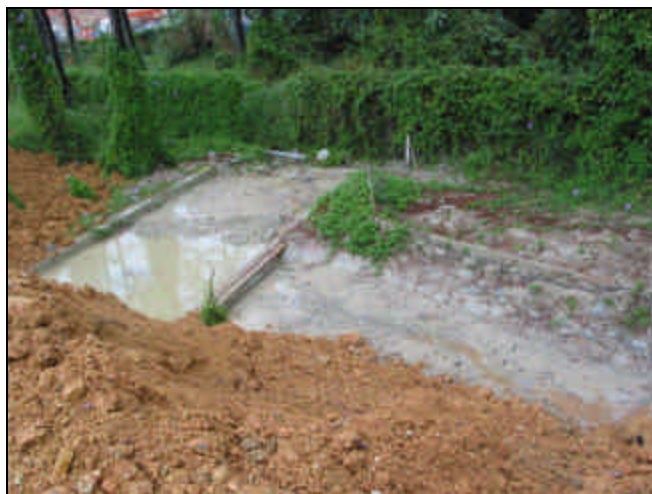
Figure 6-2 – The excavated material and silty water at the channel near Portal D area.

- Excavated material and silty water were observed at the channel near Portal D area. As instructed by ET, the Contractor agreed to cover the excavated material as soon as possible and clean up the silt from the channel. Photo showing the excavated material and silty water at the channel near Portal D area is given in Figure 6-2.

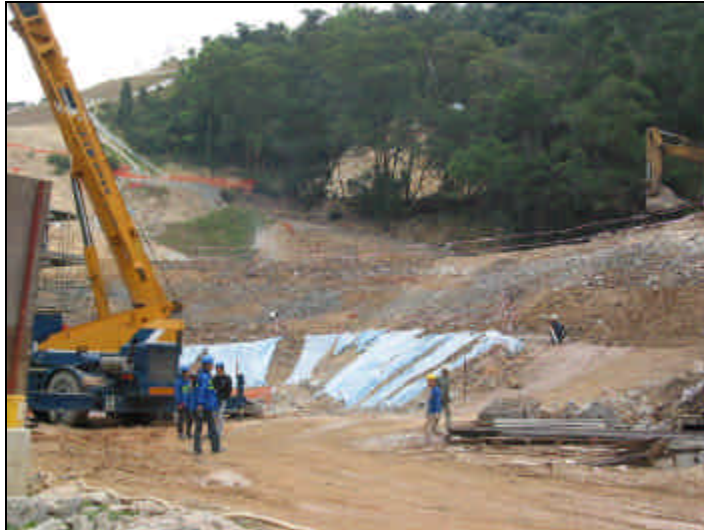
Figure 6-3 – The water sprayers and covered slope between Lee On Estate and Monte Vista.

- Exposed slope was observed between Lee on Estate and Monte Vista. As instructed by ET, the Contractor had covered the slope with tarpaulin and installed water sprayers for preventing dust generation. Photo showing the water sprayers and covered slope between Lee On Estate and Monte Vista is given in Figure 6-3.
