**SHA TIN NEW TOWN STAGE II  
CONTRACT NO. ST 86/2000  
CONSTRUCTION OF ROAD T7 IN MA ON SHAN  
ENVIRONMENTAL MONITORING AND AUDIT  
MONTHLY EM&A REPORT - MARCH 2004**

Report No.: 23156-40

**MONTHLY EM&A REPORT - MARCH 2004**

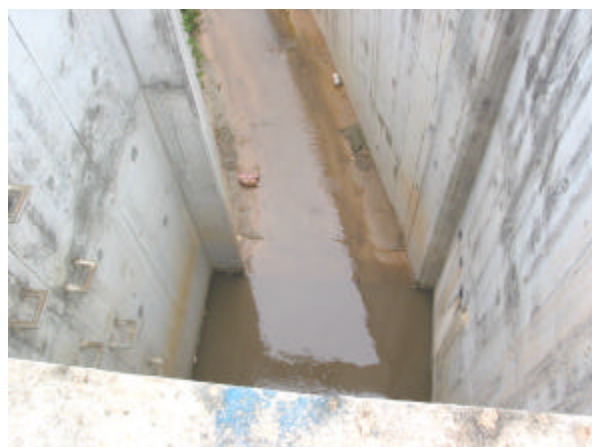
Figure 6-1 - De-silting pit at Discharge Point 3

- Discharge Point 6 was silty. Contractor had removed silt after inspection.
- Sandbags should be placed along open channel at Discharge Point 6 for flood protection.
- De-silting pit at Discharge Point 8 was silty. Maintenance of the de-silting tank was undergoing.
- Contractor was recommended to identify appropriate water course for wastewater discharge from Gate 21.
- De-silting tanks at Discharge Point 4 and wheel washing bay at Discharge Point 3 were full of silt.
- De-silting pit at Road 22 was full of silt.
