Report No.: 0041/17/ED/0628

Quarterly EM&A Report February 2021 - April 2021

Project : Contract No. CM 14/2016
Environmental Team for Operational
Environmental Monitoring and Audit for Siu
Ho Wan Sewage Treatment Works

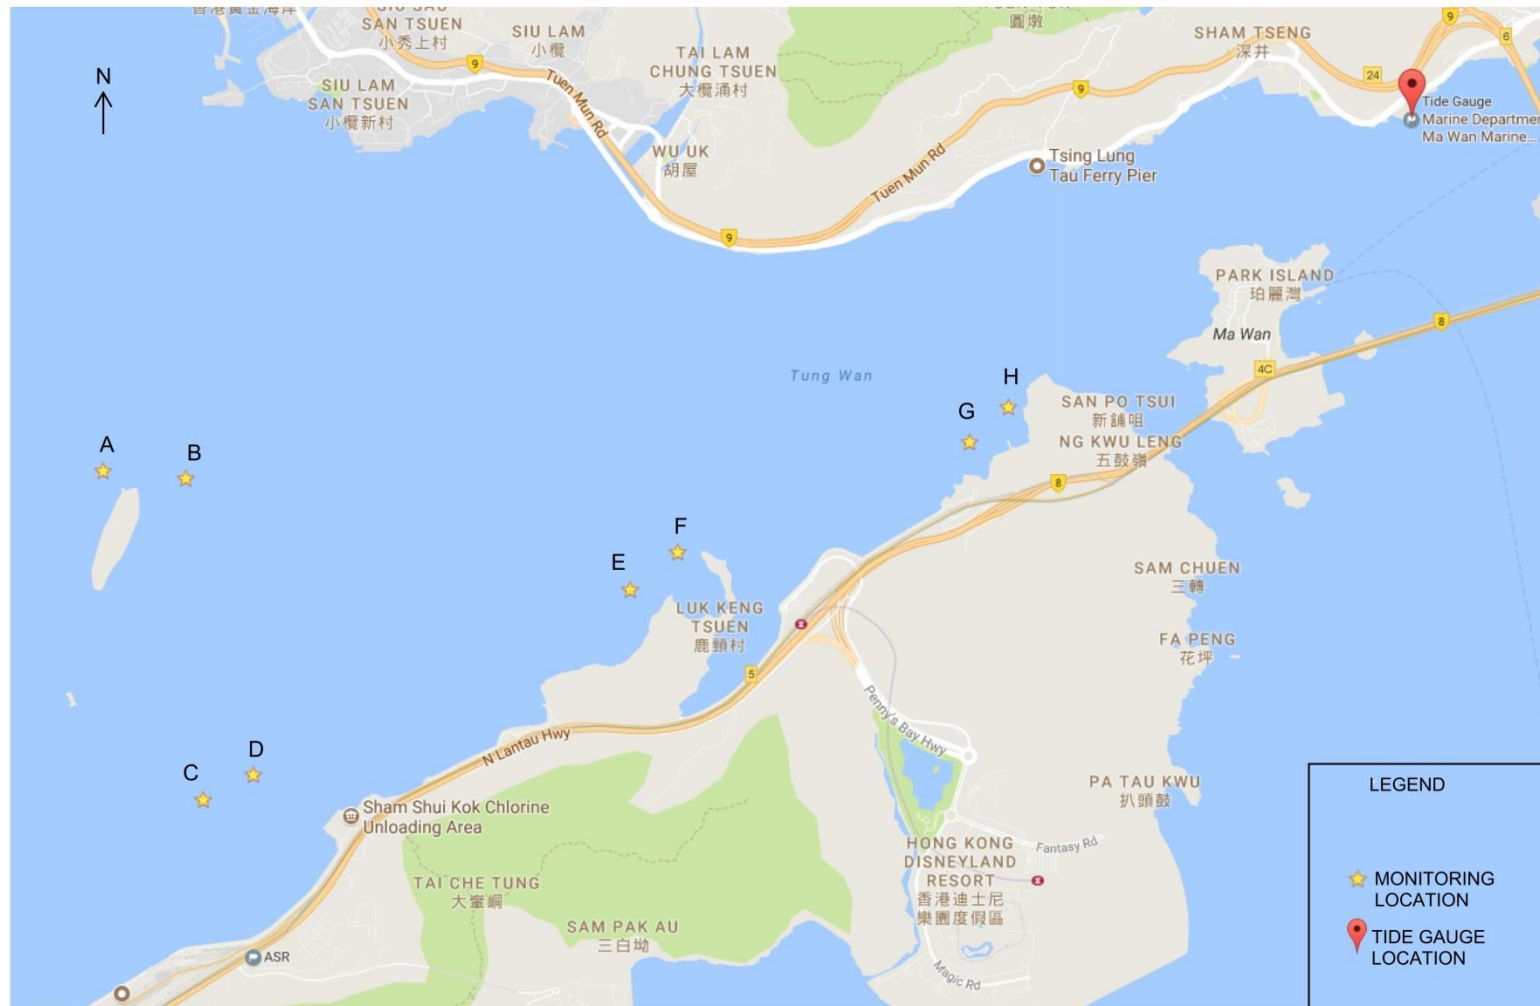
Location of the Tide Gauge
