Report No.: 0041/17/ED/0688

## Monthly EM&A Report October 2022

Project : Contract No. CM 14/2016  
Environmental Team for Operational  
Environmental Monitoring and Audit for Siu  
Ho Wan Sewage Treatment Works

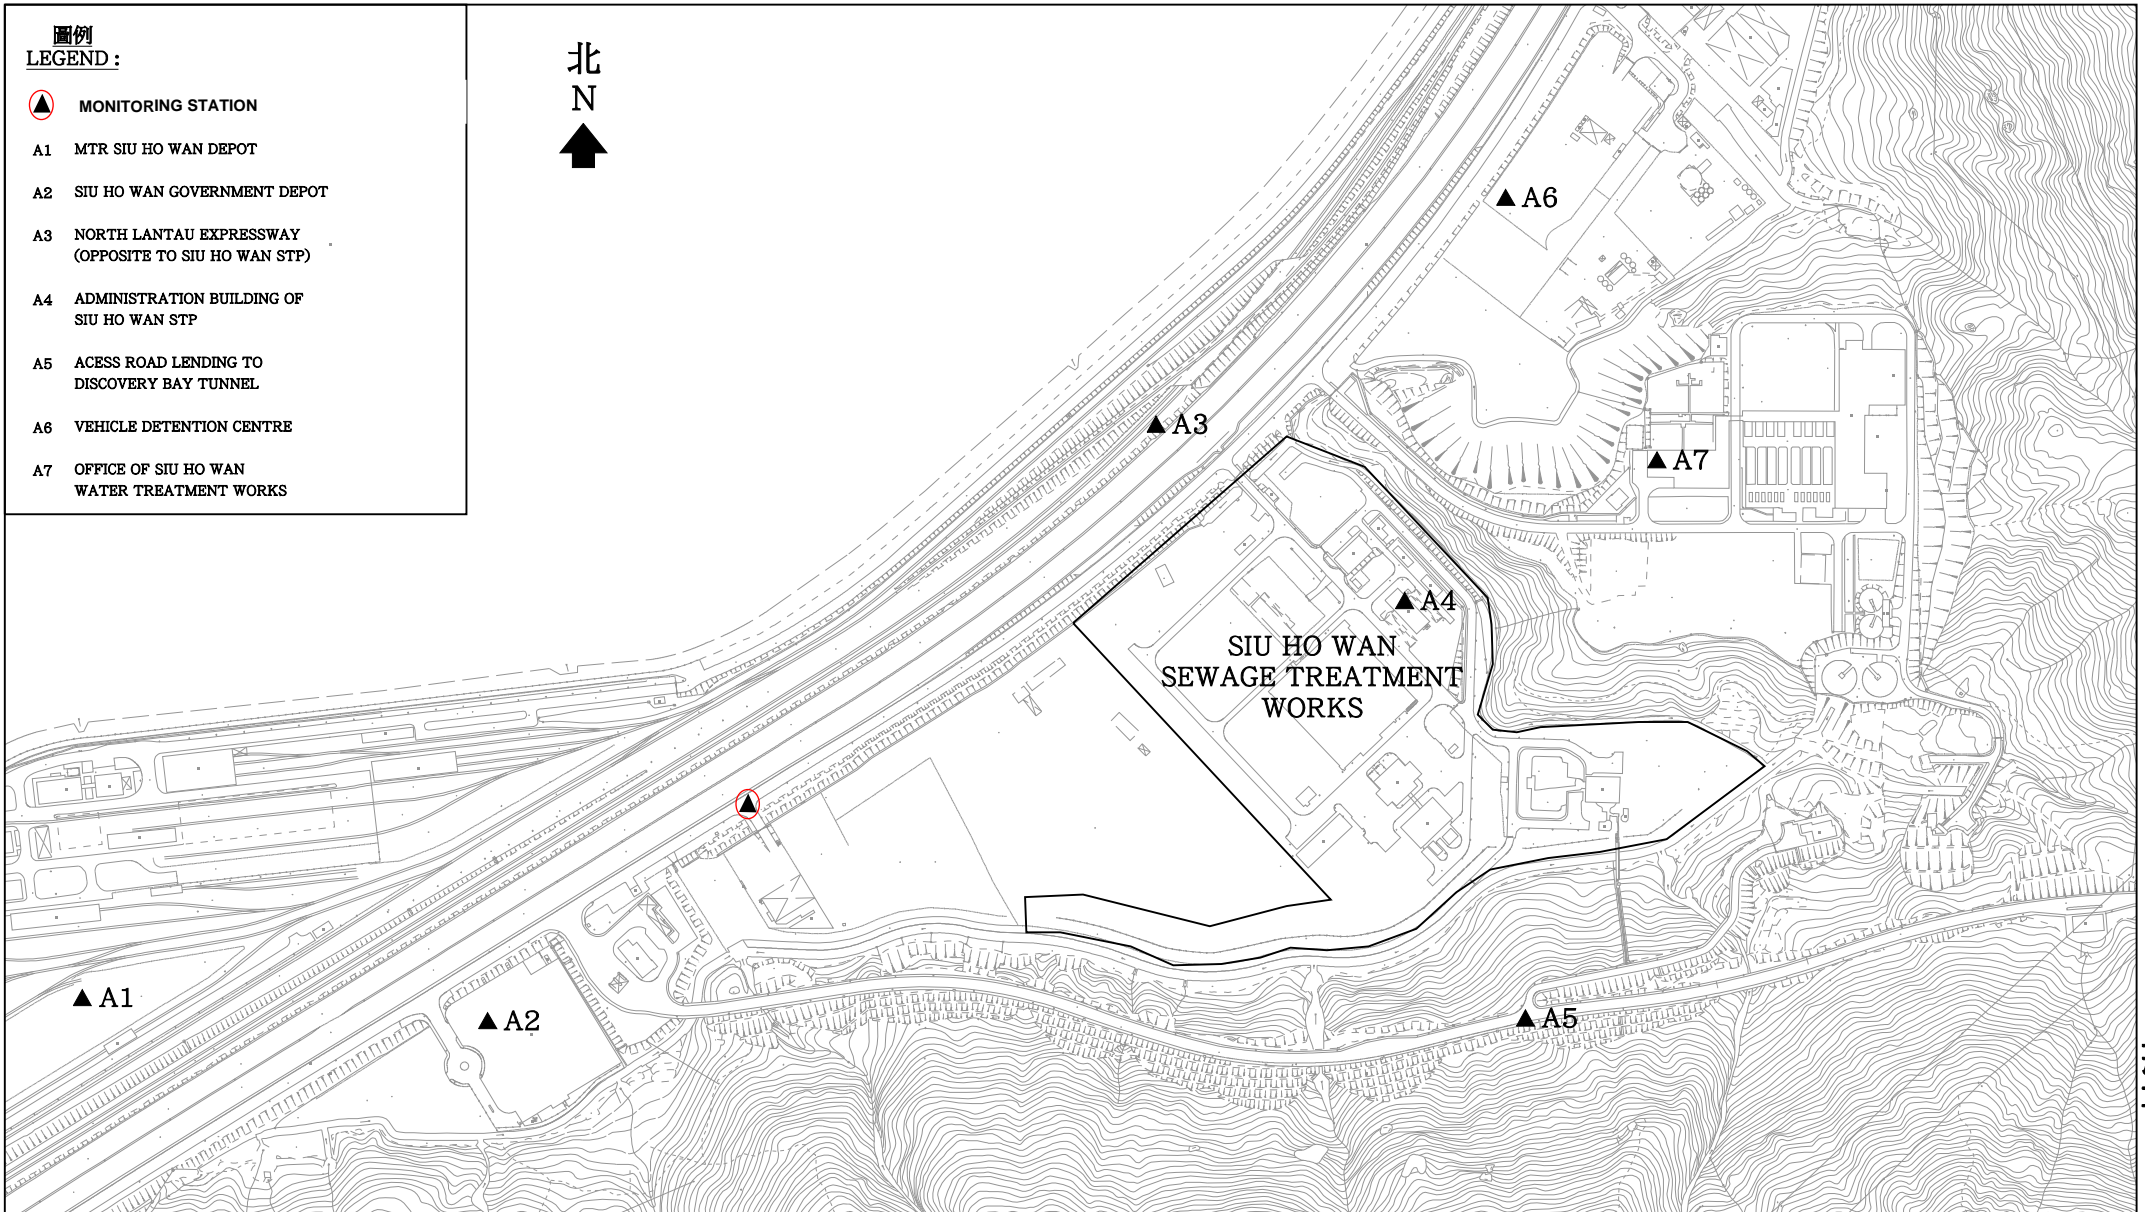
**MONITORING STATION**
- A1** MTR SIU HO WAN DEPOT
- A2** SIU HO WAN GOVERNMENT DEPOT
- A3** NORTH LANTAU EXPRESSWAY (OPPOSITE TO SIU HO WAN STP)
- A4** ADMINISTRATION BUILDING OF SIU HO WAN STP
- A5** ACCESS ROAD LENDING TO DISCOVERY BAY TUNNEL
- A6** VEHICLE DETENTION CENTRE
- A7** OFFICE OF SIU HO WAN WATER TREATMENT WORKS

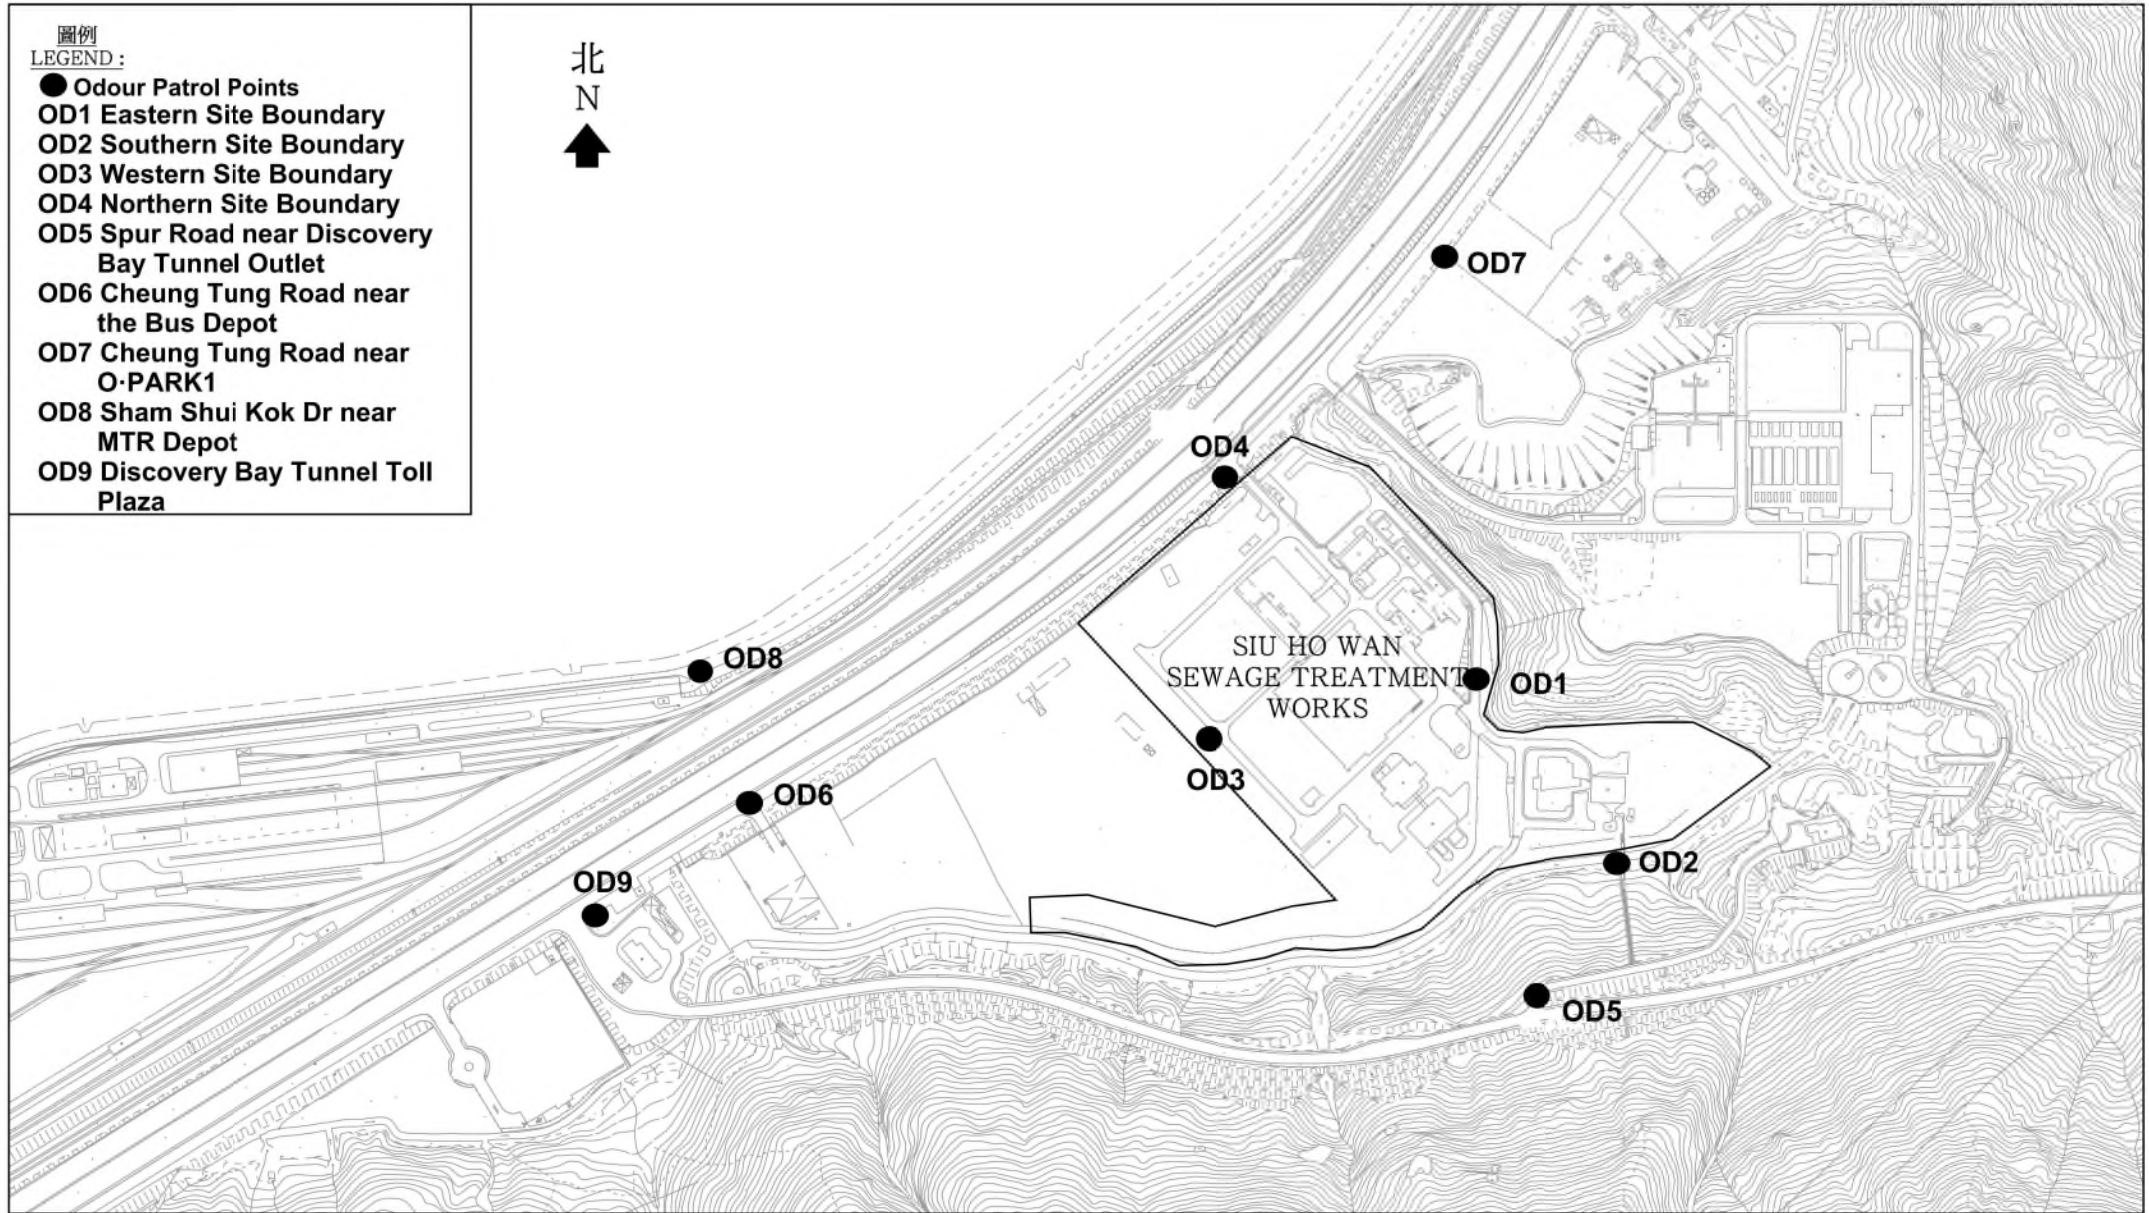
- Odour Patrol Points
- OD1 Eastern Site Boundary
- OD2 Southern Site Boundary
- OD3 Western Site Boundary
- OD4 Northern Site Boundary
- OD5 Spur Road near Discovery Bay Tunnel Outlet
- OD6 Cheung Tung Road near the Bus Depot
- OD7 Cheung Tung Road near O-PARK1
- OD8 Sham Shui Kok Dr near MTR Depot
- OD9 Discovery Bay Tunnel Toll Plaza
