**Castle Peak Road  
Improvement Between  
Sham Tseng and Ka  
Loon Tsuen,  
Tsuen Wan  
West Contract No.  
HY/99/18**

Monthly Environmental  
Monitoring and Audit  
Report  
May 2005

Monthly Environmental Monitoring and Audit Report – May 2005

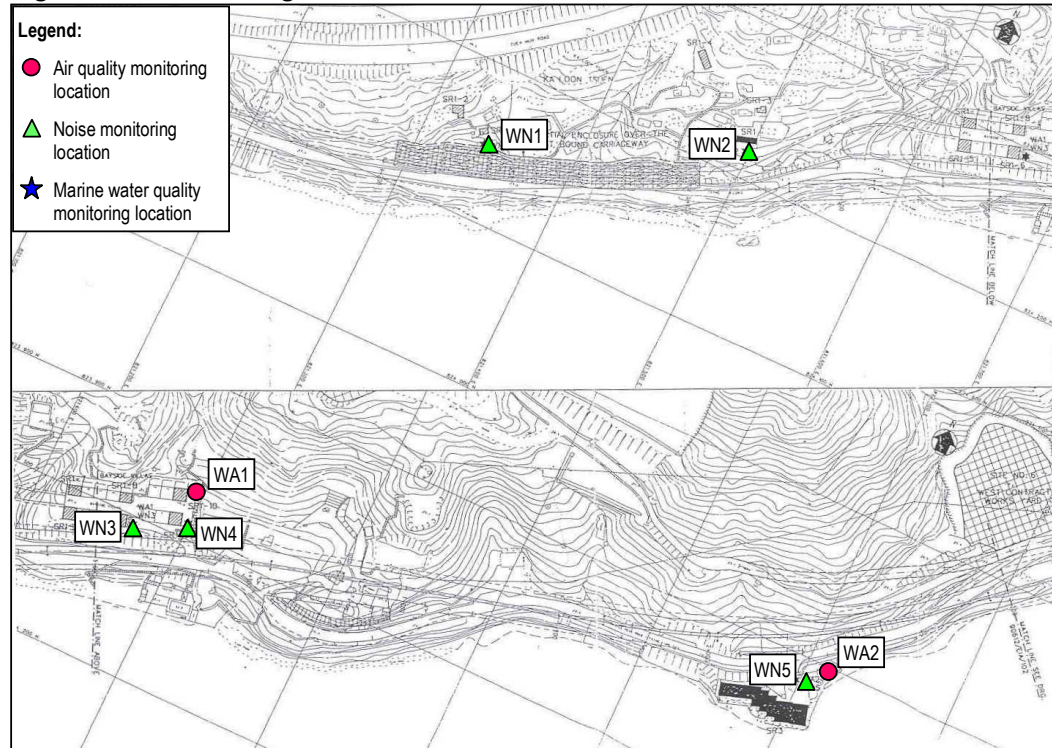
**Figure 3-1a Monitoring locations**

Water Monitoring Station No.		Location	
		Eastings	Northings
Tsing Lung Tau	WW1 (Impact Station)	822306	824405
	WW2 (Impact Station)	822377	824462
	WW3 (Impact Station)	822529	824500
	WW4 (Impact Station)	822775	824560
	WR-E-1234 (Control Station for Mid-Ebb Tide)	822204	824312
	WR-F-1234 (Control Station for Mid-Flood Tide)	822850	824519
Angler's Beach: Sham Tseung West	WW5 (Impact Station)	823700	824905
	WW6/7 (Impact Station)	823797	824964
	WW8 (Impact Station)	823900	825023
	WR-E-5678 (Control Station for Mid-Ebb Tide)	823590	824830
	WR-F-5678 (Control Station for Mid-Flood Tide)	823994	825034
Ma Wan Fish Culture Zone	FCZ1 (Impact Station)	823500	823870

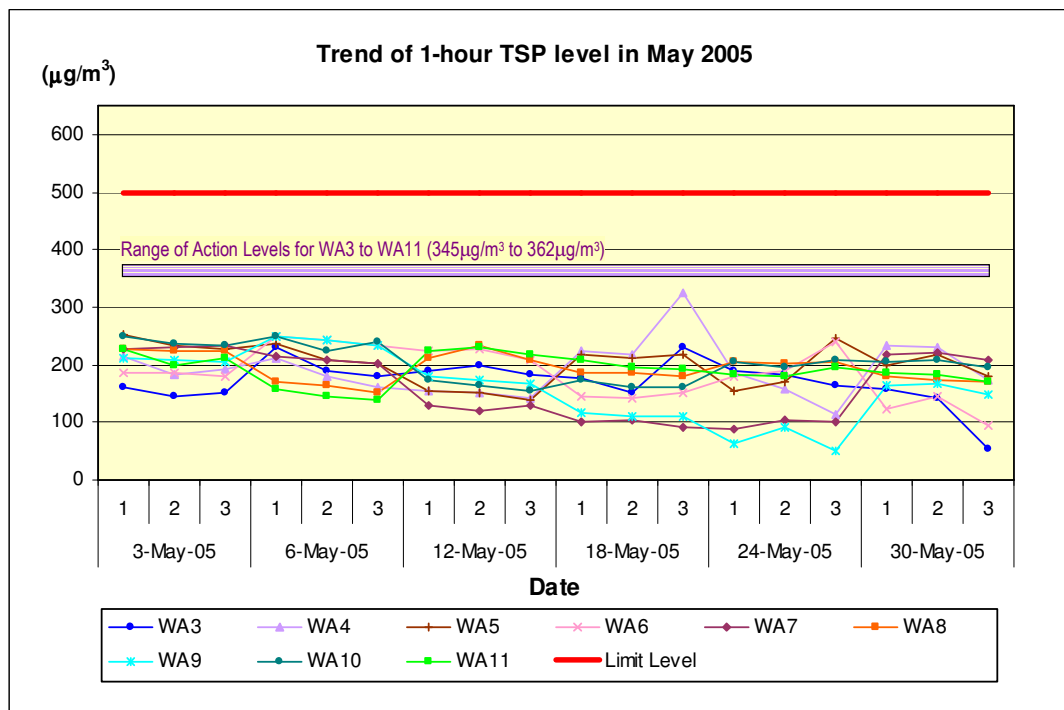
The detailed monitoring results of 1-hour TSP are given in Appendix F and the 1-hour TSP level at each monitoring location are plotted and presented in Figure 4-1.

Figure 4-1 Graphical presentation of 1-hour TSP levels for May 2005

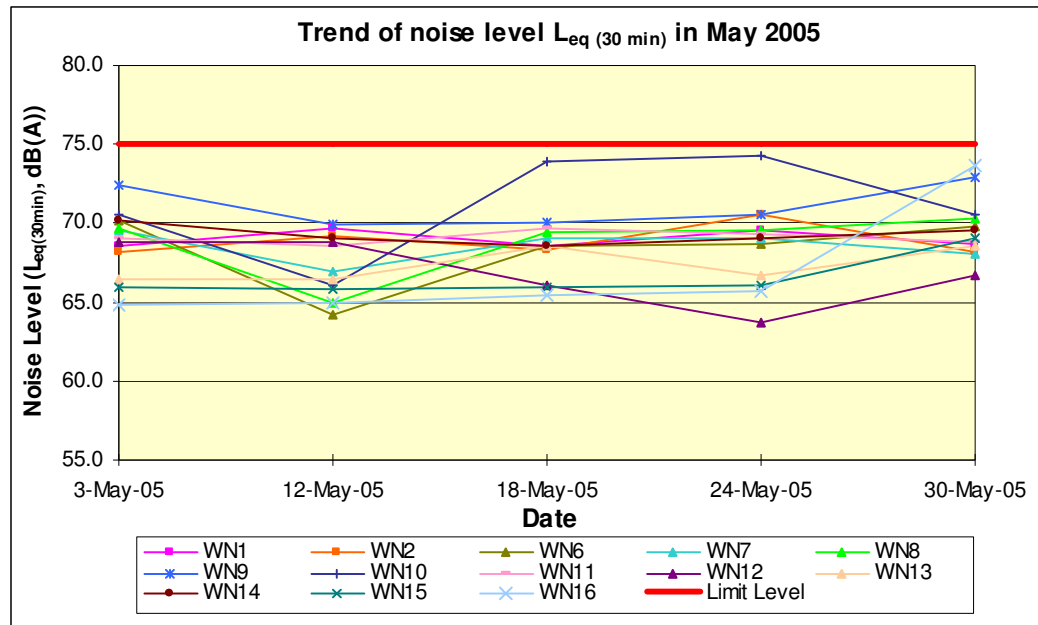
. The highest noise level was 74dB(A) recorded at No. 60-64, Tsing Lung Tau Village (WN10) on 24 May 2005 while the lowest noise level was 64dB(A) recorded at Phase 4, Sea Crest Villa (WN12) on 24 May 2005. The noise levels at each monitoring location are plotted and presented in Figure 5-1.

Figure 5-1 Graphical presentation of daytime noise levels for May 2005
