**Citybus Permanent
Headquarters and
Bus Maintenance Depot
in Chai Wan**

Monthly Environmental
Monitoring and Audit
Report
August 2002

Monthly Environmental Monitoring and Audit Report – August 2002

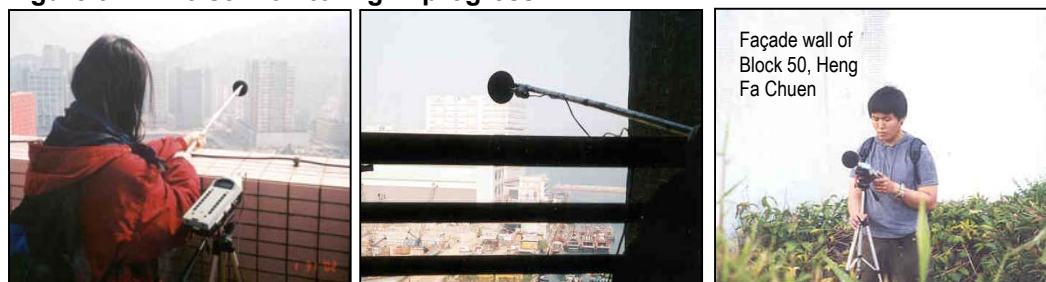
Figure 3-1 Noise monitoring in progress

A total of 4 monitoring locations were specified. They are given in Table 3-2. The measurements were taken at 1m from the building facade and maintained at a height 1.2m above floor. Three photos showing the noise monitoring work in action are given in Figure 3-1.

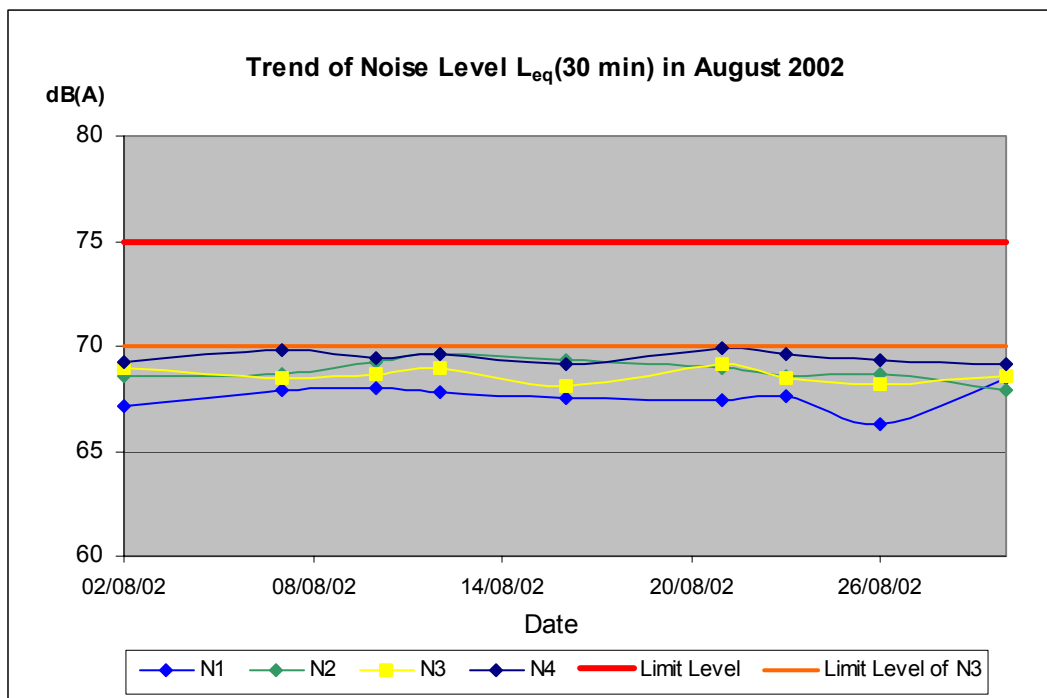
Figure 4-1 Daytime noise monitoring results for August 2002

Date of Monitoring	Monitoring Parameters	Monitoring Results, dB(A) (30 min)			
		N1	N2	N3	N4
21/08/02 (Wed)	L _{eq}	67.4	69.0	69.1	69.9
	L ₁₀	69.6	71.6	73.1	73.6
	L ₉₀	62.1	66.6	62.1	63.1
23/08/02 (Fri)	L _{eq}	67.6	68.6	68.5	69.6
	L ₁₀	70.6	71.1	72.6	73.6
	L ₉₀	62.6	66.1	62.6	62.6
26/08/02 (Mon)	L _{eq}	66.3	68.7	68.2	69.3
	L ₁₀	69.1	71.6	72.1	72.6
	L ₉₀	59.1	66.1	63.1	61.6
30/08/02 (Fri)	L _{eq}	68.5	67.9	68.6	69.1
	L ₁₀	71.1	70.6	73.1	73.1
	L ₉₀	63.6	67.1	63.1	63.6

Daytime (0700 – 1900 hours) noise monitoring was conducted at 4 locations. The highest noise level was 69.9 dB(A) recorded at Tsui Wan Estate on 21 August 2002 and the lowest was 66.3 dB(A) recorded at Heng Fa Chuen on 26 August 2002. There were no exceedances on the A/L Levels during the monitoring period.

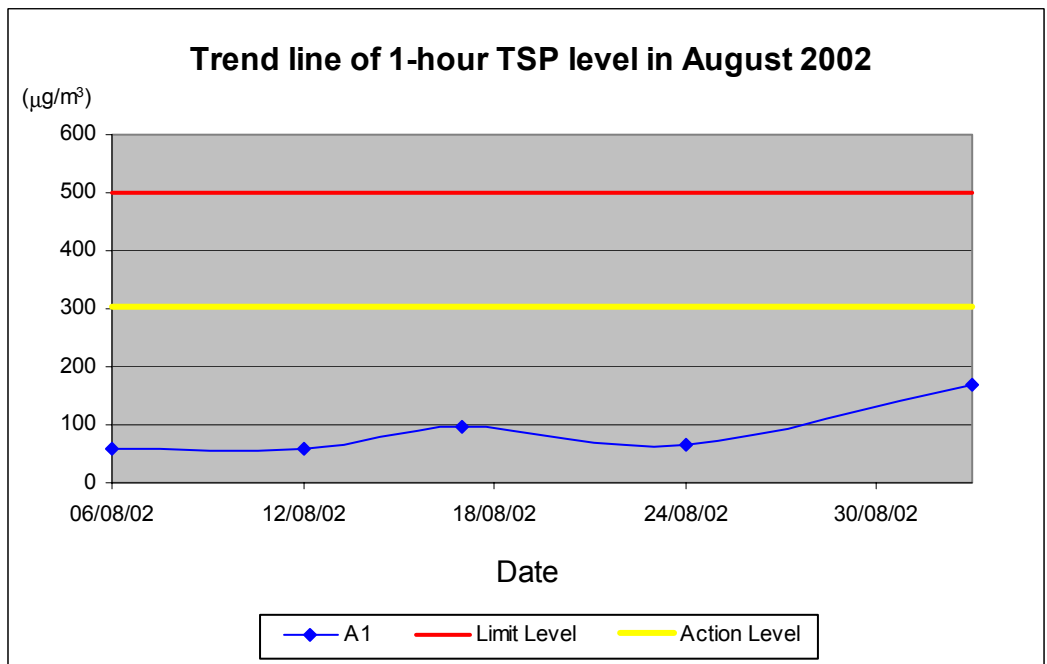
Figure 5-2 1-hour TSP monitoring results for August 2002

The 1-hour highest average TSP was 168.2 $\mu\text{g}/\text{m}^3$ recorded at the Hong Kong IVE Chai Wan on 2 September 2002 compensate for 30 August 2002 and the lowest average was 57.7 $\mu\text{g}/\text{m}^3$ recorded at the Hong Kong IVE Chai Wan on 12 August 2002. There were no exceedances on the A/L Levels during the monitoring period.

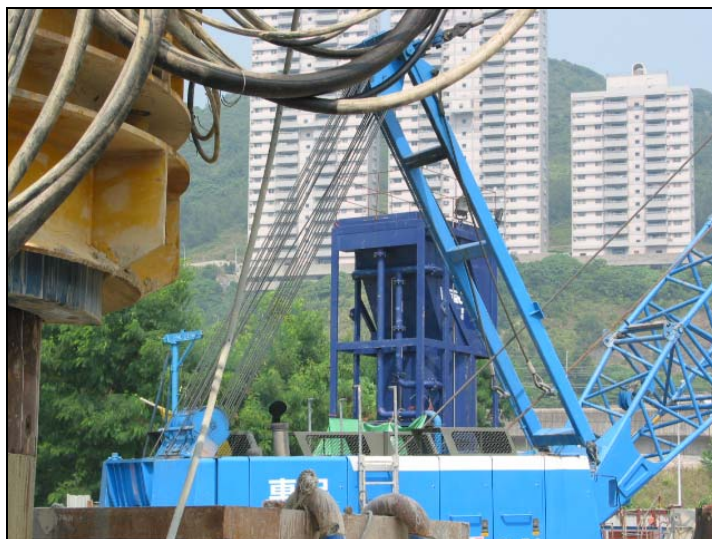
Figure 6-1 The sedimentation tanks.

- As instructed by ET, the Contractor had installed the sedimentation tanks for treating the runoff generated from the supplementary bore piling works. Photo showing the sedimentation tanks is given in Figure 6-1.
