**Citybus Permanent  
Headquarters and  
Bus Maintenance Depot  
in Chai Wan**

Monthly Environmental  
Monitoring and Audit  
Report  
September 2002

Monthly Environmental Monitoring and Audit Report – September 2002

**Ove Arup & Partners Hong Kong Ltd**

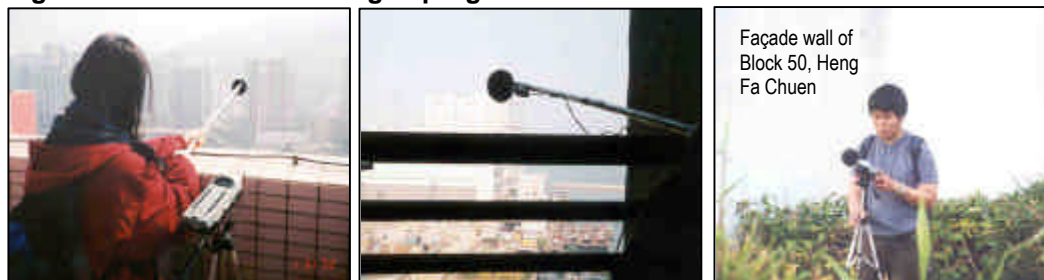
**Figure 3-1 Noise monitoring in progress**

A total of 4 monitoring locations were specified. They are given in Table 3-2. The measurements were taken at 1m from the building facade and maintained at a height 1.2m above floor. Three photos showing the noise monitoring work in action are given in Figure 3-1.

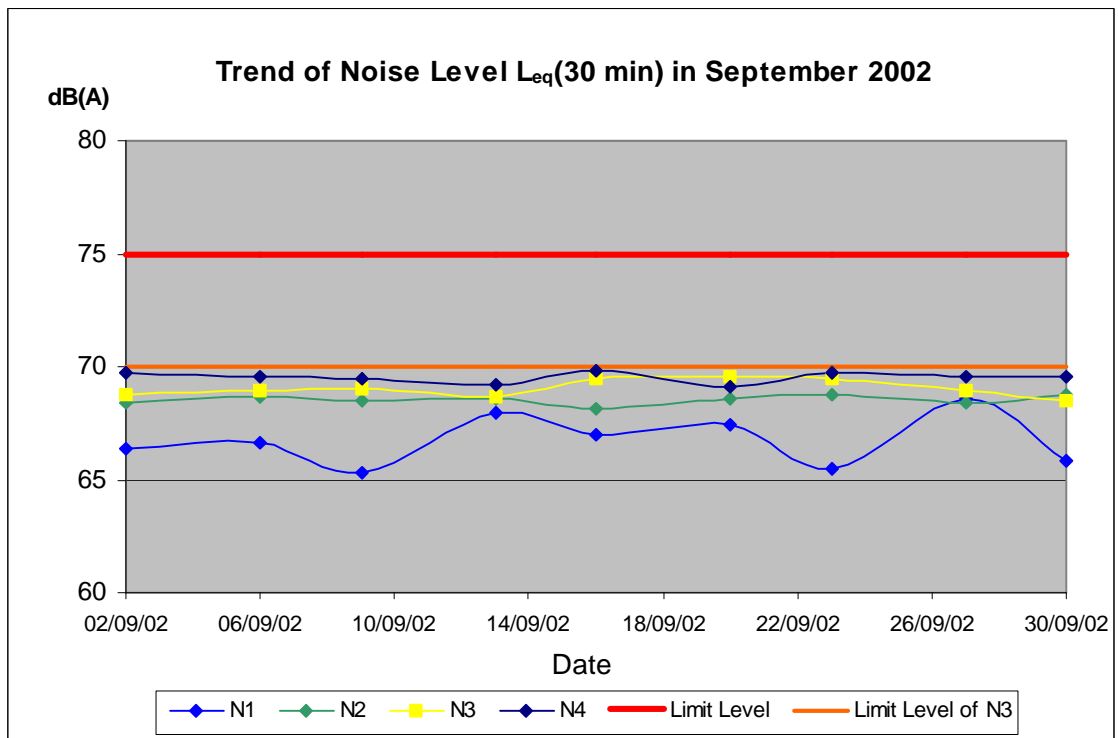
Figure 4-1 Daytime noise monitoring results for September 2002

Date of Monitoring	Monitoring Parameters	Monitoring Results, dB(A) (30 min)			
		N1	N2	N3	N4
20/09/02 (Fri)	L <sub>eq</sub>	67.4	68.6	69.6	69.1
	L <sub>10</sub>	70.1	71.1	73.1	74.1
	L <sub>90</sub>	60.6	66.1	63.6	62.6
23/09/02 (Mon)	L <sub>eq</sub>	65.5	68.8	69.5	69.7
	L <sub>10</sub>	68.6	71.1	73.1	73.6
	L <sub>90</sub>	59.6	66.6	64.1	63.6
27/09/02 (Fri)	L <sub>eq</sub>	68.6	68.4	68.9	69.6
	L <sub>10</sub>	69.1	71.6	72.6	73.6
	L <sub>90</sub>	60.6	65.1	63.6	63.1
30/09/02 (Mon)	L <sub>eq</sub>	65.8	68.8	68.5	69.6
	L <sub>10</sub>	69.1	70.6	72.1	72.8
	L <sub>90</sub>	59.1	66.6	64.1	63.1

Daytime (0700 – 1900 hours) noise monitoring was conducted at 4 locations. The highest noise level was 69.8 dB(A) recorded at Tsui Wan Estate on 16 September 2002 and the lowest was 65.3 dB(A) recorded at Heng Fa Chuen on 9 September 2002. There were no exceedances on the A/L Levels during the monitoring period.

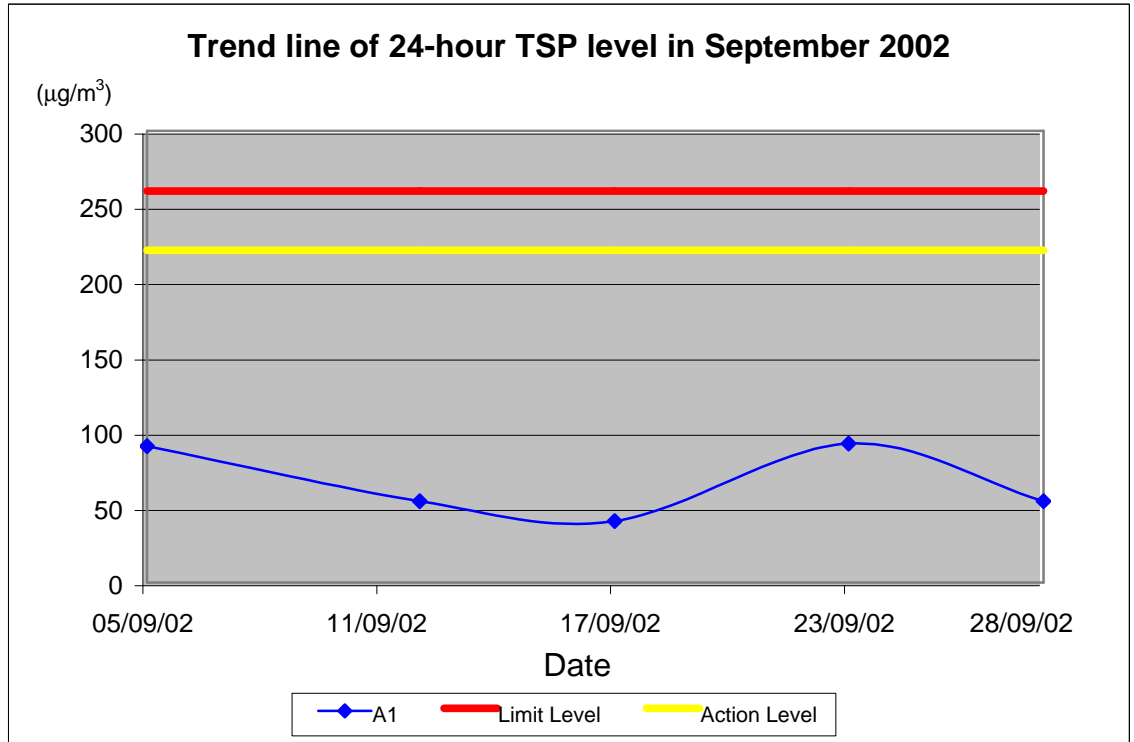
Figure 5-1 24-hour TSP monitoring results for September 2002

The highest 24-hour TSP level was 92.3  $\mu\text{g}/\text{m}^3$  recorded at the Hong Kong IVE Chai Wan on 23 September 2002 and the lowest 24-hour TSP was 40.9  $\mu\text{g}/\text{m}^3$  recorded at the Hong Kong IVE Chai Wan on 17 September 2002. There were no exceedances on the A/L Levels during the monitoring period.

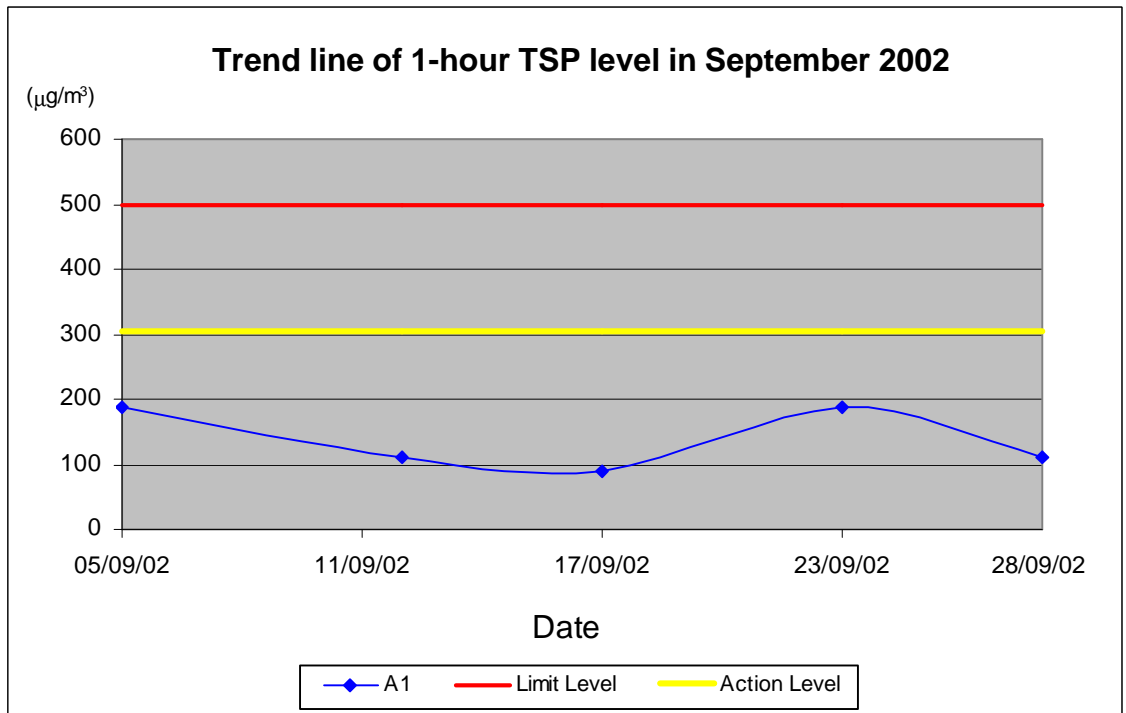
Figure 5-2 1-hour TSP monitoring results for September 2002

The 1-hour highest average TSP was 189.2  $\mu\text{g}/\text{m}^3$  recorded at the Hong Kong IVE Chai Wan on 5 September 2002 and the lowest average was 89.0  $\mu\text{g}/\text{m}^3$  recorded at the Hong Kong IVE Chai Wan on 17 September 2002. There were no exceedances on the A/L Levels during the monitoring period.

Date of Monitoring	1-hour TSP Monitoring Results ( $\mu\text{g}/\text{m}^3$ )	
	Weather	Averaged Result
05/09/02 (Thu)	Fine	189.2
12/09/02 (Thu)	Rainy	111.0
17/09/02 (Wed)	Overcast	89.0
23/09/02 (Mon)	Overcast	186.3
28/10/02 (Sat)	Overcast	112.2

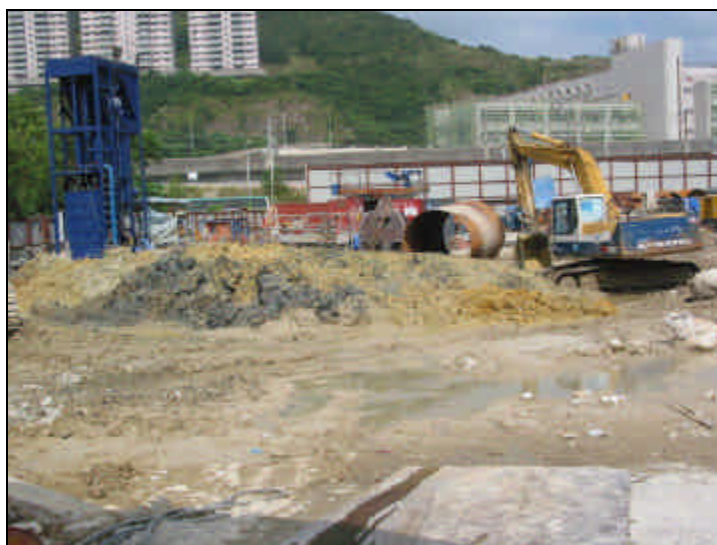
**Figure 6-1** The stockpile of the excavated material

- A stockpile of excavated material was observed near the sedimentation tank. The Contractor informed ET that the excavated material would be used for backfilling or discharged to Quarry Bay Public Filling Barging Point soon. Contractor was requested to cover the stockpile with tarpaulin. Photo showing the stockpile of excavated material is given in Figure 6-1.

- No significant air impact was identified.
- No significant noise impact was identified.
- No significant water impact was identified.
- A stockpile of excavated material was observed near the sedimentation tank. The Contractor informed ET that the excavated material would be used for backfilling or discharged to Quarry Bay Public Filling Barging Point soon. Contractor was requested to cover the stockpile with tarpaulin.

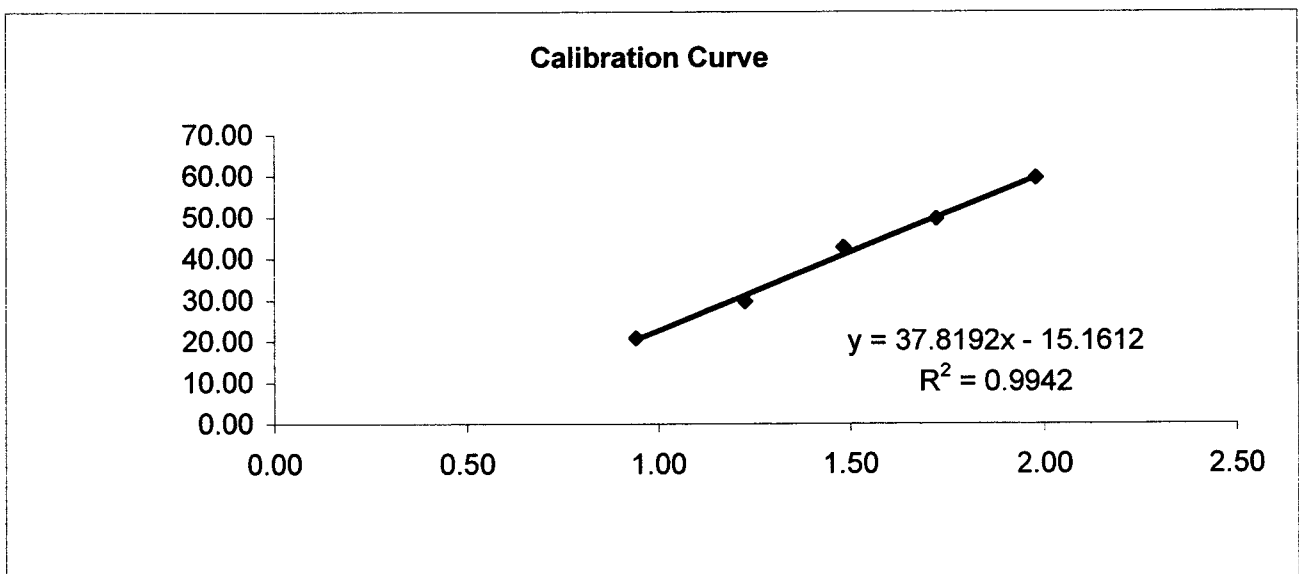
Calibration date	04-Sep-02	Barometric pressure	757.5 mm Hg
Next Calibration date	03-Nov-02	Temperature (°C)	29 °C
	Roof floor of Educational Building,		
Sampler location	IVE	Temperature (K)	302 K
Sampler model	Graseby GMW 2310	P <sub>std</sub>	760 mm Hg
Sampler serial number	6932	T <sub>std</sub>	298 K
Calibrator model		GMW-2535	
Calibrator serial number		1201	
Slope of the standard curve, m <sub>s</sub>		1.96531	
Intercept of the standard curve, b <sub>s</sub>		-0.02294

Resistance Plate No.	Manometer Reading (inch H <sub>2</sub> O)	Flow Recorder Reading (CFM)	Calculated Q <sub>std</sub> (m <sup>3</sup> /min)	Continuous Flow Recorder Reading IC (CFM)
5	3.40	21.00	0.94	20.83
7	5.80	30.00	1.23	29.75
10	8.50	43.00	1.48	42.64
13	11.50	50.00	1.72	49.59
18	15.20	60.00	1.98	59.50

Sampler slope (m) : **37.8192**  
 Sampler intercept (b) : **-15.1612**  
 Correlation coefficient (R<sup>2</sup>) : **0.9942**
