**Citybus Permanent
Headquarters and
Bus Maintenance Depot
in Chai Wan**

Monthly Environmental
Monitoring and Audit
Report
December 2002

Monthly Environmental Monitoring and Audit Report – December 2002

Ove Arup & Partners Hong Kong Ltd

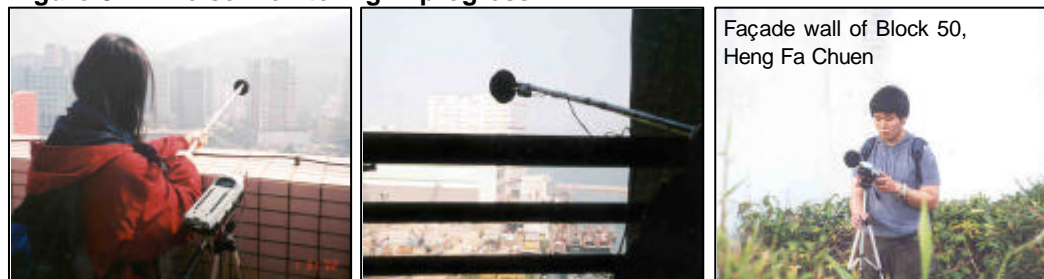
Figure 3-1 Noise monitoring in progress

A total of 4 monitoring locations were specified. They are given in Table 3-2. The measurements were taken at 1m from the building facade and maintained at a height 1.2m above floor. Three photos showing the noise monitoring work in action are given in Figure 3-1.

- The sound level meter and the battery were checked to ensure that they were in proper condition.
- The sound level meter was set on a tripod at 1.2m above ground and at least 1m from the exterior of the building façade.
- Before conducting the measurement, the sound level meter was calibrated by an acoustical calibrator.
- The measurement parameter was set to A-weighted sound pressure level. The time weighting was set in fast response and the time period of measurement at 30 minutes.
- The wind speed was checked during noise monitoring to ensure the steady wind speed did not exceed 5m/s, or wind with gusts did not exceed 10m/s.
- Any abnormal conditions that generated intrusive noise during the measurement were recorded on the field record sheet.
- After each measurement, the equivalent continuous sound pressure level (L_{eq}), L_{10} and L_{90} were recorded on the field record sheet.

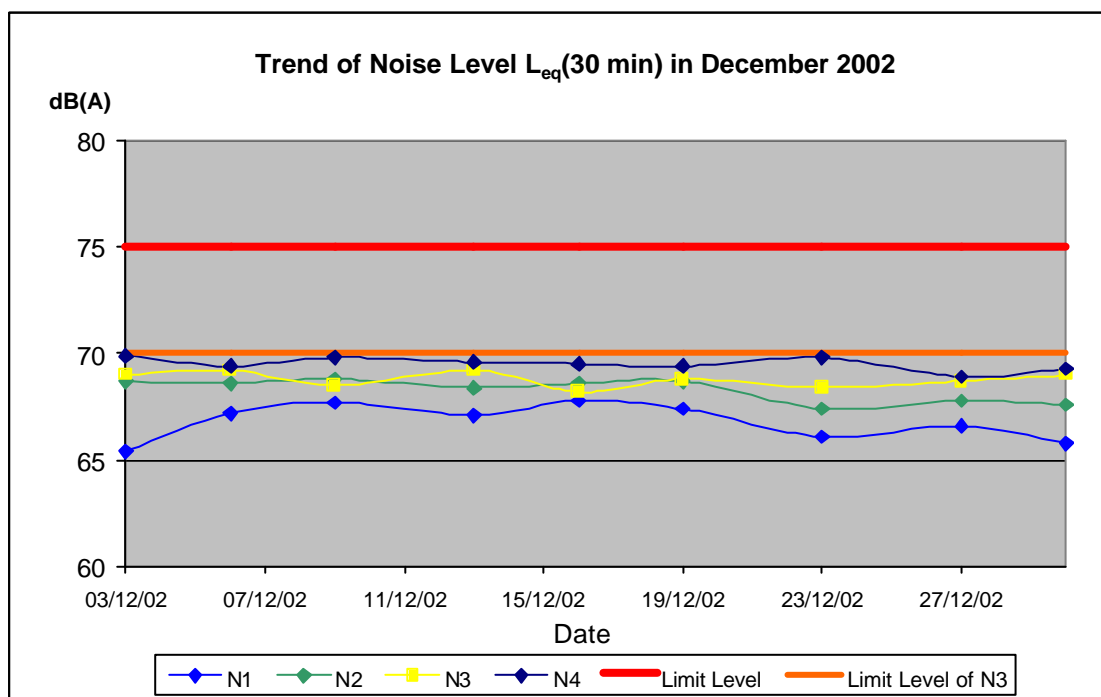
Figure 4-1 Daytime noise monitoring results for December 2002

Daytime (0700 – 1900 hours) noise monitoring was conducted at 4 locations. The highest noise level was 69.9 dB(A) recorded at Tsuen Wan Estate on 3 December 2002 and the lowest was 65.4 dB(A) recorded at Heng Fa Chuen on 3 December 2002. There were no exceedances on the A/L Levels during the monitoring period.

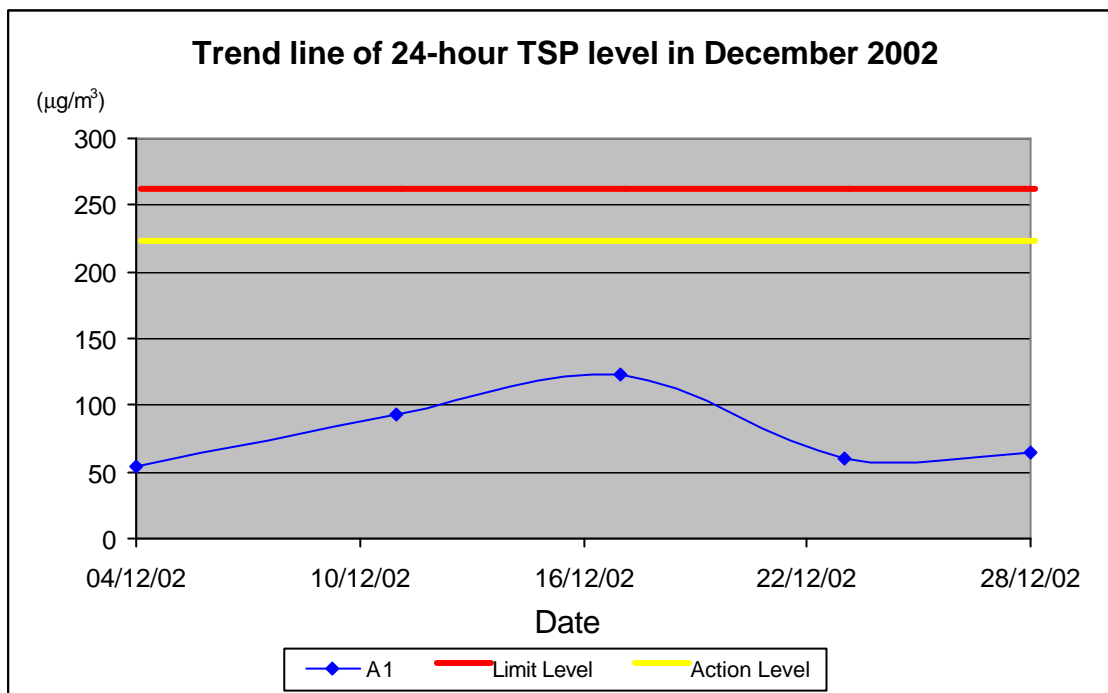
Figure 5-1 24-hour TSP monitoring results for December 2002

The highest 24-hour TSP level was 123.6 $\mu\text{g}/\text{m}^3$ recorded at the Hong Kong IVE Chai Wan on 17 December 2002 and the lowest 24-hour TSP level was 54.3 $\mu\text{g}/\text{m}^3$ recorded at the Hong Kong IVE Chai Wan on 4 December 2002. There were no exceedances on the A/L Levels during the monitoring period.

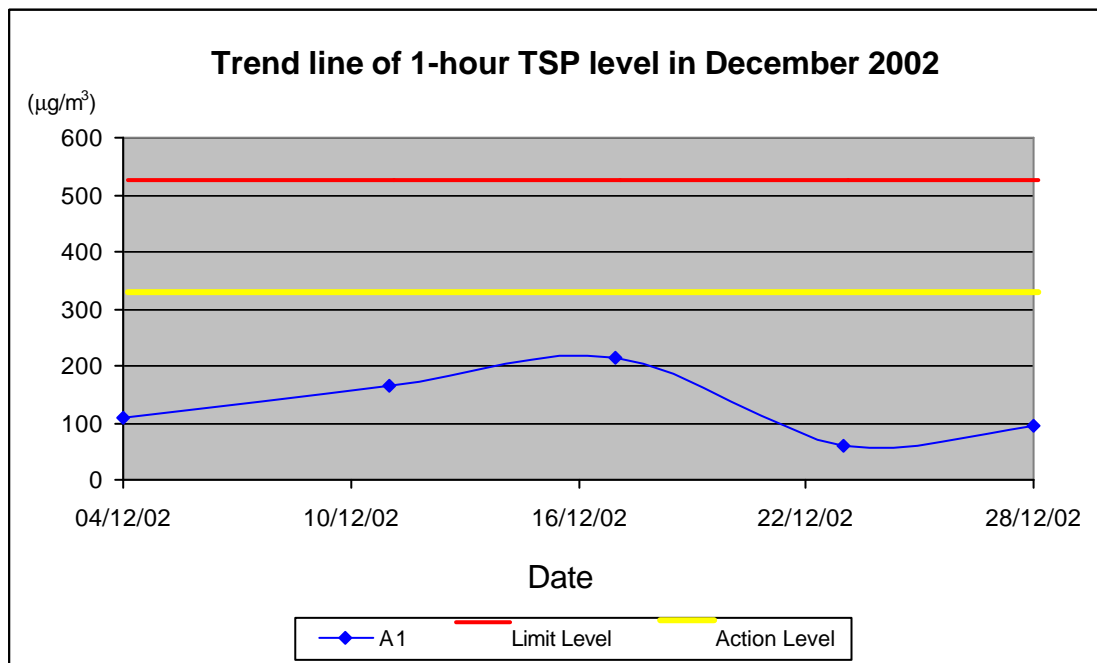
Figure 5-2 1-hour TSP monitoring results for December 2002

The highest average 1-hour TSP level was 214.7 $\mu\text{g}/\text{m}^3$ recorded at the Hong Kong IVE Chai Wan on 17 December 2002 and the lowest average 1-hour TSP level was 59.8 $\mu\text{g}/\text{m}^3$ recorded at the Hong Kong IVE Chai Wan on 23 December 2002. There were no exceedances on the A/L Levels during the monitoring period.

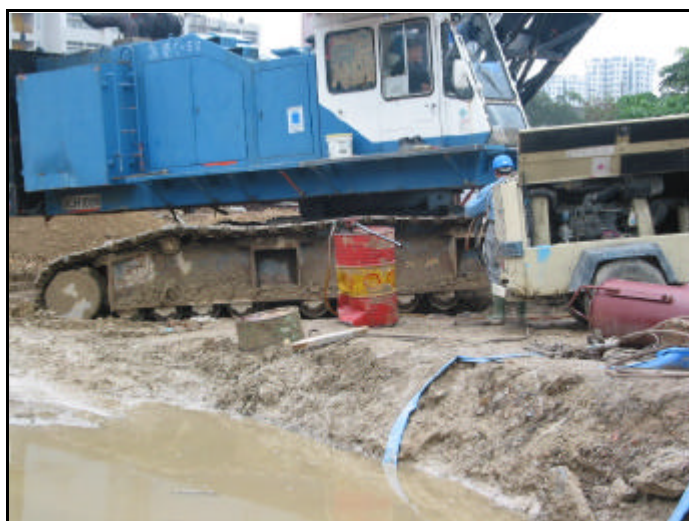
Figure 6-1 The diesel drum without drip tray

- Diesel drum was found without drip tray. As instructed by ET, Contractor had placed the diesel drum back to the drip tray. Photo showing the diesel drum without drip tray is given in Figure 6-1.

- No significant air impact was identified.
- No significant noise impact was identified.
- No significant water impact was identified.
- Diesel drum was found without drip tray. As instructed by ET, Contractor had placed the diesel drum back to the drip tray.

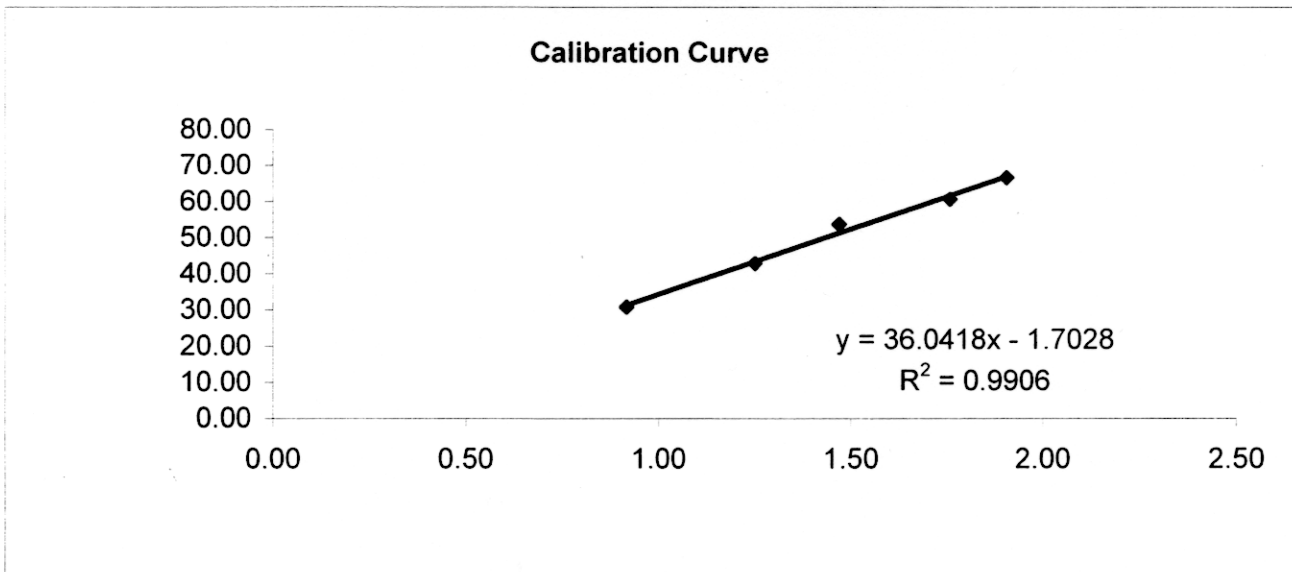
Linear Regression

Sampler slope (m) : **36.0418**
 Sampler intercept (b) : **-1.7028**
 Correlation coefficient (R²) : **0.9906**
