**Citybus Permanent
Headquarters and
Bus Maintenance Depot
in Chai Wan**

Monthly Environmental
Monitoring and Audit
Report
January 2003

Ove Arup & Partners Hong Kong Ltd

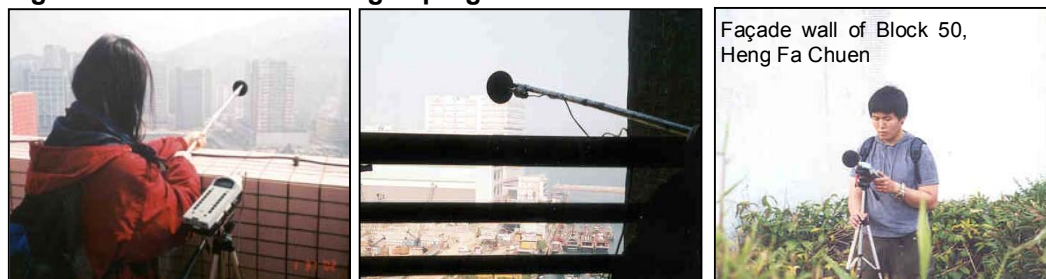
Figure 3-1 Noise monitoring in progress

A total of 4 monitoring locations were specified. They are given in Table 3-2. The measurements were taken at 1m from the building facade and maintained at a height 1.2m above floor. Three photos showing the noise monitoring work in action are given in Figure 3-1.

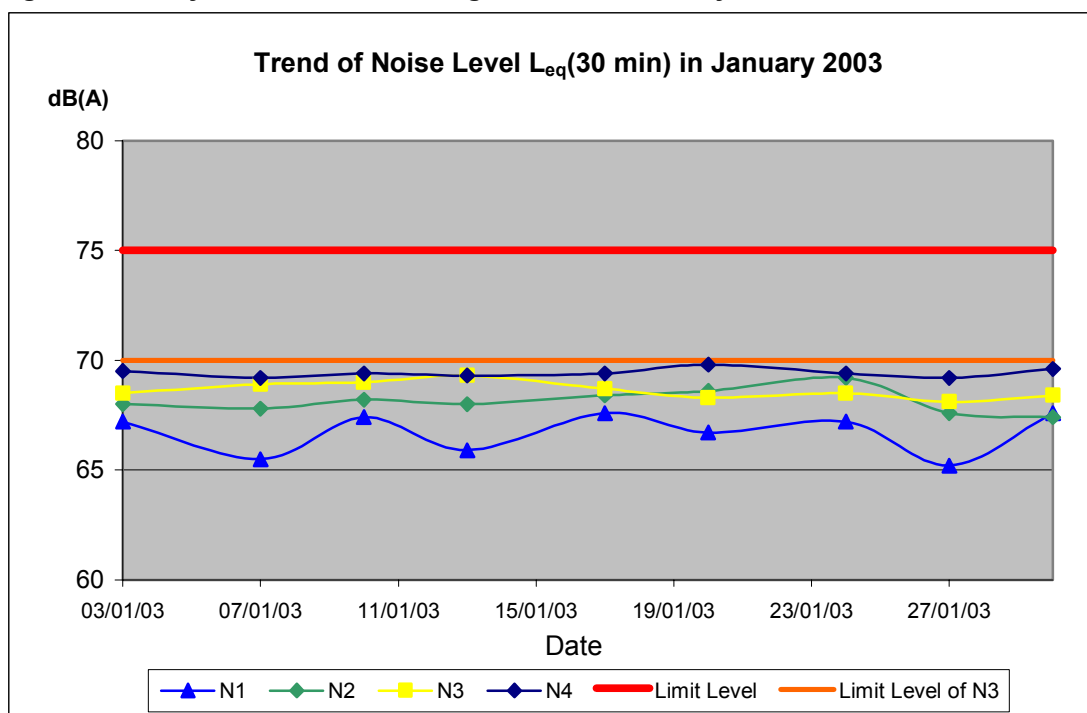
Figure 4-1 Daytime noise monitoring results for January 2003

Daytime (0700 – 1900 hours) noise monitoring was conducted at 4 locations. The highest noise level was 69.8 dB(A) recorded at Tsuen Wan Estate on 20 January 2003 and the lowest was 65.2 dB(A) recorded at Heng Fa Chuen on 27 January 2003. There were no exceedances on the A/L Levels during the monitoring period.

Date of Monitoring	Monitoring Parameters	Monitoring Results, dB(A) (30 min)			
		N1	N2	N3	N4
20/01/03 (Mon)	L _{eq}	66.7	68.6	68.3	69.8
	L ₁₀	70.6	71.6	72.6	73.6
	L ₉₀	60.6	66.6	63.6	62.1
24/01/03 (Fri)	L _{eq}	67.2	69.2	68.5	69.4
	L ₁₀	71.6	72.6	73.1	73.6
	L ₉₀	61.6	67.1	64.1	62.6
27/01/03 (Mon)	L _{eq}	65.2	67.6	68.1	69.2
	L ₁₀	68.6	70.1	72.6	72.6
	L ₉₀	58.6	65.1	63.6	62.6
30/01/03 (Thu)	L _{eq}	67.6	67.4	68.4	69.6
	L ₁₀	70.6	70.1	72.6	73.1
	L ₉₀	62.6	66.1	63.1	62.6

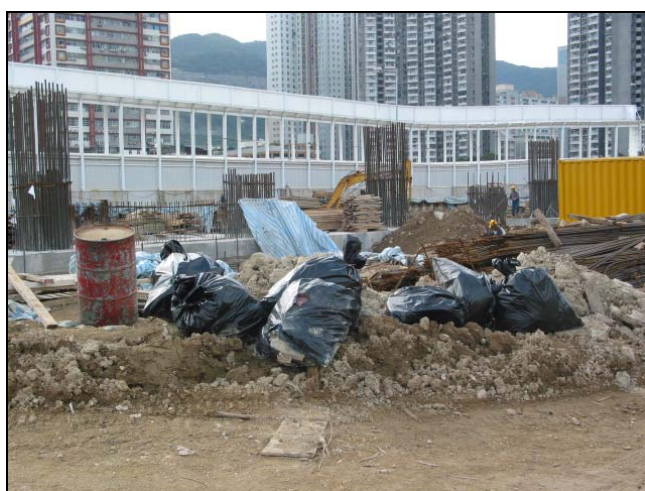
Figure 6-1 The debris at site

- Debris was observed at the site. As instructed by ET, the Contractor had agreed to clean up the debris regularly. Photo showing the rubbish at site is given in Figure 6-1.

- No significant air impact was identified.
- No significant noise impact was identified.
- No significant water impact was identified.
- Debris was observed at the site. As instructed by ET, the Contractor had agreed to clean up the debris regularly.
