**Citybus Permanent
Headquarters and
Bus Maintenance Depot
in Chai Wan**

Monthly Environmental
Monitoring and Audit
Report
February 2003

Ove Arup & Partners Hong Kong Ltd

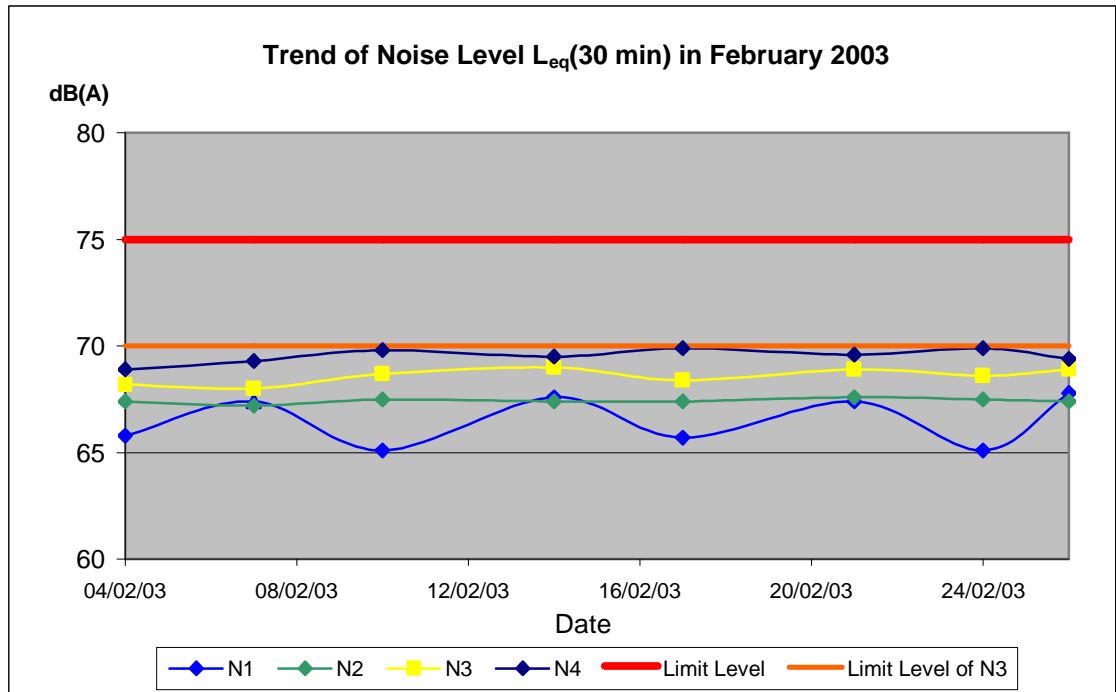
Figure 4-1 Daytime noise monitoring results for February 2003

Date of Monitoring	Monitoring Parameters	Monitoring Results, dB(A) (30 min)			
		N1	N2	N3	N4
21/02/03 (Fri)	L _{eq}	67.4	67.6	68.9	69.6
	L ₁₀	71.6	70.6	73.1	73.1
	L ₉₀	61.1	65.1	63.1	62.1
24/02/03 (Mon)	L _{eq}	65.1	67.5	68.6	69.9
	L ₁₀	70.6	70.1	72.6	74.1
	L ₉₀	61.6	65.1	64.1	63.1
26/02/03 (Wed)	L _{eq}	67.8	67.4	68.9	69.4
	L ₁₀	72.1	71.1	74.1	73.1
	L ₉₀	62.1	65.1	63.1	62.6

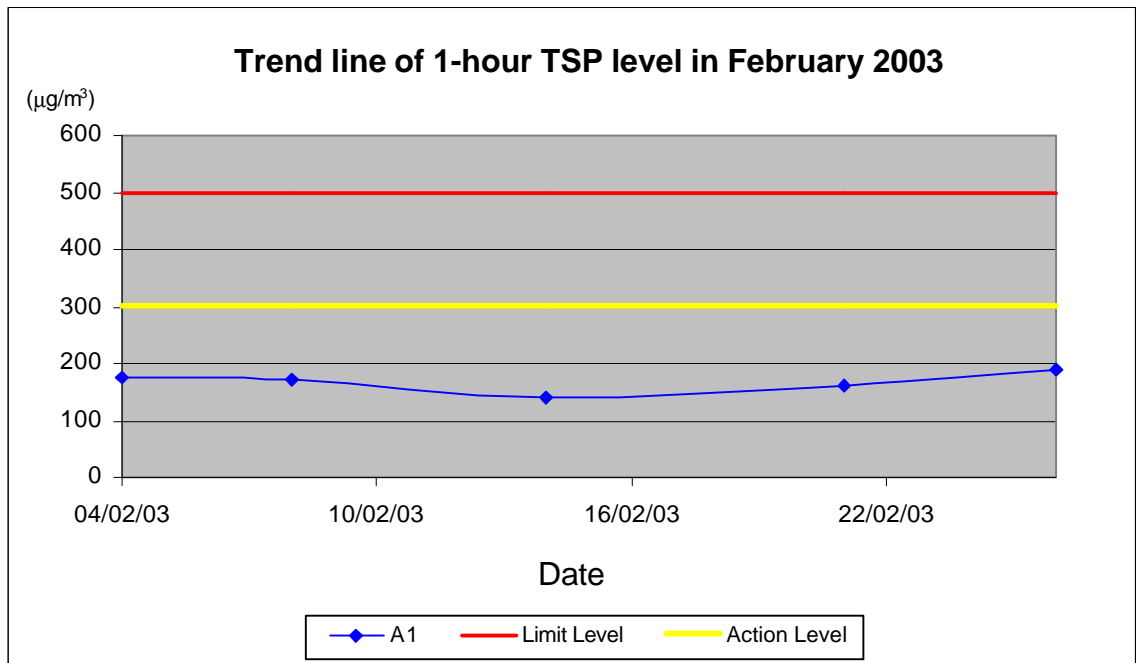
Figure 5-2 1-hour TSP monitoring results for February 2003

Date of Monitoring	1-hour TSP Monitoring Results ($\mu\text{g}/\text{m}^3$)	
	Weather	Averaged Result
04/02/03 (Tue)	Fine	175.9
08/02/03 (Sat)	Overcast	170.6
14/02/03 (Fri)	Overcast	140.8
21/02/03 (Fri)	Overcast	160.3
26/02/03 (Wed)	Fine	191.1

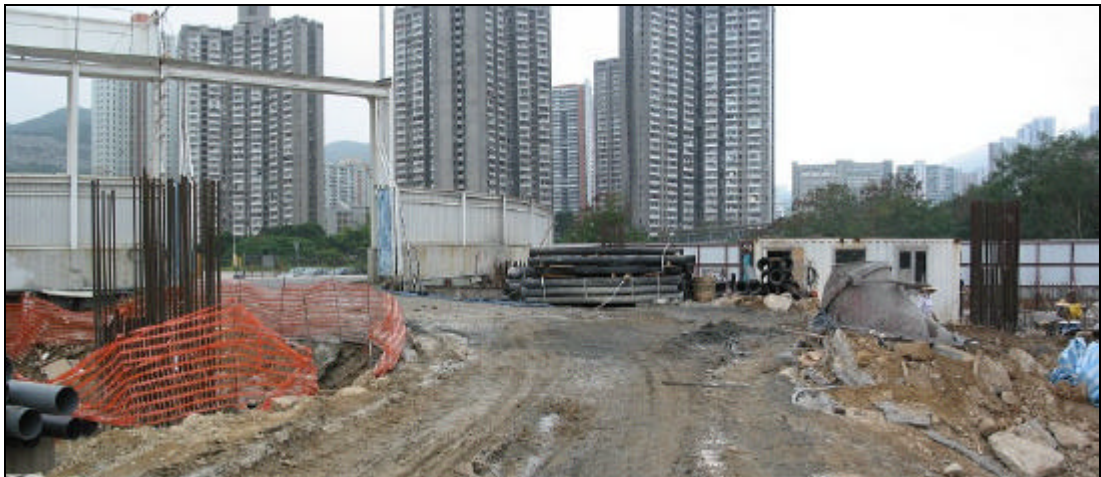
Figure 6-1 No wheel washing facility was provided at site access

- No wheel washing facility was provided at site access from superstructure's Contractor. As instructed by ET, the Contractor agreed to provide the wheel washing facility as soon as possible. Photo showing the site access is given in Figure 6-1.

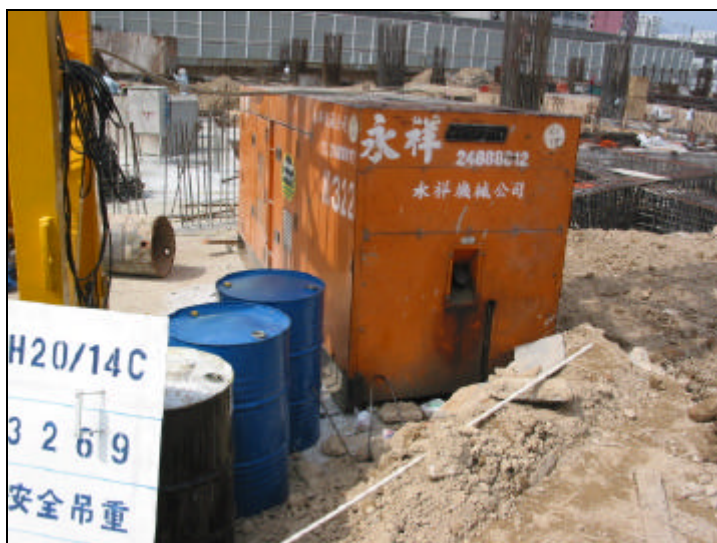
Figure 6-2 Generator and diesel drums without drip-tray

- No drip-tray was provided for generator and diesel drums at the site. As instructed by ET, the Contractor had agreed to provide drip-trays as soon as possible. Photo showing the generator and diesel drums without drip-tray is given in Figure 6-2.
