**Citybus Permanent  
Headquarters and  
Bus Maintenance Depot  
in Chai Wan**

Monthly Environmental  
Monitoring and Audit  
Report  
March 2003

Monthly Environmental Monitoring and Audit Report – March 2003

April 2003

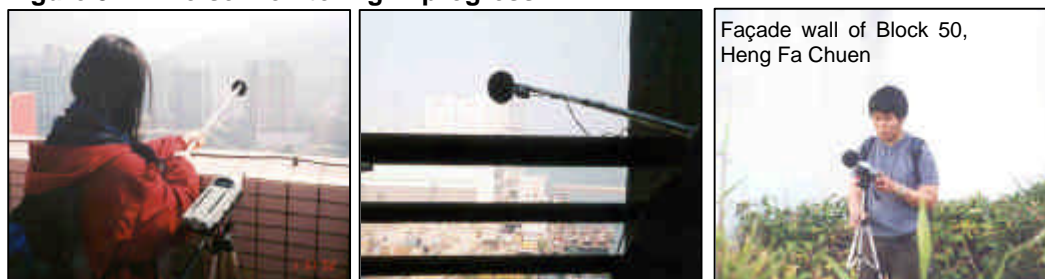
**Figure 3-1 Noise monitoring in progress**

A total of 4 monitoring locations were specified. They are given in Table 3-2. The measurements were taken at 1m from the building facade and maintained at a height 1.2m above floor. Three photos showing the noise monitoring work in action are given in Figure 3-1.

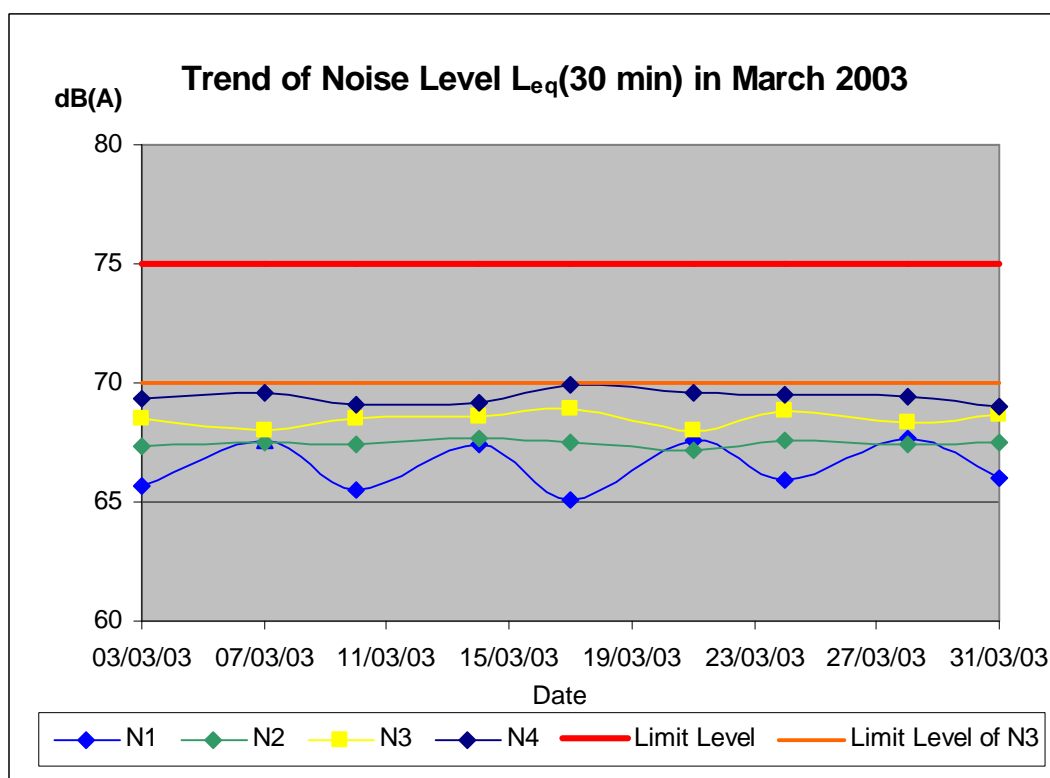
Figure 4-1 Daytime noise monitoring results for March 2003

Daytime (0700 – 1900 hours) noise monitoring was conducted at 4 locations. The highest noise level was 69.9 dB(A) recorded at Tsuen Wan Estate on 17 March 2003 and the lowest was 65.1 dB(A) recorded at Heng Fa Chuen on 17 March 2003. There were no exceedances on the A/L Levels during the monitoring period.

Date of Monitoring	Monitoring Parameters	Monitoring Results, dB(A) (30 min)			
		N1	N2	N3	N4
21/03/03 (Fri)	L <sub>eq</sub>	67.6	67.2	68.0	69.6
	L <sub>10</sub>	72.6	70.1	72.6	73.1
	L <sub>90</sub>	62.6	65.1	62.6	62.6
24/03/03 (Mon)	L <sub>eq</sub>	65.9	67.6	68.8	69.5
	L <sub>10</sub>	70.6	71.1	74.1	72.6
	L <sub>90</sub>	59.6	66.1	62.1	63.1
28/03/03 (Fri)	L <sub>eq</sub>	67.7	67.4	68.3	69.4
	L <sub>10</sub>	72.6	71.1	74.6	73.6
	L <sub>90</sub>	62.1	65.1	63.1	62.6
31/03/03 (Mon)	L <sub>eq</sub>	66.0	67.5	68.7	69.0
	L <sub>10</sub>	70.1	71.1	74.6	72.6
	L <sub>90</sub>	60.1	65.1	62.6	62.6

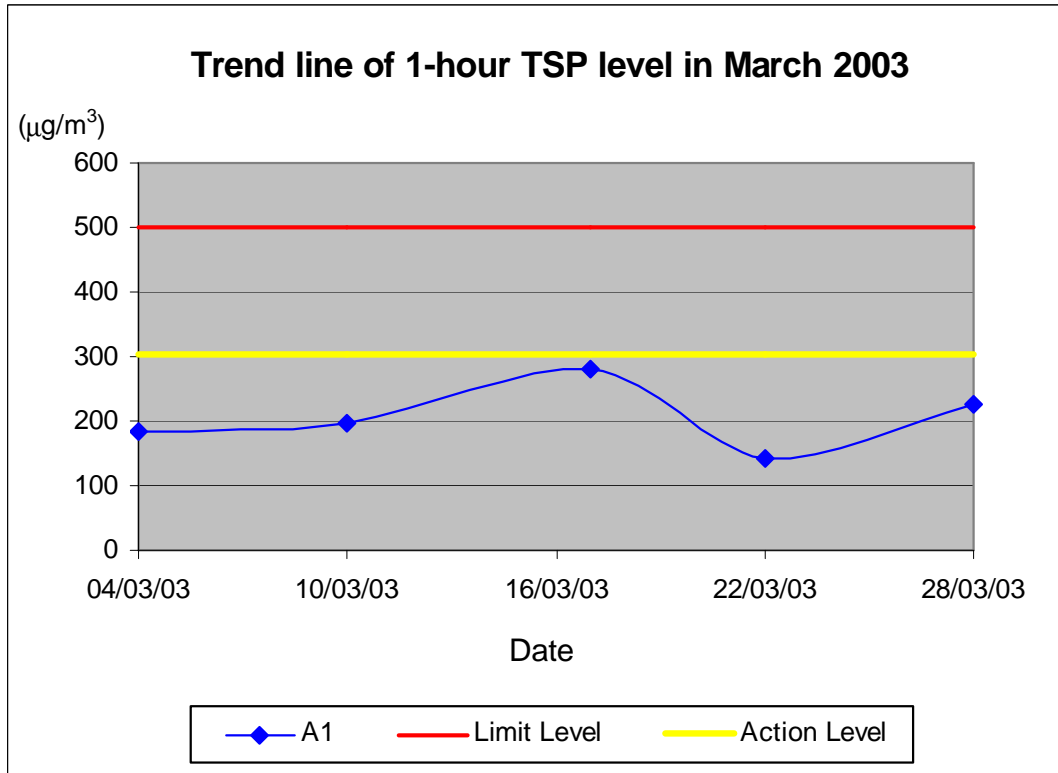
**Figure 5-1 24-hour TSP monitoring results for March 2003**

The highest 24-hour TSP level was 148.0  $\mu\text{g}/\text{m}^3$  recorded at the Hong Kong IVE Chai Wan on 17 March 2003 and the lowest 24-hour TSP was 74.6  $\mu\text{g}/\text{m}^3$  recorded at the Hong Kong IVE Chai Wan on 22 March 2003. There were no exceedances on the A/L Levels during the monitoring period.

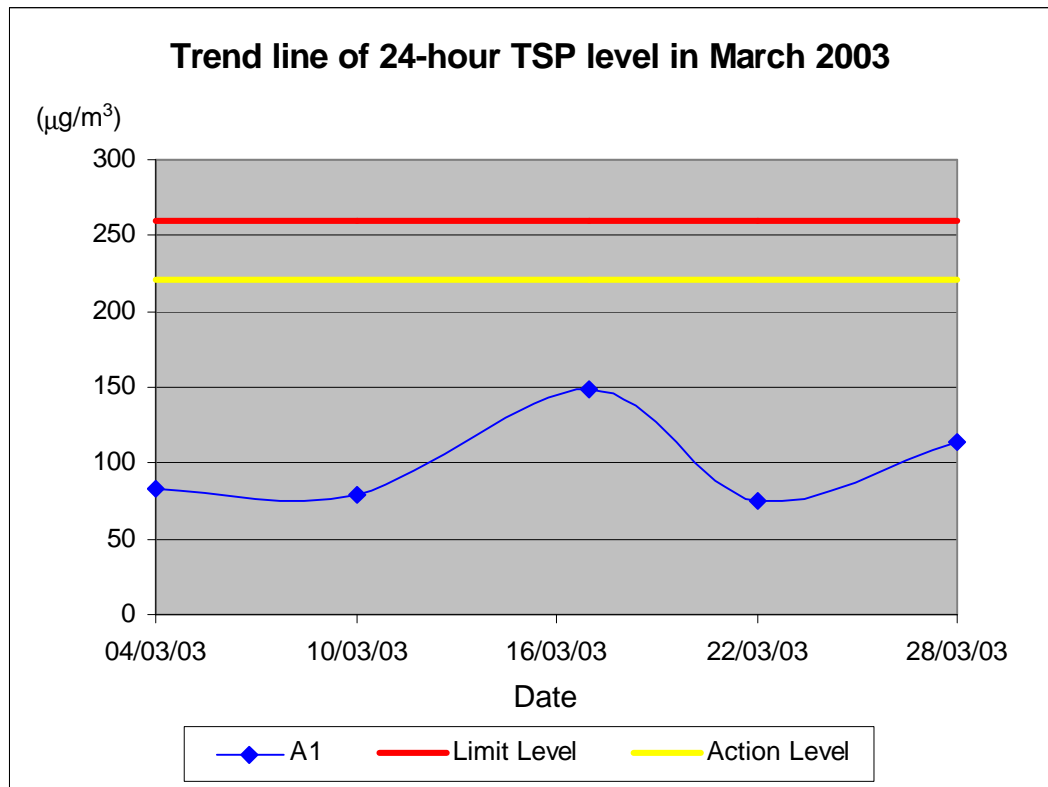
**Figure 5-2 1-hour TSP monitoring results for March 2003**

The highest average 1-hour TSP was 281.4  $\mu\text{g}/\text{m}^3$  recorded at the Hong Kong IVE Chai Wan on 17 March 2003 and the lowest average 1-hour TSP was 143.2  $\mu\text{g}/\text{m}^3$  recorded at the Hong Kong IVE Chai Wan on 22 March 2003. There were no exceedances on the A/L Levels during the monitoring period.

Date of Monitoring	1-hour TSP Monitoring Results ( $\mu\text{g}/\text{m}^3$ )	
	Weather	Averaged Result
04/03/03 (Tue)	Overcast	184.4
10/03/03 (Mon)	Overcast	195.9
17/03/03 (Mon)	Fine	281.4
22/03/03 (Sat)	Overcast	143.2
28/03/03 (Fri)	Overcast	226.3

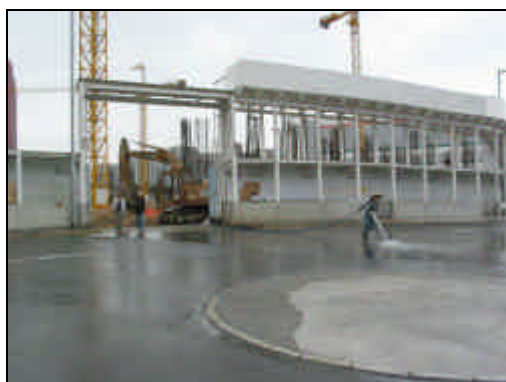
**Figure 6-1** The wheel washing at site access

- Wheel washing facility was provided at site access. Performance was satisfactory. Photo showing the wheel washing at site access is given in Figure 6-1.

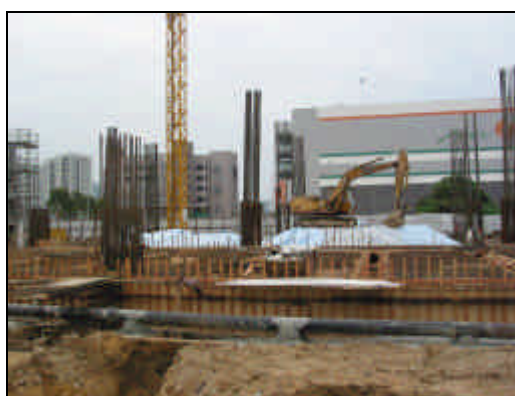
**Figure 6-2** The covered stockpile

- Stockpile was observed within the site area. As instructed by ET, the Contractor had covered the stockpile with tarpaulin. Photo showing the covered stockpile is given in Figure 6-2.

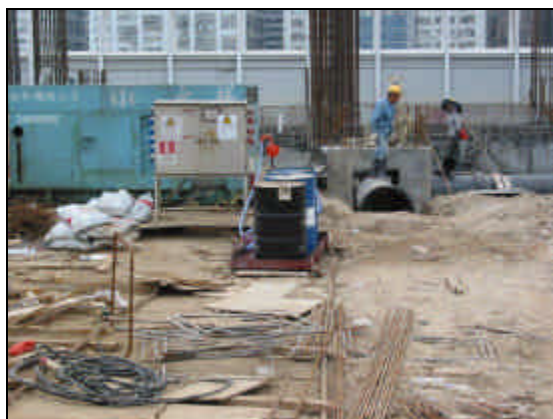
**Figure 6-3** Drip-tray was provided

- Drip-trays were provided for generator and diesel drums at the site. Performance was satisfactory. Photos showing the generator and diesel drums with drip-tray are given in Figure 6-3 and Figure 6-4 respectively.
