**Citybus Permanent  
Headquarters and  
Bus Maintenance Depot  
in Chai Wan**

Monthly Environmental Monitoring and Audit Report – May 2003

**Ove Arup & Partners Hong Kong Ltd**

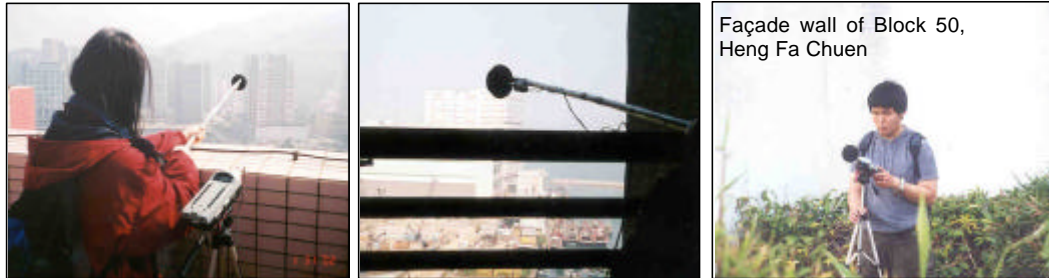
**Figure 3-1 Noise monitoring in progress**

A total of 4 monitoring locations were specified. They are given in Table 3-2. The measurements were taken at 1m from the building facade and maintained at a height 1.2m above floor. Three photos showing the noise monitoring work in action are given in Figure 3-1.

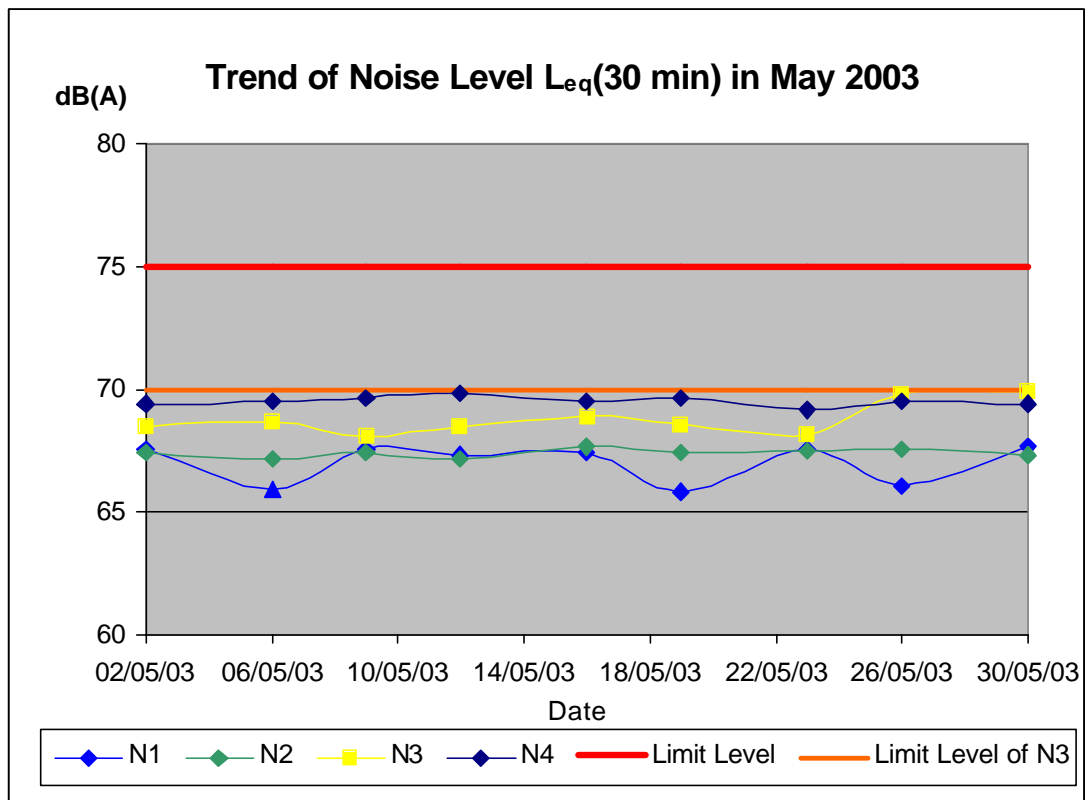
Figure 4-1 Daytime noise monitoring results for May 2003

Date of Monitoring	Monitoring Parameters	Monitoring Results, dB(A) (30 min)			
		N1	N2	N3	N4
19/05/03 (Tue)	L <sub>eq</sub>	65.8	67.4	68.6	69.7
	L <sub>10</sub>	70.1	70.1	73.6	73.6
	L <sub>90</sub>	60.6	65.6	64.1	63.1
23/05/03 (Fri)	L <sub>eq</sub>	67.6	67.5	68.2	69.2
	L <sub>10</sub>	72.6	70.1	73.1	74.1
	L <sub>90</sub>	62.1	65.1	63.6	62.1
26/05/03 (Mon)	L <sub>eq</sub>	66.1	67.6	69.8	69.5
	L <sub>10</sub>	70.1	70.6	74.6	73.1
	L <sub>90</sub>	60.1	65.1	62.6	62.6
30/05/03 (Fri)	L <sub>eq</sub>	67.7	67.3	69.9	69.4
	L <sub>10</sub>	72.6	70.1	75.1	74.6
	L <sub>90</sub>	62.6	65.6	62.6	62.1

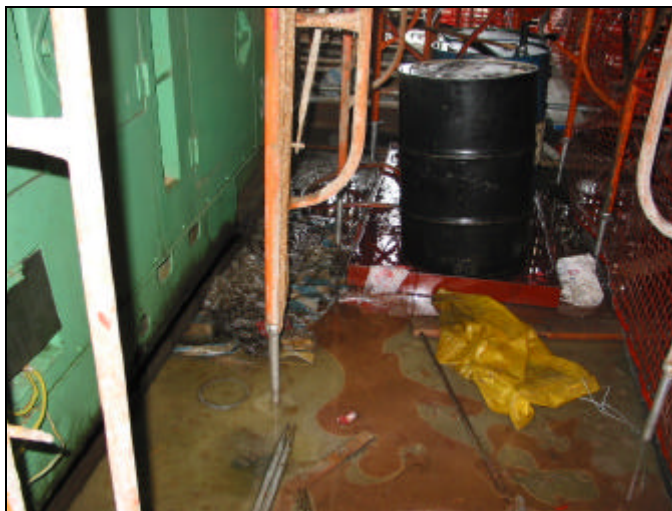
**Figure 6-1** Oil spillage from drip tray

- Oil spillage from drip-tray was observed at ground floor. As instructed by ET, the Contractor had clean up the oil spillage immediately. Photo showing the oil spillage from drip-tray is given in Figure 6-1.

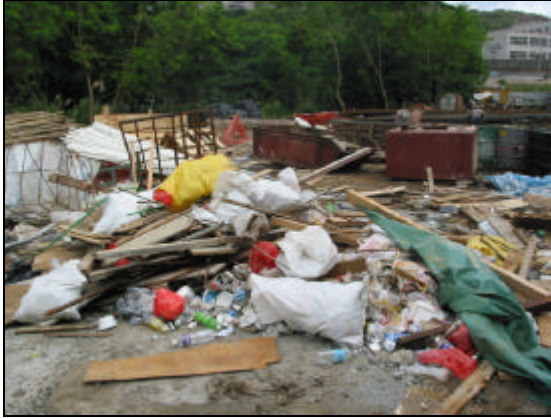
**Figure 6-2** Rubbish near site office

- Rubbish was observed at the site and near to site office. As informed by the Contractor, rubbish would be cleaned up as daily base. Photos showing the rubbish near the site office and at the site are given in Figure 6-2 and Figure 6-3 respectively.
