**Citybus Permanent  
Headquarters and  
Bus Maintenance Depot  
in Chai Wan**

Monthly Environmental  
Monitoring and Audit  
Report  
July 2003

Monthly Environmental Monitoring and Audit Report – July 2003

**Ove Arup & Partners Hong Kong Ltd**

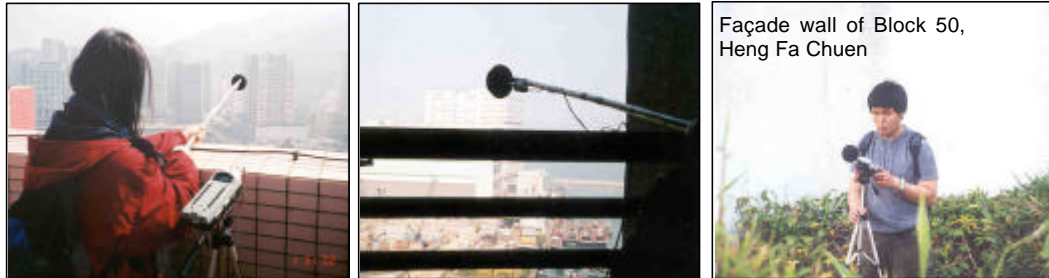
**Figure 3-1 Noise monitoring in progress**

A total of 4 monitoring locations were specified. They are given in Table 3-2. The measurements were taken at 1m from the building facade and maintained at a height 1.2m above floor. Three photos showing the noise monitoring work in action are given in Figure 3-1.

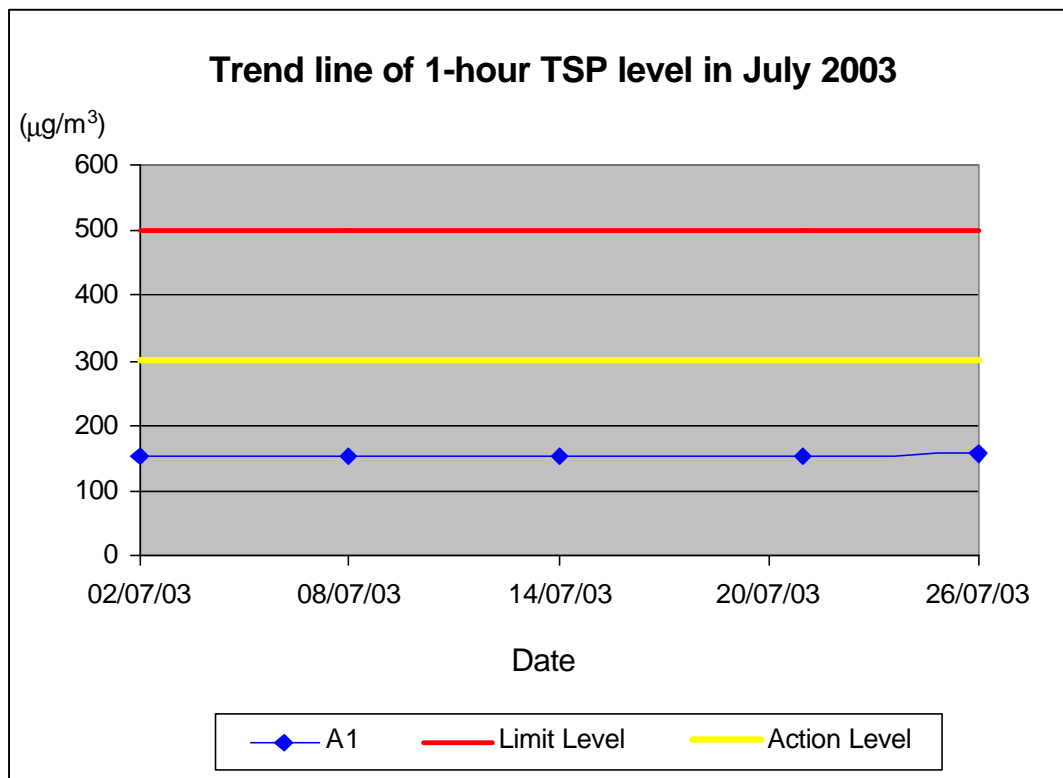
**Figure 5-2 1-hour TSP monitoring results for July 2003**

Date of Monitoring	1-hour TSP Monitoring Results ( $\mu\text{g}/\text{m}^3$ )	
	Weather	Averaged Result
02/07/03 (Wed)	Fine	153.2
08/07/03 (Tue)	Fine	155.5
14/07/03 (Mon)	Fine	155.5
21/07/03 (Mon)	Fine	155.0
26/07/03 (Sat)	Fine	156.3

The highest average 1-hour TSP was 156.3 µg/m<sup>3</sup> recorded at the Hong Kong IVE Chai Wan on 26 July 2003 and the lowest average 1-hour TSP was 153.2 µg/m<sup>3</sup> recorded at the Hong Kong IVE Chai Wan on 2 July 2003. There were no exceedances on the A/L Levels during the monitoring period.

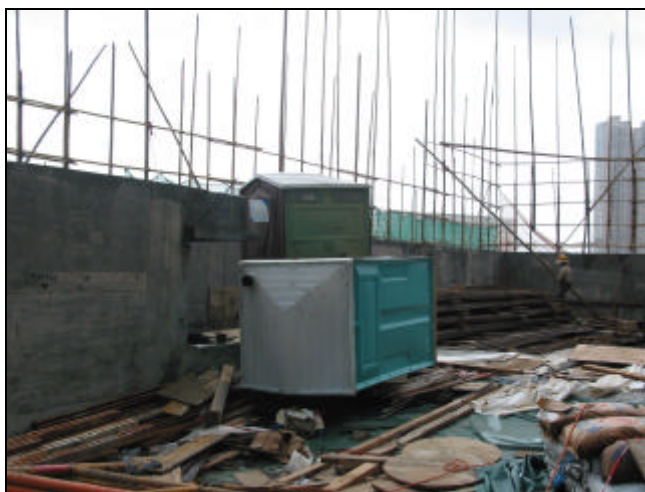
**Figure 6-1** The collapsed chemical toilet on 3/F.

- The chemical toilet on 3/F was collapsed due to the typhoon on 24 July 2003. As instructed by ET, the Contractor has erected the chemical toilet and cleaned up the affected area immediately. Photo showing the chemical toilet at 3/F has been blown down is given in Figure 6-1.

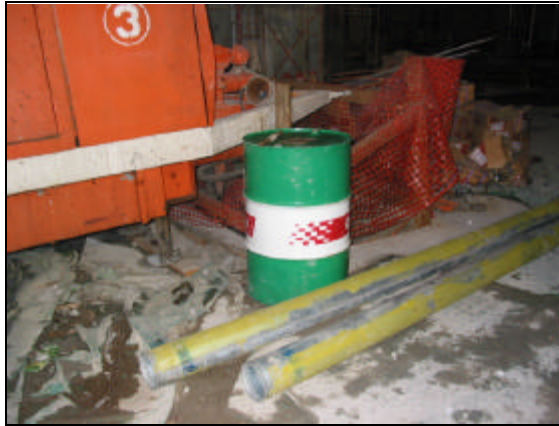
**Figure 6-2** Oil drums without drip tray

- Oil drums without drip tray were observed (Figure 6-2). As instructed by ET, the Contractor had provided a drip tray immediately.
