**Citybus Permanent
Headquarters and
Bus Maintenance Depot
in Chai Wan**

Monthly Environmental
Monitoring and Audit
Report
September 2003

Monthly Environmental Monitoring and Audit Report – September 2003

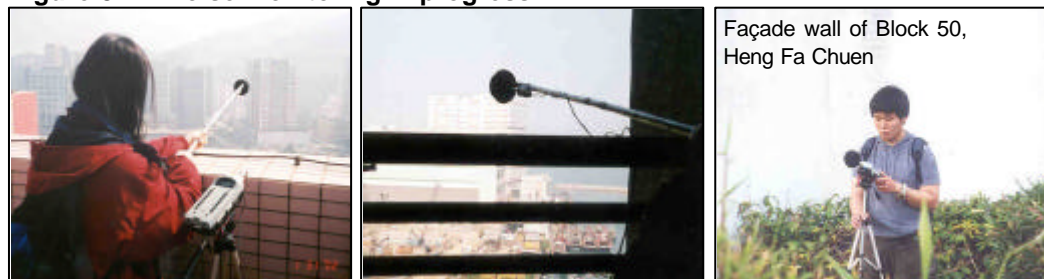
Figure 3-1 Noise monitoring in progress

A total of 4 monitoring locations were specified. They are given in Table 3-2. The measurements were taken at 1m from the building facade and maintained at a height 1.2m above floor. Three photos showing the noise monitoring work in action are given in Figure 3-1.

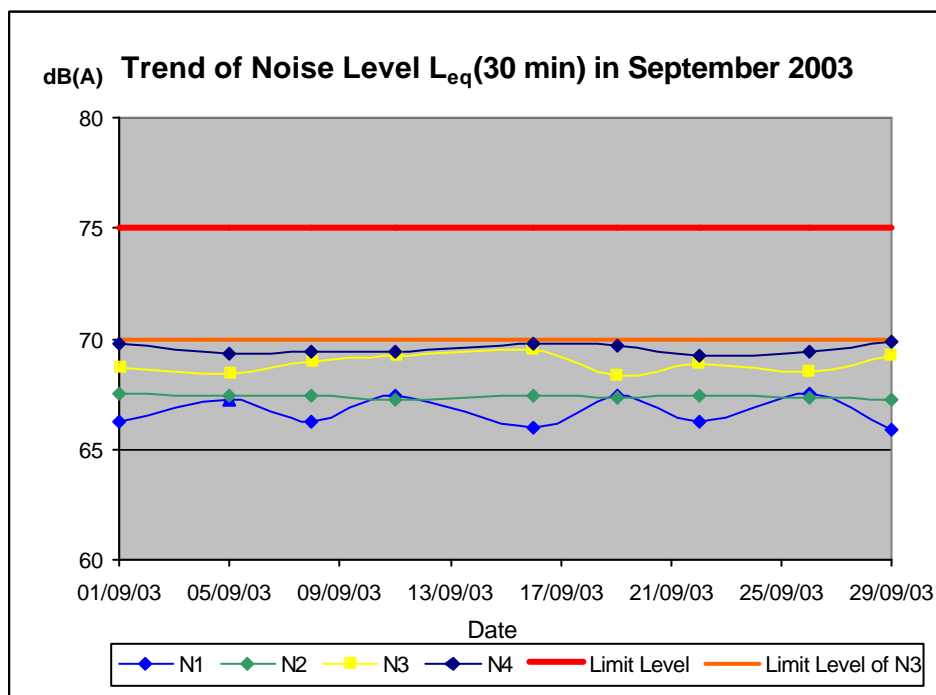
Figure 4-1 Daytime noise monitoring results for September 2003

Daytime (0700 – 1900 hours) noise monitoring was conducted at 4 locations. The highest noise level was 69.9 dB(A) recorded at Tsui Wan Estate on 29 September 2003 and the lowest was 65.9 dB(A) recorded at Heng Fa Chuen on 29 September 2003 respectively. There were no exceedances on the A/L Levels during the monitoring period.

Date of Monitoring	Monitoring Parameters	Monitoring Results, dB(A) (30 min)			
		N1	N2	N3	N4
19/09/03 (Fri)	L ₉₀	61.1	66.1	63.6	63.1
	L _{eq}	67.4	67.3	68.3	69.7
	L ₁₀	72.6	70.1	72.1	74.1
	L ₉₀	62.6	66.1	63.1	62.1
22/09/03 (Mon)	L _{eq}	66.2	67.4	68.9	69.2
	L ₁₀	70.1	70.1	73.1	73.1
	L ₉₀	61.6	66.1	64.1	62.6
26/09/03 (Fri)	L _{eq}	67.5	67.3	68.5	69.4
	L ₁₀	73.1	70.1	73.1	74.6
	L ₉₀	62.6	66.1	62.6	62.1
29/09/03 (Mon)	L _{eq}	65.9	67.2	69.2	69.9
	L ₁₀	70.1	70.1	74.1	74.1
	L ₉₀	60.6	66.1	63.6	63.6

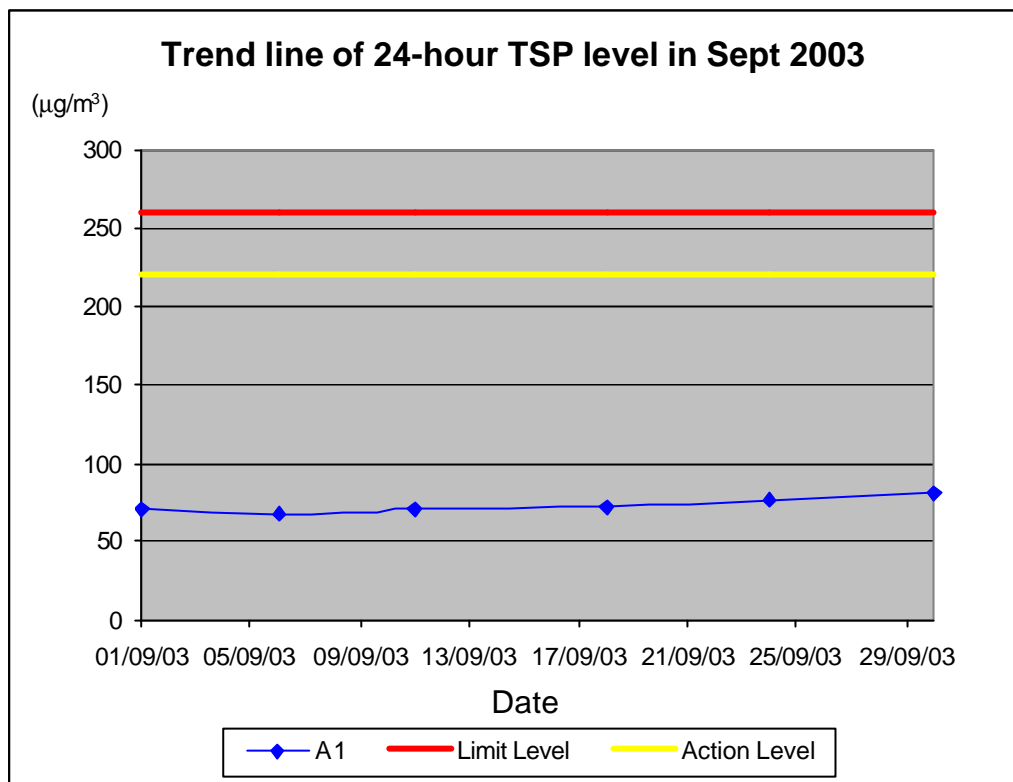
Figure 5-1 24-hour TSP monitoring results for September 2003

The highest 24-hour TSP level was 80.5 $\mu\text{g}/\text{m}^3$ recorded at the Hong Kong IVE Chai Wan on 30 September 2003 and the lowest 24-hour TSP was 67.6 $\mu\text{g}/\text{m}^3$ recorded at the Hong Kong IVE Chai Wan on 6 September 2003. There were no exceedances on the A/L Levels during the monitoring period.

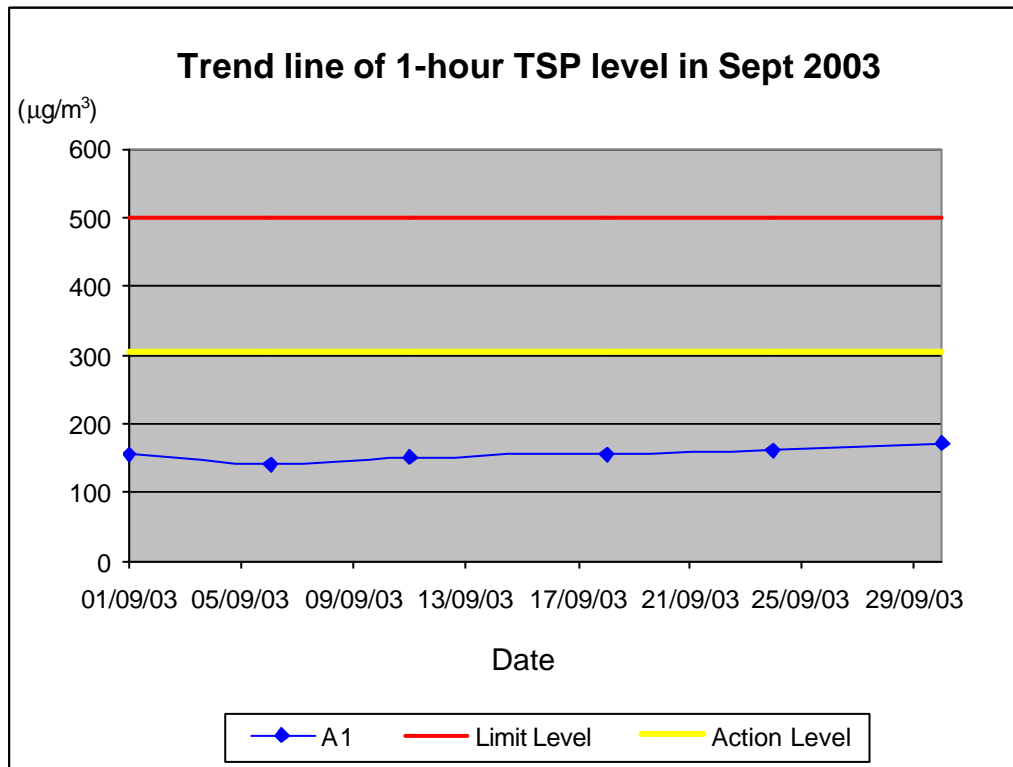
Figure 5-2 1-hour TSP monitoring results for September 2003

The highest average 1-hour TSP was 173.5 $\mu\text{g}/\text{m}^3$ recorded at the Hong Kong IVE Chai Wan on 30 September 2003 and the lowest average 1-hour TSP was 80.6 $\mu\text{g}/\text{m}^3$ recorded at the Hong Kong IVE Chai Wan on 18 September 2003. There were no exceedances on the A/L Levels during the monitoring period.

Date of Monitoring	1-hour TSP Monitoring Results ($\mu\text{g}/\text{m}^3$)	
	Weather	Averaged Result
01/09/03 (Mon)	Fine	153.4
06/09/03 (Sat)	Overcast	142.9
11/09/03 (Thu)	Overcast	151.9
18/09/03 (Thu)	Overcast	154.6
24/09/03 (Wed)	Overcast	162.0
30/09/03 (Tue)	Overcast	173.5

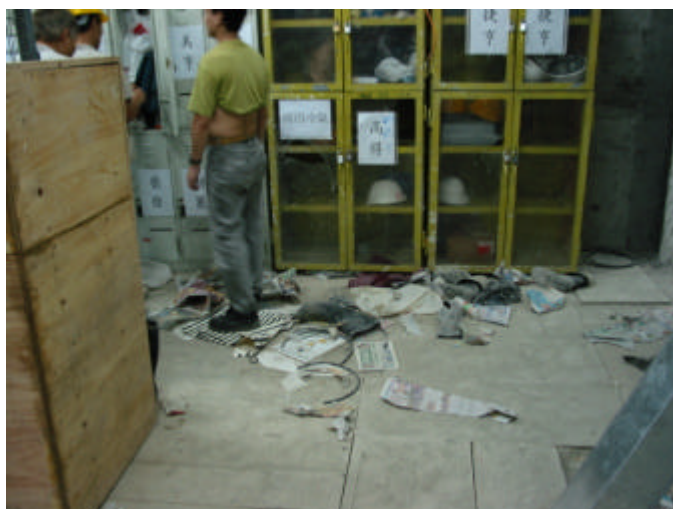
Figure 6-1 General refuse accumulating on 3/F.

- General refuse was observed accumulating on 3/F of depot (Figure 6-1). As instructed by ET, the Contractor had cleaned up the refuse immediately.
