**Citybus Permanent
Headquarters and
Bus Maintenance Depot
in Chai Wan**

Monthly Environmental
Monitoring and Audit
Report
October 2003

Monthly Environmental Monitoring and Audit Report – October 2003

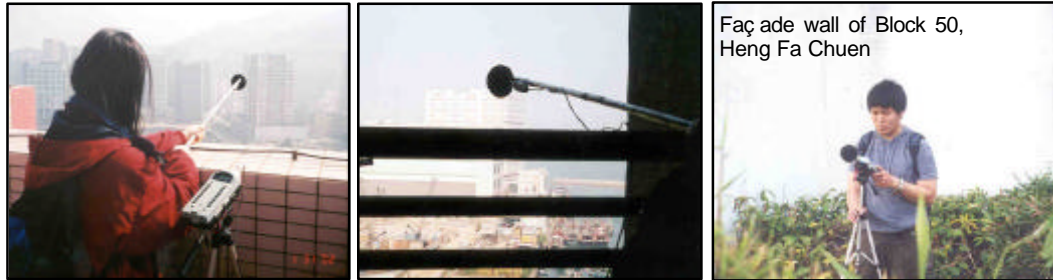
Figure 3-1 Noise monitoring in progress

A total of 4 monitoring locations were specified. They are given in Table 3-2. The measurements were taken at 1m from the building facade and maintained at a height 1.2m above floor. Three photos showing the noise monitoring work in action are given in Figure 3-1.

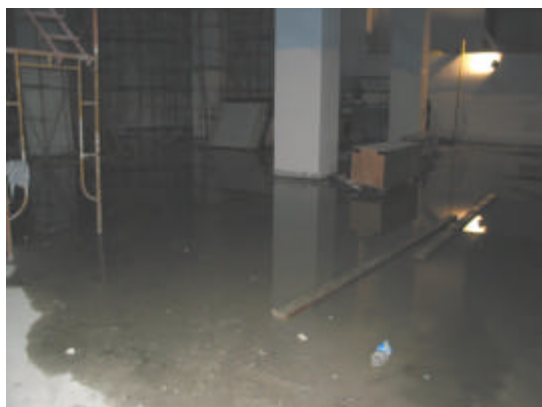
Figure 6-1 Stagnant water in Level 1

- A few chemical containers were not stored in bunded areas. As instructed by ET, the Contractor had moved them into drip trays.
- Stagnant water was accumulated in Level 1. As instructed by ET, the Contractor had removed stagnant water more frequently.
