**Citybus Permanent  
Headquarters and  
Bus Maintenance Depot  
in Chai Wan**

Monthly Environmental  
Monitoring and Audit  
Report  
November 2003

Monthly Environmental Monitoring and Audit Report – November 2003

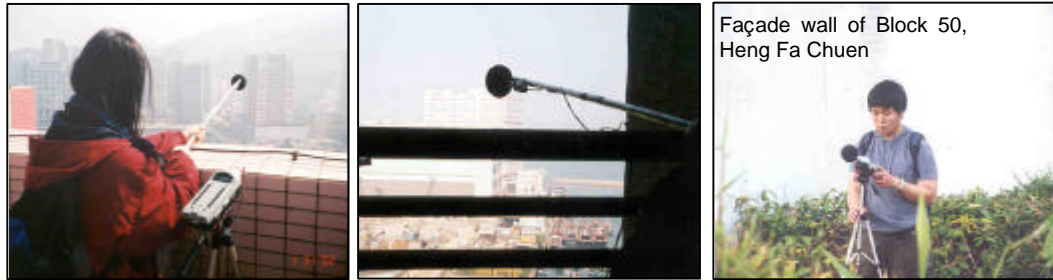
**Figure 3-1 Noise monitoring in progress**

A total of 4 monitoring locations were specified. They are given in Table 3-2. The measurements were taken at 1m from the building facade and maintained at a height 1.2m above floor. Three photos showing the noise monitoring work in action are given in Figure 3-1.

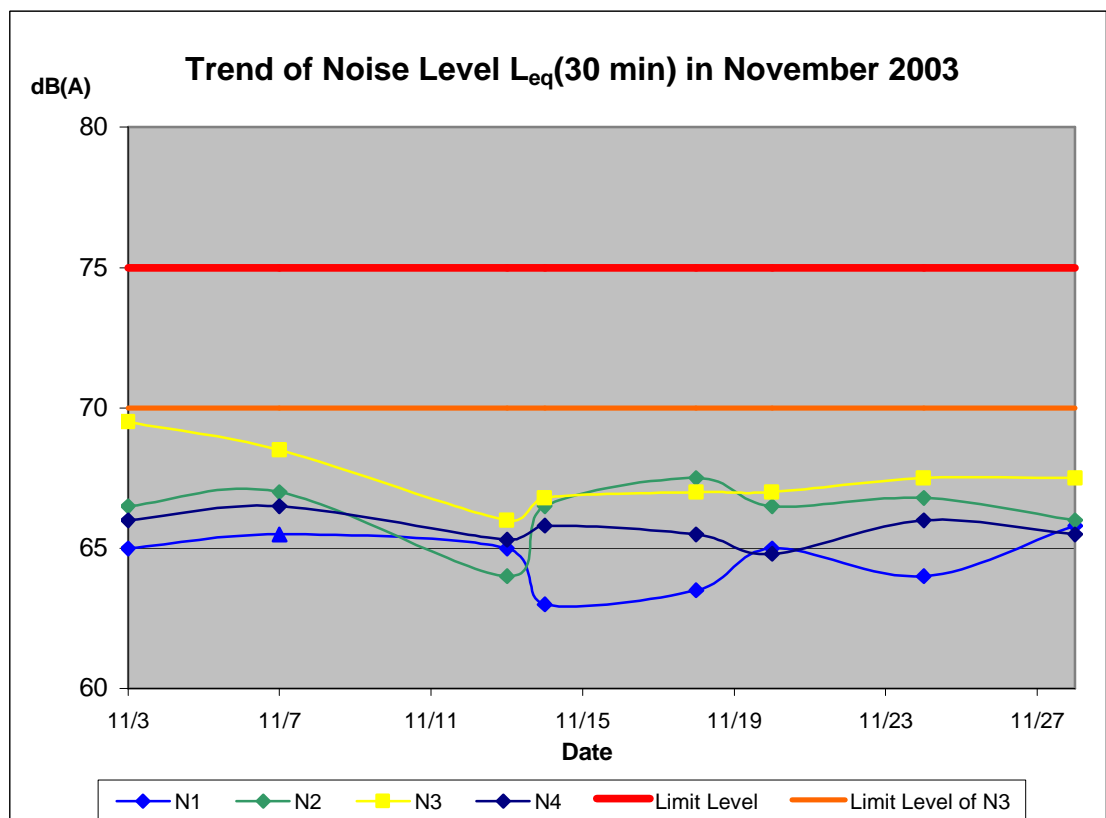
Figure 4-1 Daytime noise monitoring results for November 2003

Daytime (0700 – 1900 hours) noise monitoring was conducted at 4 locations. The highest noise level was 69.5 dB(A) recorded at Hong Kong IVE Chan Wan on 3 November 2003 and the lowest was 63.0 dB(A) recorded at Heng Fa Chuen on 14 November 2003 respectively. There were no exceedances on the A/L Levels during the monitoring period.

Date of Monitoring	Monitoring Parameters	Monitoring Results, dB(A) (30 min)			
		N1	N2	N3	N4
18/11/03 (Tue)	L <sub>eq</sub>	63.5	67.5	67.0	65.5
	L <sub>10</sub>	66.0	70.0	71.0	69.0
	L <sub>90</sub>	61.0	62.5	64.5	62.0
20/11/03 (Thu)	L <sub>eq</sub>	65.0	66.5	67.0	64.8
	L <sub>10</sub>	68.5	69.0	69.5	67.5
	L <sub>90</sub>	61.0	62.0	65.5	62.0
24/11/03 (Mon)	L <sub>eq</sub>	64.0	66.8	67.5	66.0
	L <sub>10</sub>	67.5	69.0	72.5	69.5
	L <sub>90</sub>	61.0	62.5	65.0	64.0
28/11/03 (Fri)	L <sub>eq</sub>	65.8	66.0	67.5	65.5
	L <sub>10</sub>	69.0	68.5	70.0	68.5
	L <sub>90</sub>	62.5	64.0	65.5	62.0

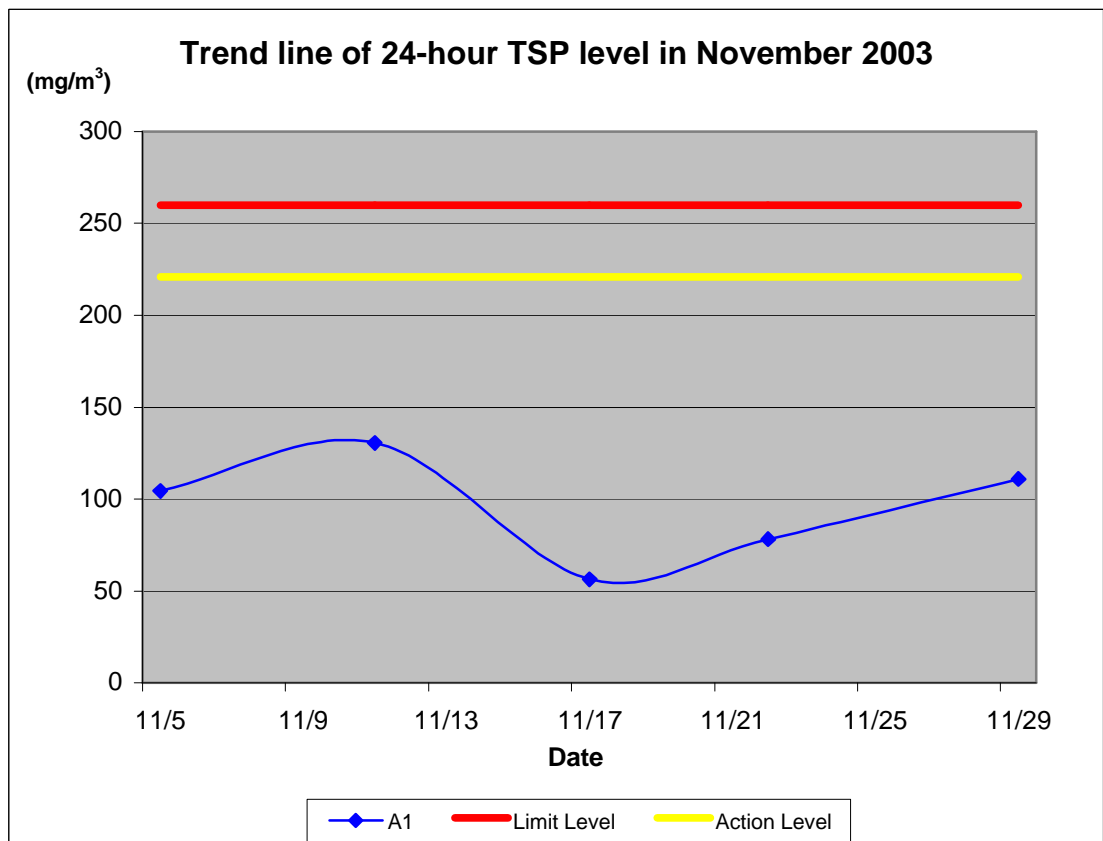
**Figure 5-1 24-hour TSP monitoring results for November 2003**

The highest 24-hour TSP level was 56.5  $\mu\text{g}/\text{m}^3$  recorded at the Hong Kong IVE Chai Wan on 17 November 2003 and the lowest 24-hour TSP was 130.6  $\mu\text{g}/\text{m}^3$  recorded at the Hong Kong IVE Chai Wan on 11 November 2003. There were no exceedances on the A/L Levels during the monitoring period.

Date of Monitoring	24-hour TSP Monitoring Results ( $\mu\text{g}/\text{m}^3$ )	
	Weather	Result
05/11/03 (Wed)	Fine	104.4
11/11/03 (Tue)	Sunny	130.6
17/11/03 (Mon)	Sunny	56.5
22/11/03 (Sat)	Sunny	78.2
29/11/03 (Sat)	Sunny	110.9

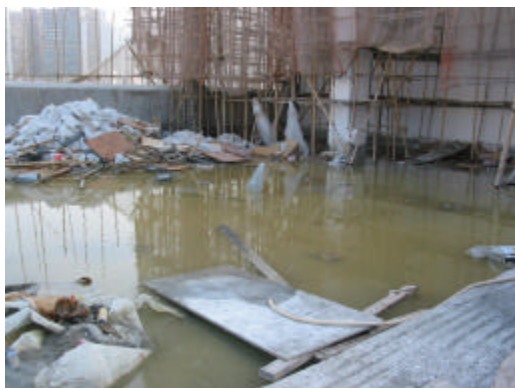
**Figure 6-1 Stagnant water in Level 3**

- The Contractor was recommended to provide designated storage area for chemical wastes, e.g. paint containers.
- Stagnant water was accumulated in Level 3. As instructed by ET, the Contractor had removed the stagnant water.

- No significant air quality impact was identified.
- No significant noise impact was identified.
- No significant water quality impact was identified.
- The Contractor was recommended to provide designated storage area for chemical wastes, e.g. paint containers.
- Stagnant water was accumulated in Level 3. As instructed by ET, the Contractor had removed the stagnant water.

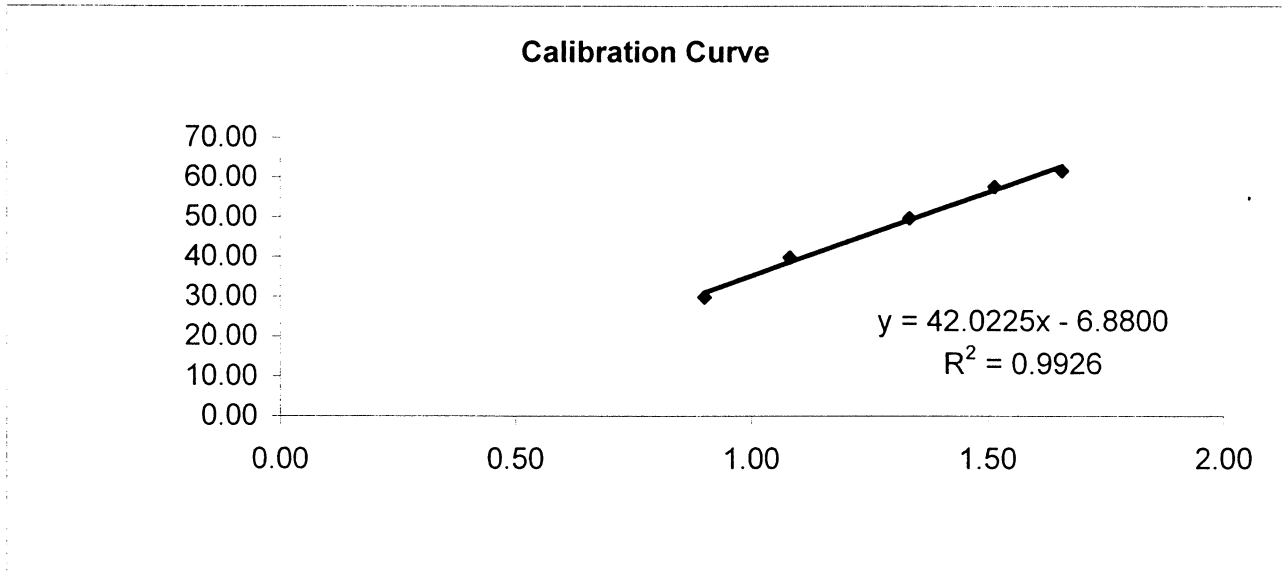
Resistance Plate No.	Manometer Reading (inch H <sub>2</sub> O)	Flow Recorder Reading (CFM)	Calculated Q <sub>std</sub> (m <sup>3</sup> /min)	Continuous Flow Recorder Reading IC (CFM)
5	3.00	30.00	0.90	29.81
7	4.40	40.00	1.08	39.75
10	6.80	50.00	1.34	49.68
13	8.80	58.00	1.51	57.63
18	10.60	62.00	1.66	61.61

Sampler slope (m) : **42.0225**  
 Sampler intercept (b) : **-6.8800**  
 Correlation coefficient (R<sup>2</sup>) : **0.9926**
