Citybus Permanent Headquarters and Bus Maintenance Depot in Chai Wan

Monthly Environmental Monitoring and Audit Report December 2003

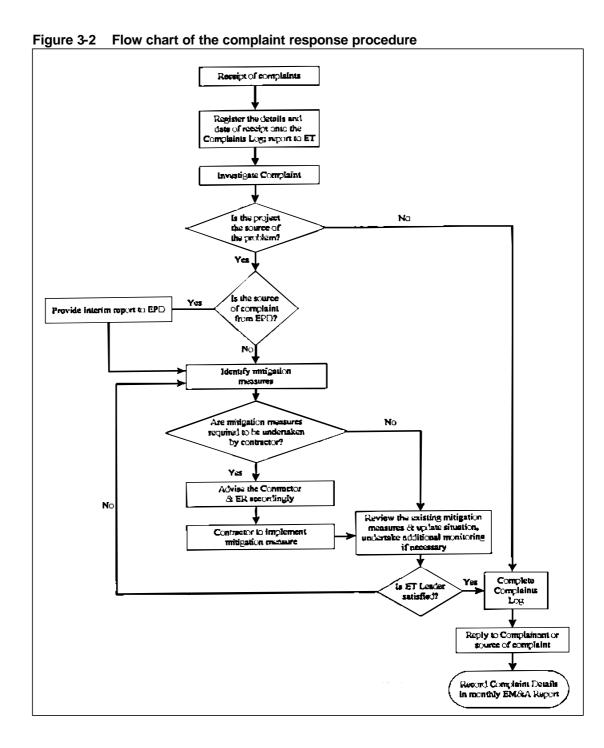
A flow chart of the complaint response procedures is shown in Figure 3-2 for reference.

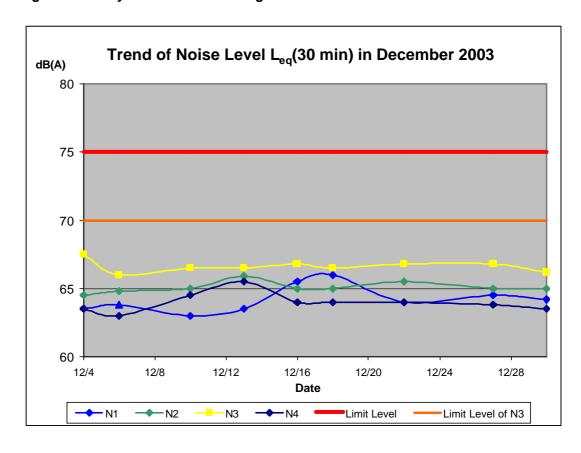
Figure 4-1 Daytime noise monitoring results for December 2003

Date of	Monitoring	Monitoring Results, dB(A) (30 n			nin)	
Monitoring	Parameters	N1	N2	N3	N4	
	L _{eq}	65.5	65.0	66.8	64.0	
16/12/03 (Tue)	L ₁₀	69.5	68.0	69.5	66.8	
	L ₉₀	62.0	62.0	61.5	60.0	
	L _{eq}	66.0	65.0	66.5	64.0	
18/12/03 (Thu)	L ₁₀	68.5	68.5	68.5	69.0	
	L ₉₀	63.5	62.0	62.5	61.5	
	L _{eq}	64.0	65.5	66.8	64.0	
22/12/03 (Mon)	L ₁₀	66.5	67.5	69.5	68.5	
	L ₉₀	61.0	62.0	62.0	60.0	
	L _{eq}	64.5	65.0	66.8	63.8	
27/12/03 (Sat)	L ₁₀	66.0	68.5	68.5	65.8	
	L ₉₀	61.0	62.0	62.0	60.5	
	L _{eq}	64.2	65.0	66.2	63.5	
30/12/03 (Tue)	L ₁₀	68.0	69.5	69.5	66.0	
	L ₉₀	61.0	62.0	62.5	61.0

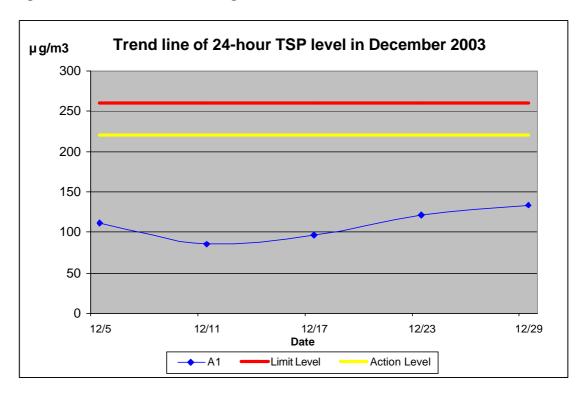
Figure 5-1 24-hour TSP monitoring results for December 2003

Date of Monitoring	24-hour TSP Monitoring Results (µg/m³)		
Date of Monitoring	Weather	Result	
05/12/03 (Fri)	Sunny	114.5	
11/12/03 (Thu)	Sunny	86.1	
17/12/03 (Wed)	Sunny	96.7	
23/12/03 (Tue)	Sunny	121.2	
29/12/03 (Mon)	Sunny	133.6

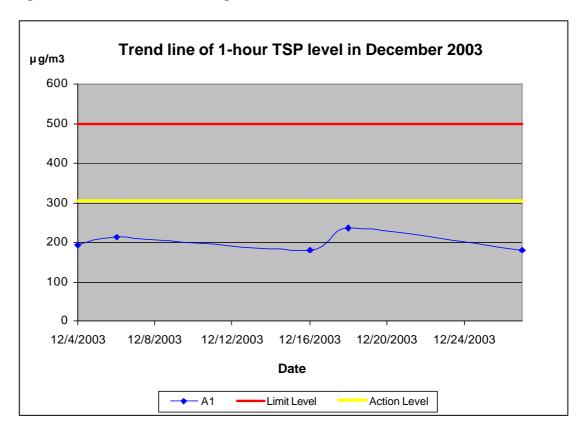
Figure 5-2 1-hour TSP monitoring results for December 2003

Date of Monitoring	1-hour TSP Monito	oring Results (µg/m³)
Date of Monitoring	Weather	Averaged Result
04/12/03 (Thu)	Sunny	192.3
06/12/03 (Sat)	Sunny	213.2
16/12/03 (Mon)	Sunny	180.5
18/12/03 (Thu)	Sunny	236.3
27/12/03 (Sat)	Sunny	180.7
