**DELIVERY OF RECLAMATION MATERIAL TO
MAINLAND—**

**ENVIRONMENTAL MONITORING AND ADUIT
(CONTRACT NO.: CV/2005/01)**

TUEN MUN AREA 38 FILL BANK

MONTHLY EM&A REPORT

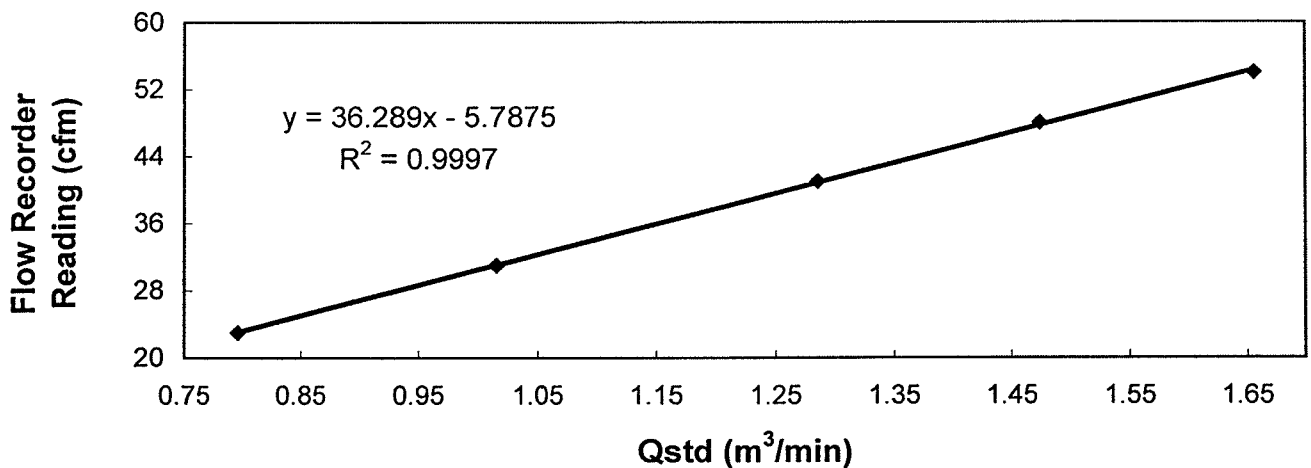
**Sampler 9503 Calibration Curve
Site: Tuen Mun 38 (TM-A1)
Date of Calibration: 10 May 2008**

Flow recorder reading (cfm)	54	48	41	31	23
Qstd (Actual flow rate, m ³ /min)	1.66	1.47	1.29	1.02	0.80
Pressure :	756.81 mm Hg			Temp. :	299 K

Acceptance Criteria : Correlation coefficient (r) of the calibration curve greater than 0.990 after a 5-point calibration

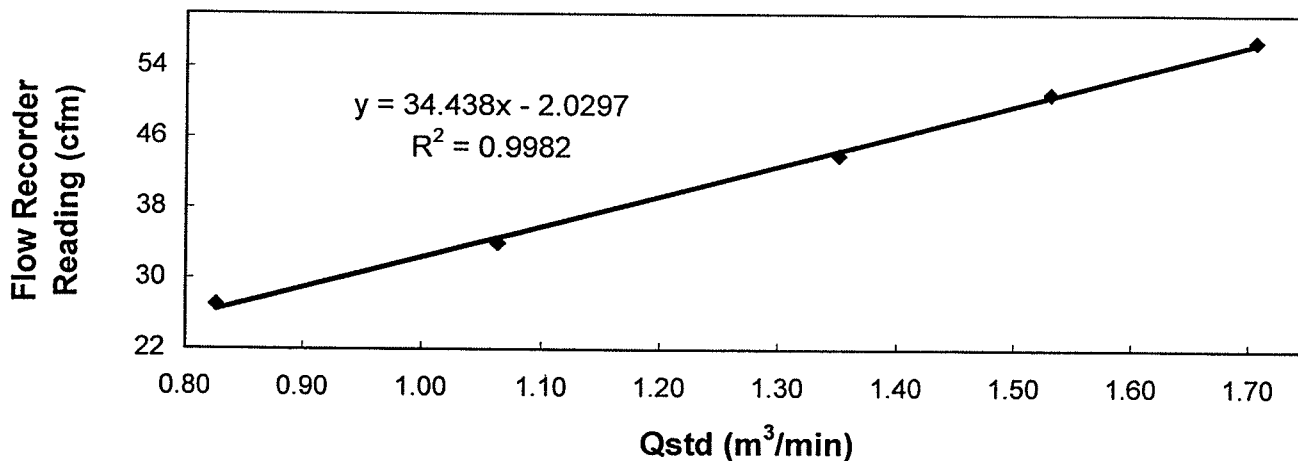
Sampler 8115 Calibration Curve
Site: Tuen Mun 38 (TM-A2)
Date of Calibration: 10 May 2008

Flow recorder reading (cfm)	57	51	44	34	27
Qstd (Actual flow rate, m ³ /min)	1.71	1.53	1.35	1.06	0.83
Pressure :	756.81 mm Hg			Temp. :	299 K

Acceptance Criteria : Correlation coefficient (r) of the calibration curve greater than 0.990 after a 5-point calibration

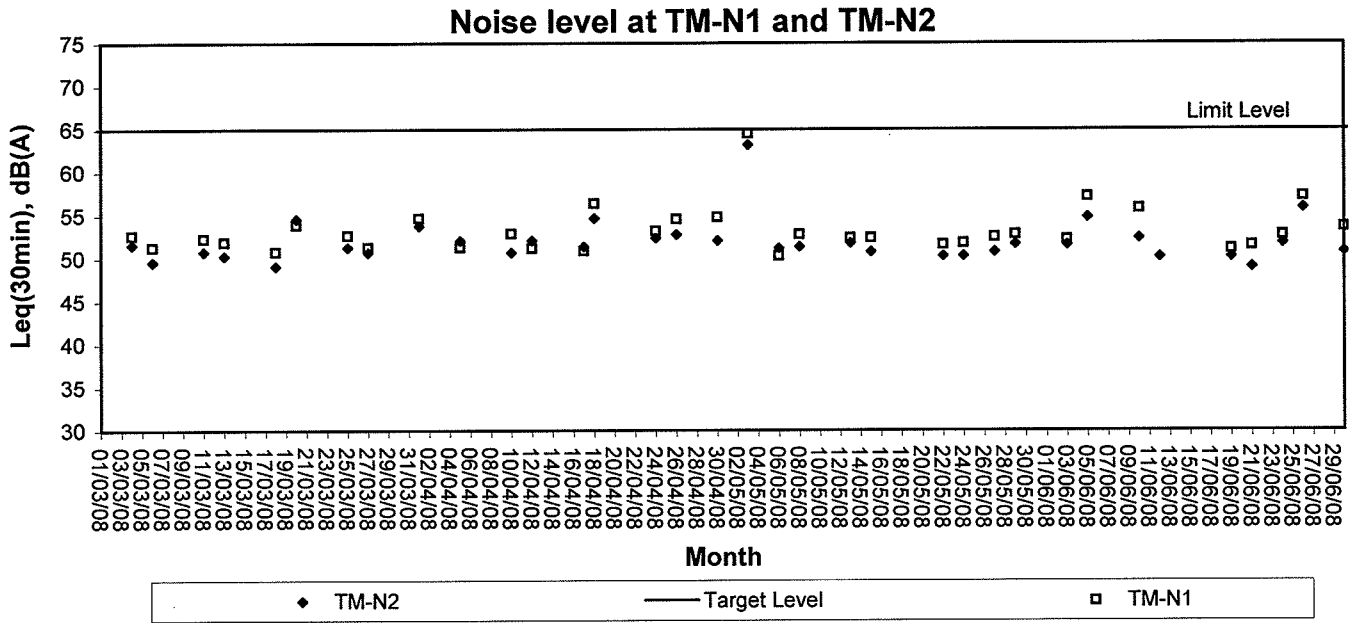
Noise Monitoring (Day-time)

The major sources of noise pollution observed in this reporting month were noise from the traveling dump trucks and from the operation of site machines.
