**DELIVERY OF RECLAMATION MATERIAL TO
MAINLAND—**

**ENVIRONMENTAL MONITORING AND ADUIT
(CONTRACT NO.: CV/2005/01)**

TUEN MUN AREA 38 FILL BANK

MONTHLY EM&A REPORT

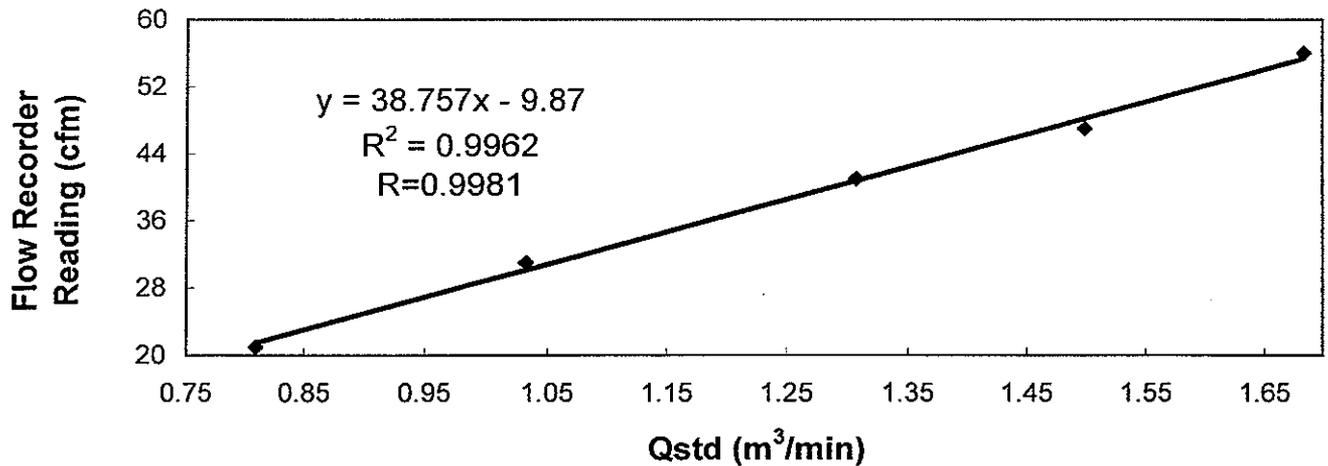
Sampler 9503 Calibration Curve
Site: Tuen Mun 38 (TM-A1)
Date of Calibration: 11 November 2008

Flow recorder reading (cfm)	56	47	41	31	21
Qstd (Actual flow rate, m ³ /min)	1.68	1.50	1.31	1.03	0.81
Pressure :	764.31 mm Hg			Temp. :	292 K

Acceptance Criteria : Correlation coefficient (r) of the calibration curve greater than 0.990 after a 5-point calibration

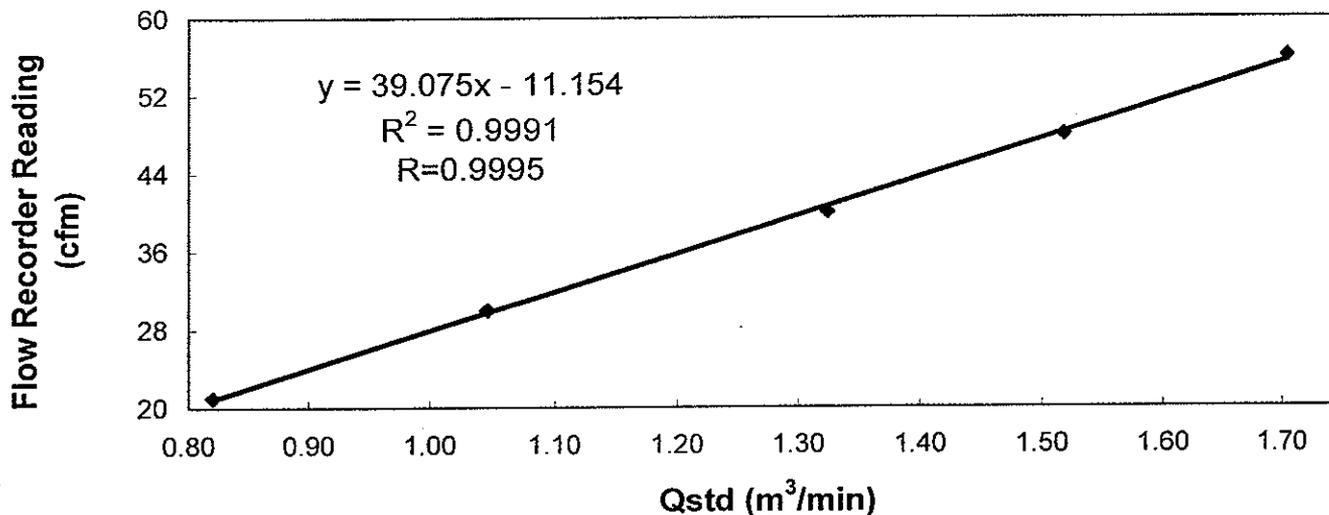
Sampler 9503 Calibration Curve
Site: Tuen Mun 38 (TM-A1)

Flow recorder reading (cfm)	56	48	40	30	21
Qstd (Actual flow rate, m ³ /min)	1.71	1.52	1.32	1.05	0.82
Pressure :	769.56 mm Hg		Temp. :	286 K

Acceptance Criteria : Correlation coefficient (r) of the calibration curve greater than 0.990 after a 5-point calibration

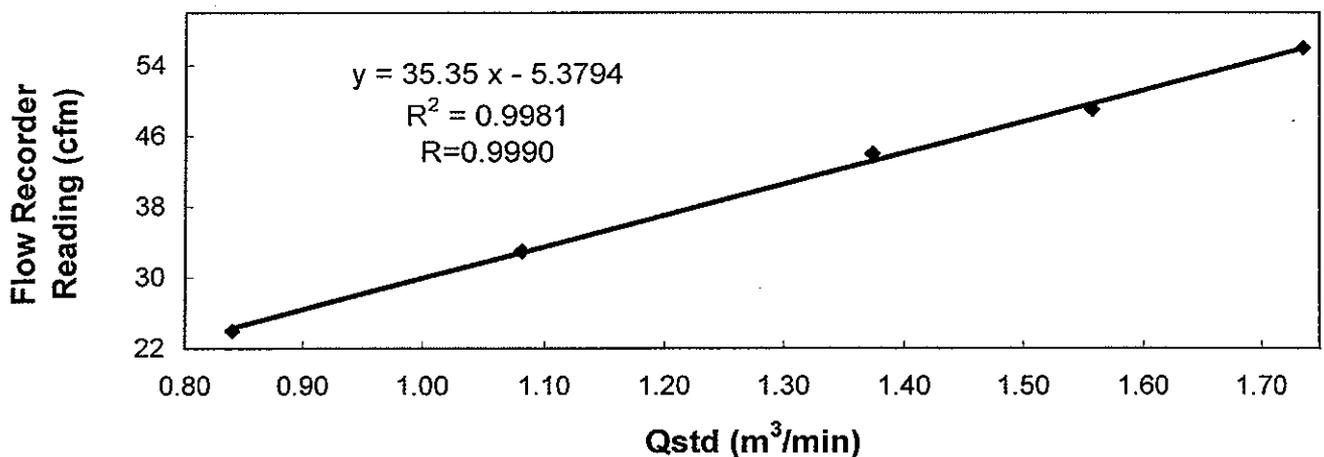
Sampler 8115 Calibration Curve
Site: Tuen Mun 38 (TM-A2)
Date of Calibration: 11 November 2008

Flow recorder reading (cfm)	56	49	44	33	24
Qstd (Actual flow rate, m ³ /min)	1.74	1.56	1.37	1.08	0.84
Pressure :	764.31 mm Hg		Temp. :	292 K

Acceptance Criteria : Correlation coefficient (r) of the calibration curve greater than 0.990 after a 5-point calibration

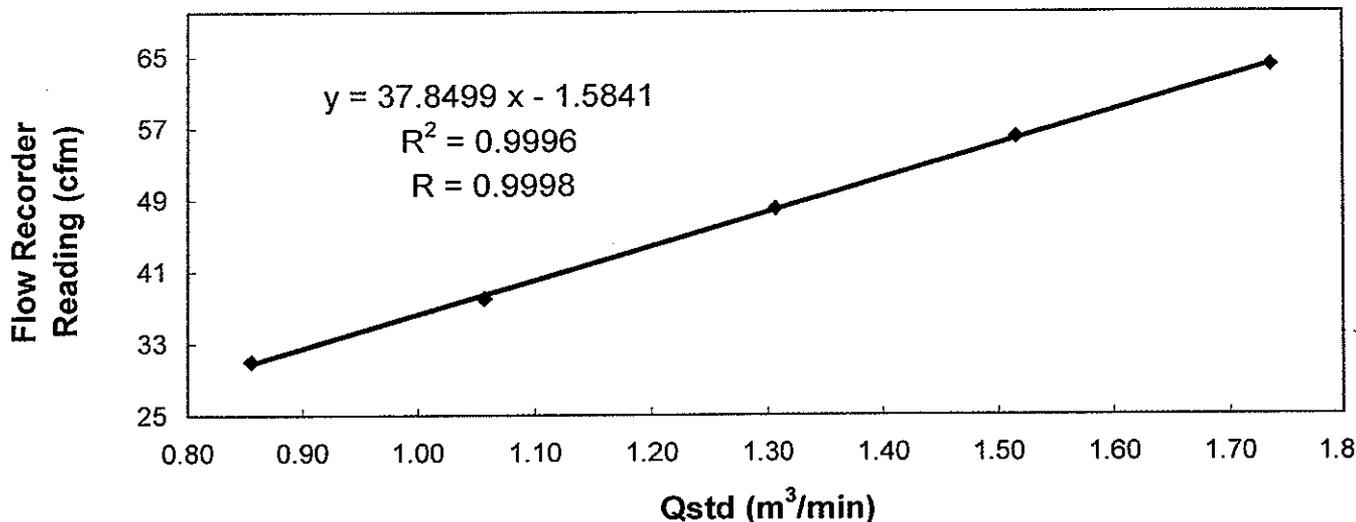
Sampler 1176 Calibration Curve
Site: Tseung Kwan O (A-2)

Flow recorder reading (cfm)	64	56	48	38	31
Qstd (Actual flow rate, m ³ /min)	1.74	1.52	1.31	1.06	0.86
Pressure :	759.06 mm Hg			Temp. :	290 K

Acceptance Criteria : Correlation coefficient (r) of the calibration curve greater than 0.990 after a 5-point calibration

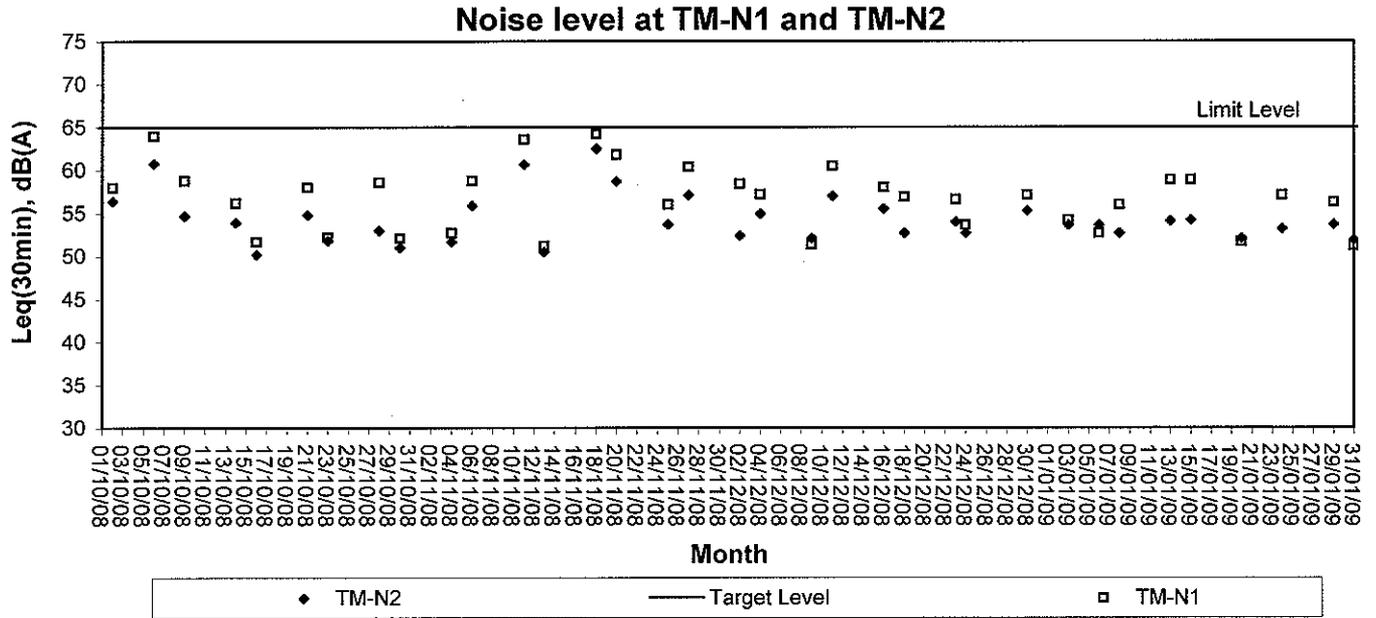
Noise Monitoring (Day-time)

The major sources of noise pollution observed in this reporting month were noise from the traveling dump trucks and from the operation of site machines.

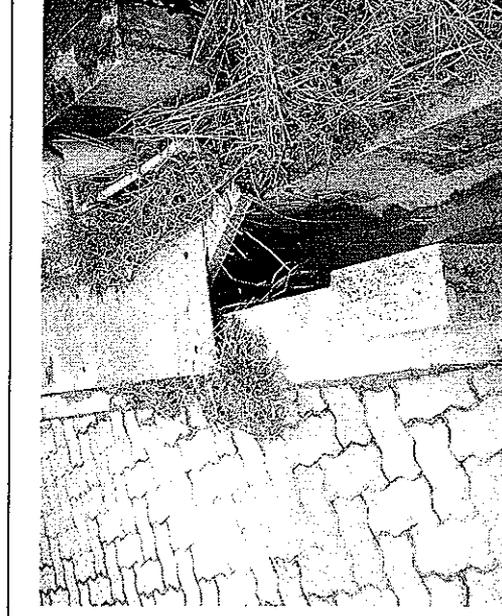
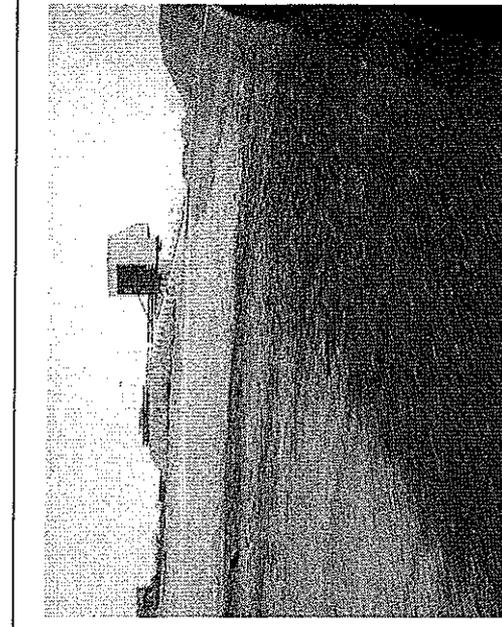
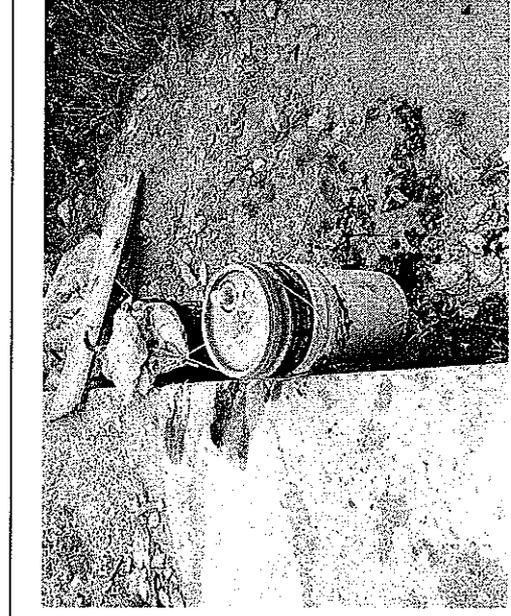
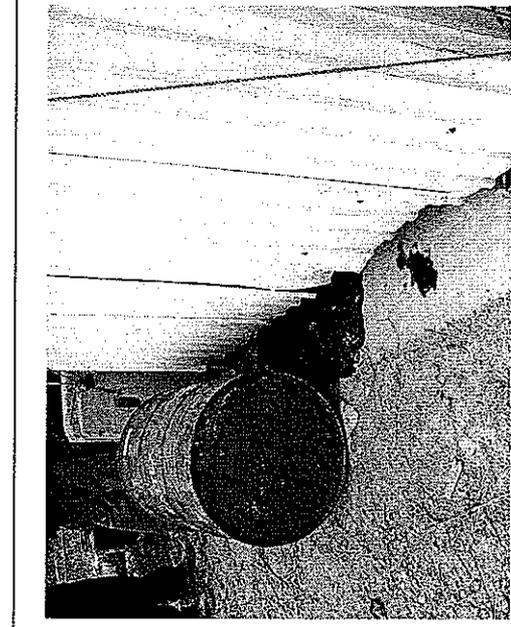
- Tipping hall No.3 was found damaged during the weekly site inspection on 29 January 2009. The Contractor was reminded to repair the damaged part of the tipping hall immediately. Since the observation was noted in the last weekly site inspection, it will be verified in the coming month.

- Two used oil buckets were disposed of on the ground at chemical waste storage area during the weekly site inspection on 29 January 2009. The Contractor was reminded to collect the buckets and dispose / store them properly. Since the observation was noted in the last weekly site inspection, it will be verified in the coming month; and

- During weekly site inspection on 29 January 2009, oil stains were noted on the ground at chemical waste storage area. The Contractor was reminded to clean and treat the oil and contaminated soil as chemical waste. Since the observation was noted in the last weekly site inspection, it will be verified in the coming month.
