**DELIVERY OF RECLAMATION MATERIAL TO
MAINLAND—**

**ENVIRONMENTAL MONITORING AND ADUIT
(CONTRACT NO.: CV/2005/01)**

TUEN MUN AREA 38 FILL BANK

MONTHLY EM&A REPORT

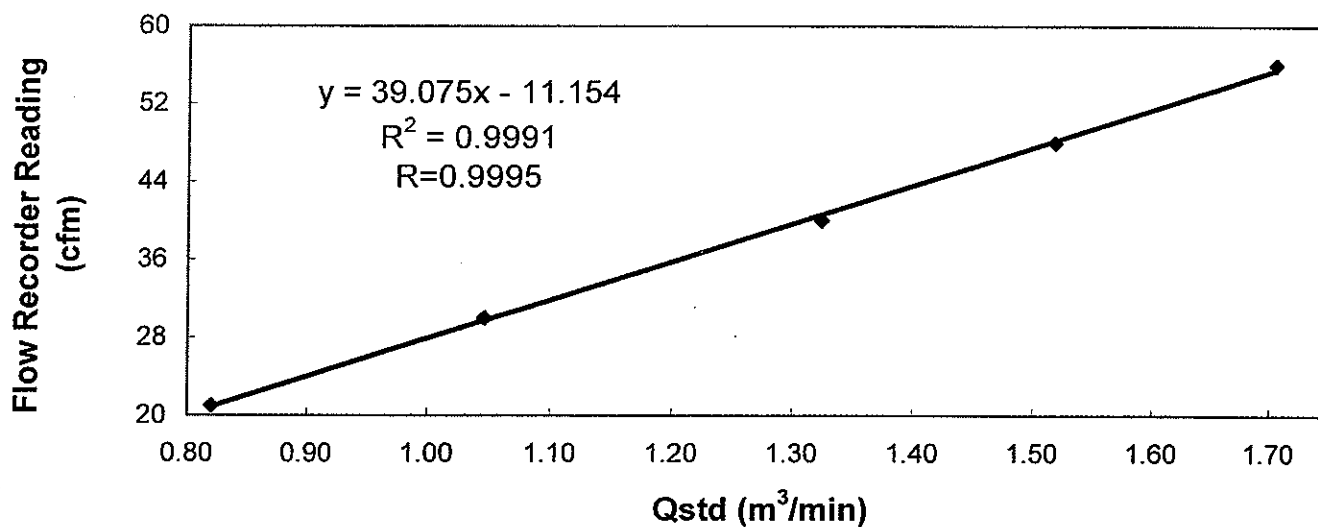
Sampler 9503 Calibration Curve
Site: Tuen Mun 38 (TM-A1)

Flow recorder reading (cfm)	56	48	40	30	21
Qstd (Actual flow rate, m ³ /min)	1.71	1.52	1.32	1.05	0.82
Pressure :	769.56 mm Hg			Temp. :	286 K

Acceptance Criteria : Correlation coefficient (r) of the calibration curve greater than 0.990 after a 5-point calibration

The high volume sampler complies * / does not comply * with the specified requirements and is deemed acceptable * / unacceptable * for use.

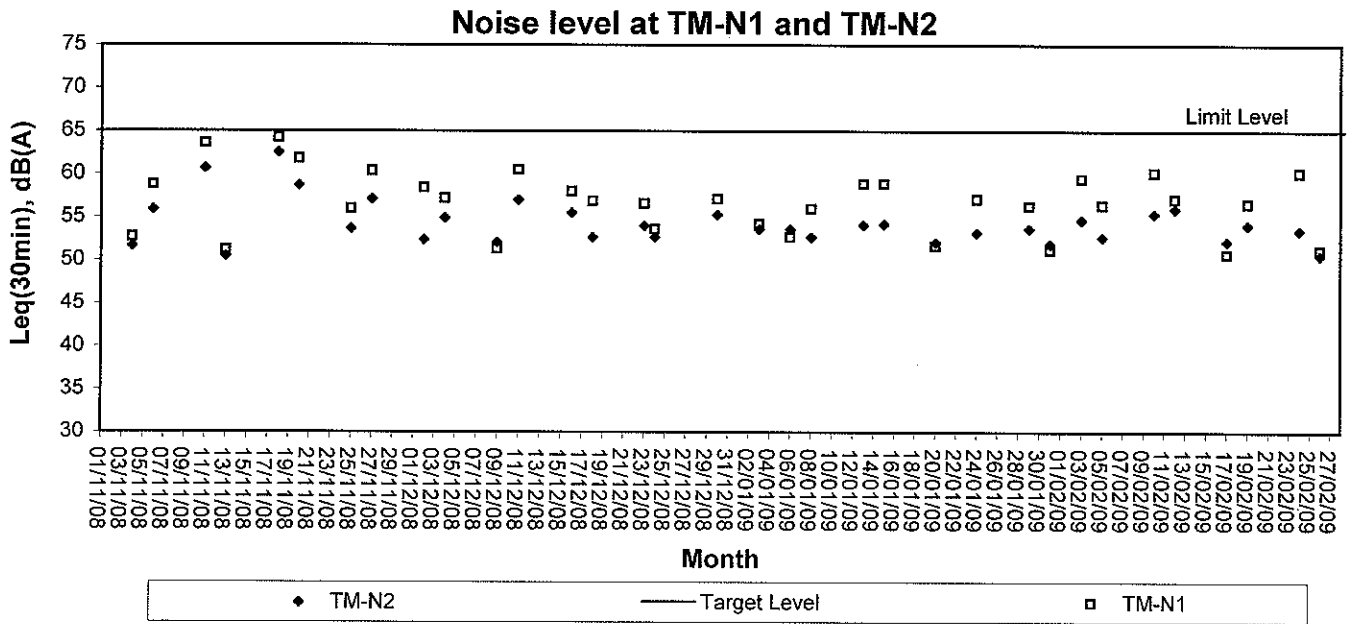
Noise Monitoring (Day-time)

Date	Start Sampling Time (hh:mm)	Noise Level dB (A)			Wind Speed (m/s)	Weather Condition
		L _{eq} (30min)	L ₁₀	L ₉₀		
03/02/09	09:18	59.5	64.2	57.1	0.7	Sunny
05/02/09	15:46	56.4	58.0	53.2	0.8	Fine
10/02/09	09:55	60.2	61.9	54.8	1.6	Sunny
12/02/09	12:50	57.1	60.2	52.8	0.9	Sunny
17/02/09	14:00	50.7	52.9	47.6	1.2	Cloudy
19/02/09	13:30	56.6	63.4	54.1	0.7	Cloudy
24/02/09	14:10	60.2	65.3	58.1	0.3	Sunny
26/02/09	15:00	51.2	54.9	48.6	0.9	Cloudy

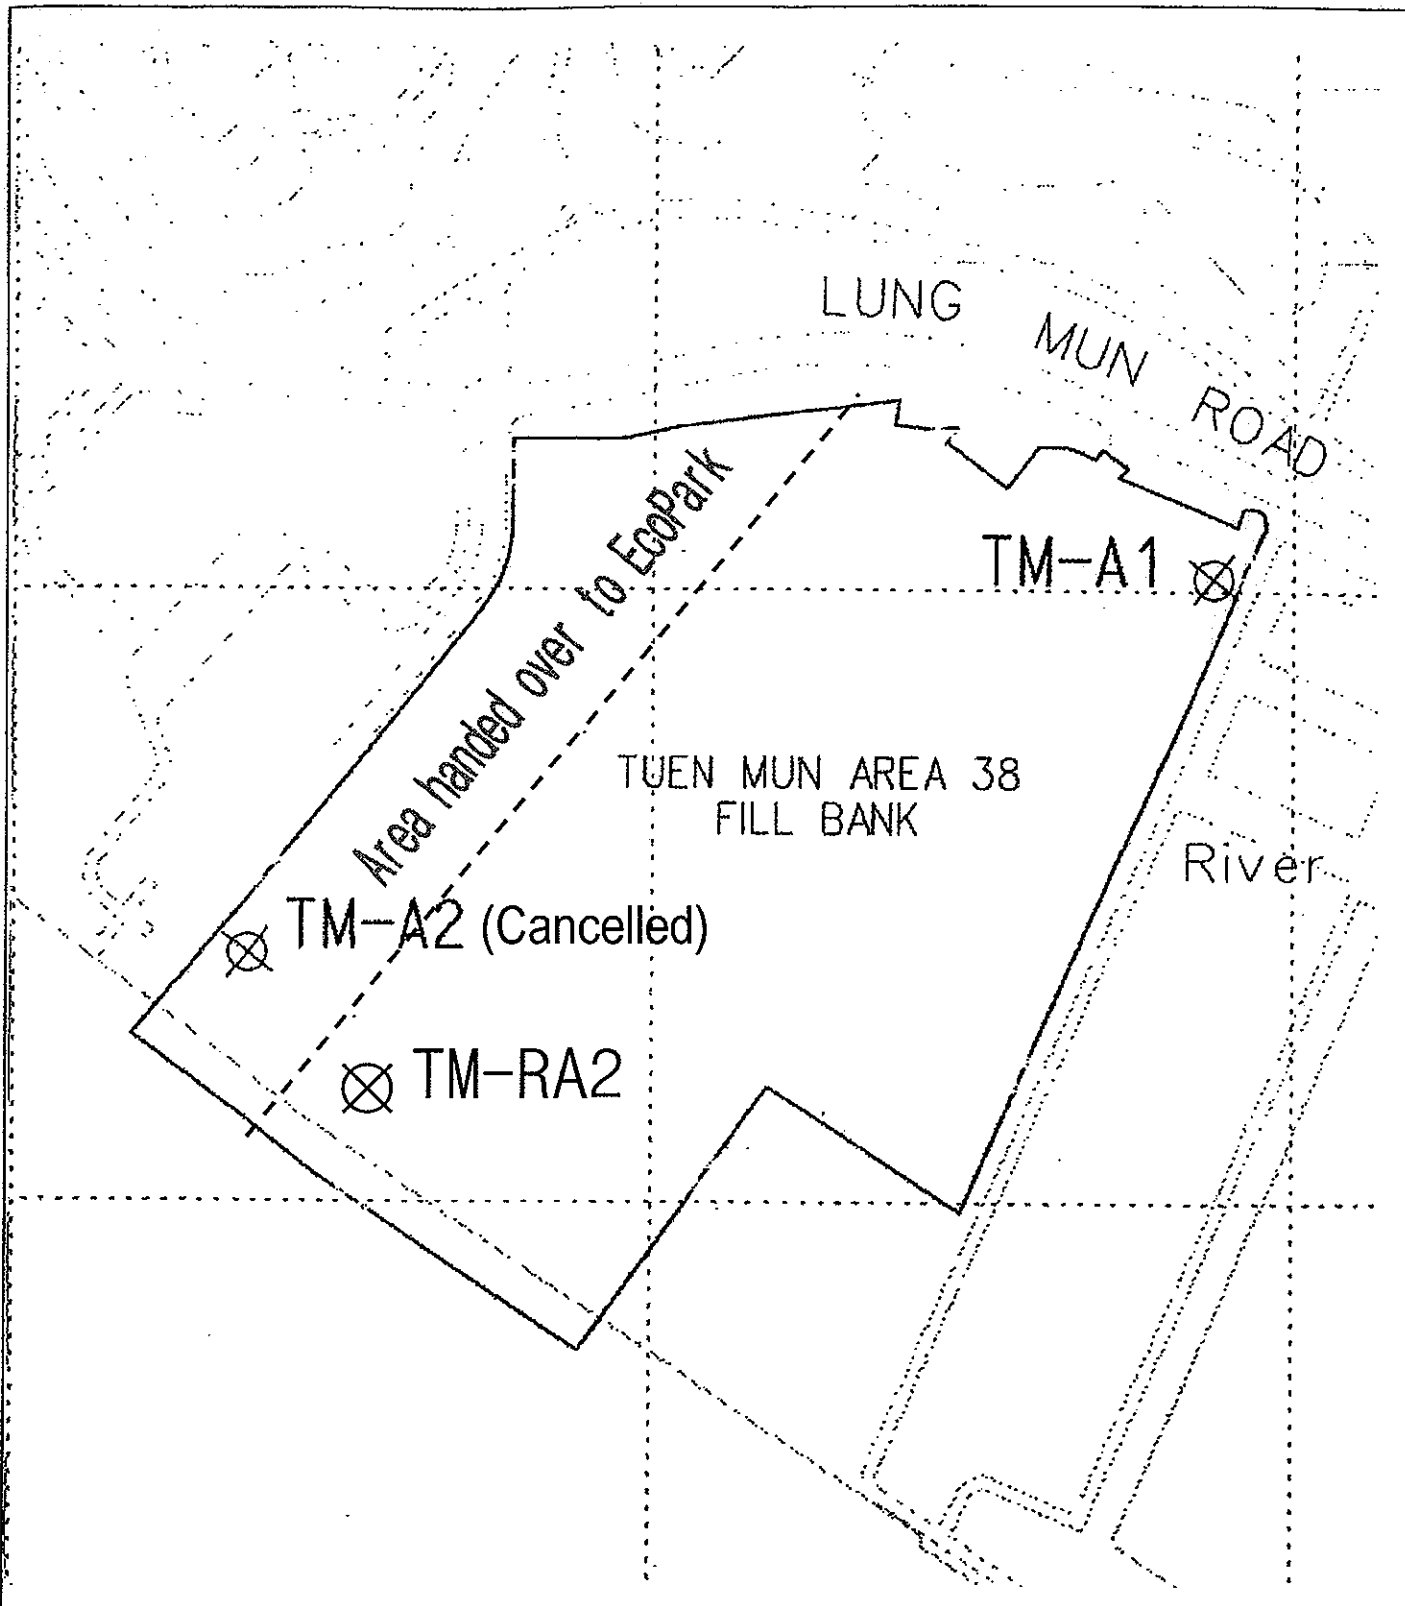
Figure 2 A
 Locations of Air Quality Monitoring Stations –
 Tuen Mun Area 38 Fill Bank

The locations of monitoring stations are shown in Figure 2A.

Since the area for existing air monitoring station TM-A2 near Tipping Hall No.1 was handed over to EcoPark, air monitoring station TM-A2 was cancelled and the air monitoring was carried out at air monitoring station TM-RA2 (refer to Figure 2A attached) from 28 October 2008.

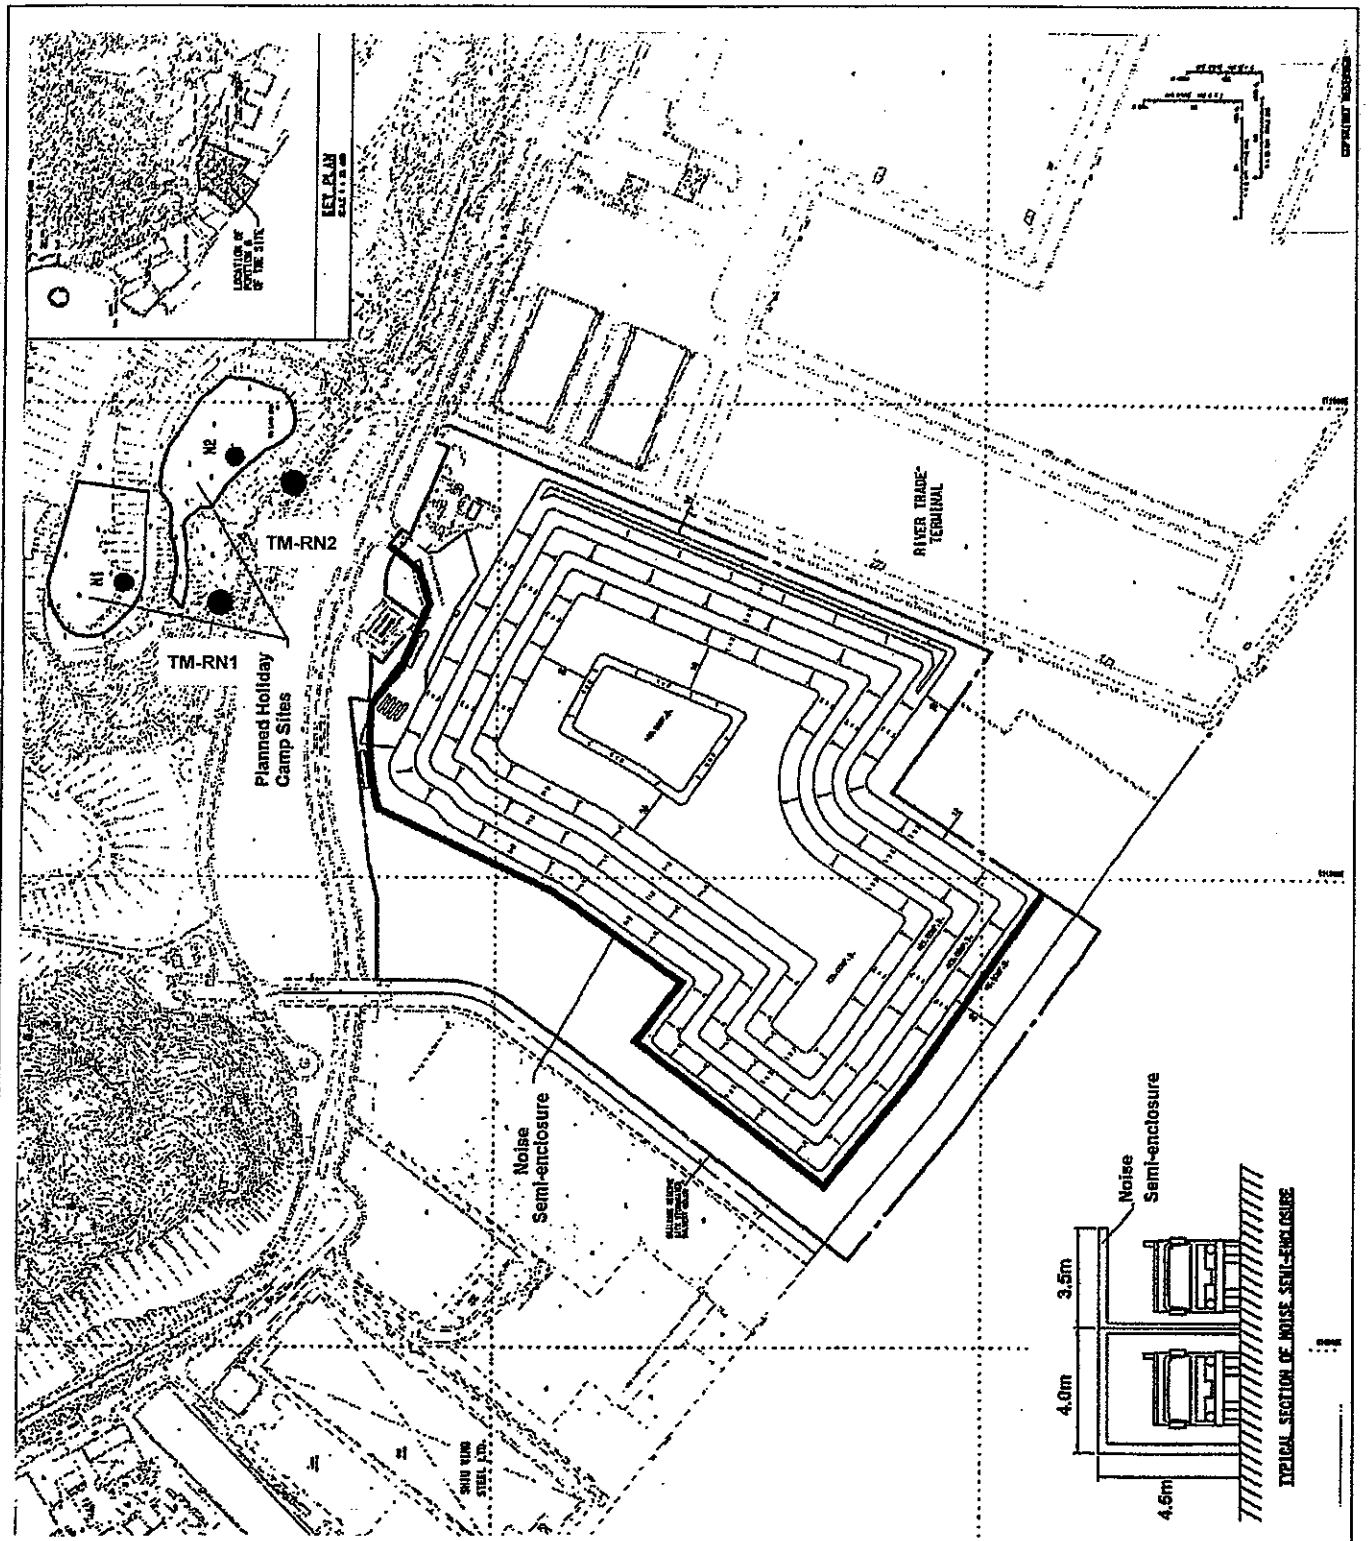
Figure 4
 Locations of Noise Quality Monitoring Stations –
 Tuen Mun Area 38 Fill Bank

The noise monitoring locations, TM-RN1 and TM-RN2 are shown in Figure 4.
