CONTRACT NO. DE/2005/04

**SUPPLY AND INSTALLATION OF ELECTRICAL AND MECHANICAL EQUIPMENT FOR
UPGRADING OF TING KOK ROAD PUMPING STATION NO. 5**

ENVIRONMENTAL MONITORING AND AUDIT

MONTHLY EM&A REPORT NO. 2

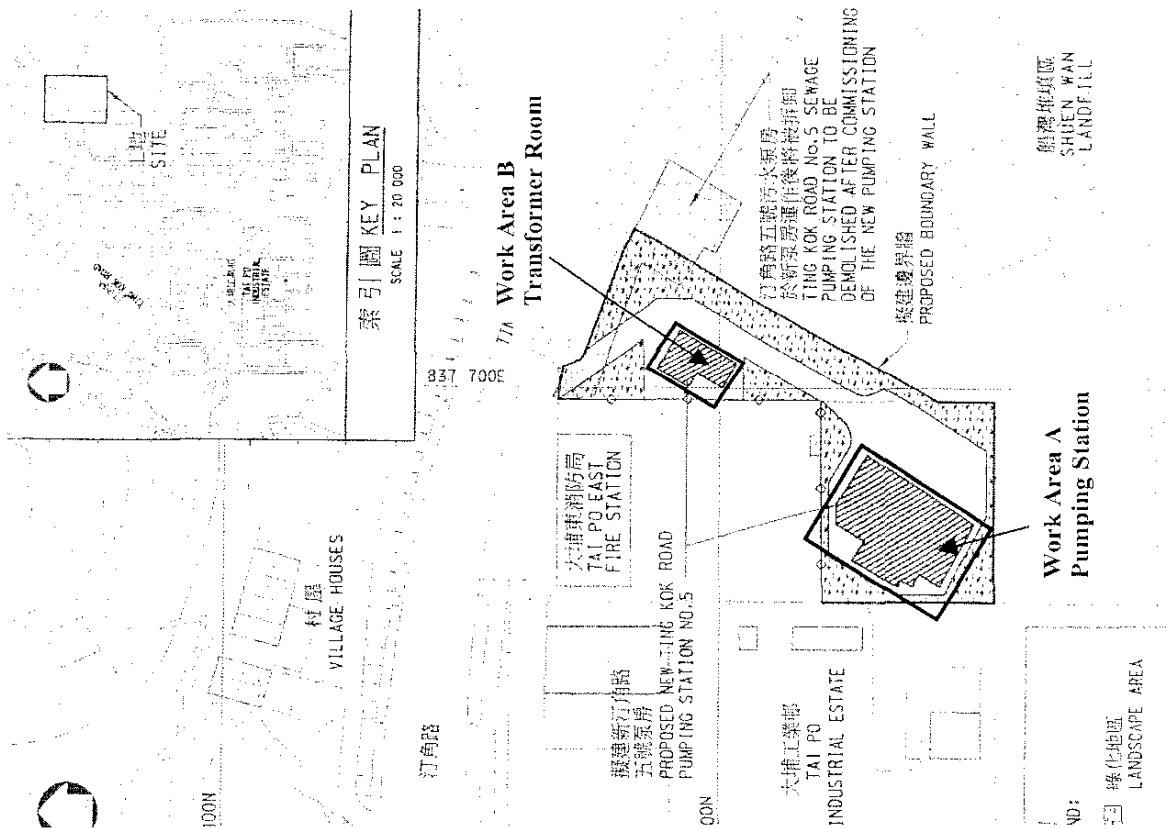
Ungrading Ting Kok Road Pumping Station No. 5 – E&M Works EM&A Site Inspection – July 2007 Site Layout

The site locations inspected were marked on a site layout plan and the location code was recorded on the checklist. The site layout plan is shown in Appendix 8.
