SkyCity Nine Eagles Golf Course EM&A Quarterly Compliance Report

May 2008 to
July 2008

Report no: 01508R0051

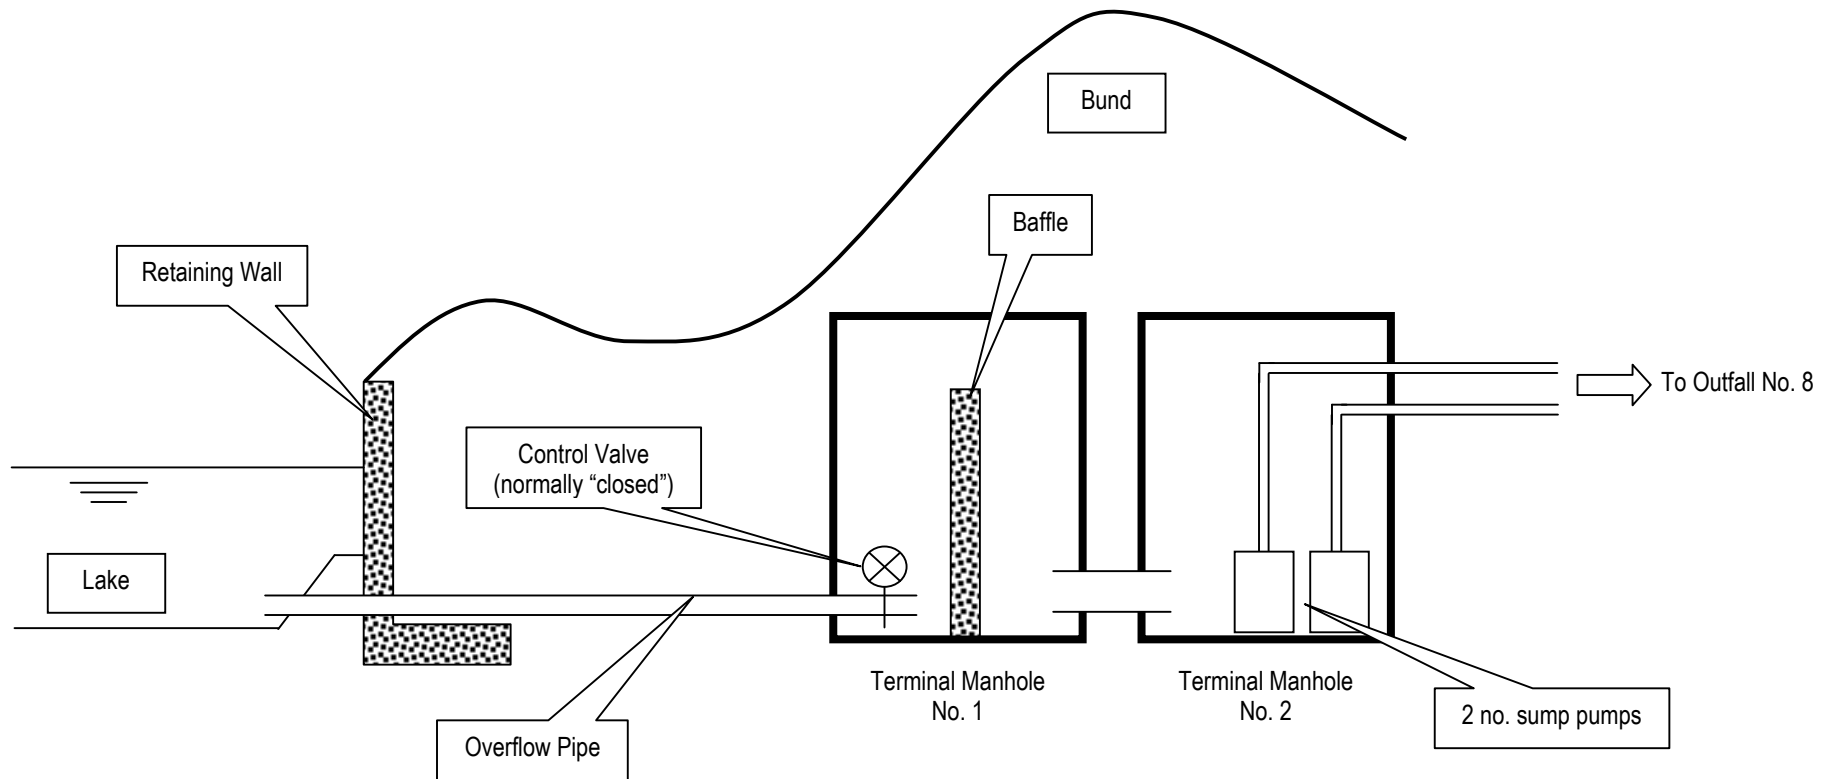
Figure 2-1 Schematic of Lake Water Control System

The Golf Course has been designed to contain water within two artificial lakes, which are linked together by two underwater pipes,. Because of the sloping topography of the site, all rainwater collected within the Golf Course will drain into the lakes through a sub-soil drainage system. The lakes provide a source of freshwater for irrigation, from which surplus water will flow back into the lakes.

If more than 20,000m³ of water flows into the lakes, then the Golf Course may flood. To avoid this, the Golf Course Supervisor can authorise the opening of a control valve to allow the water to overflow from the lake and into off-site storm drains that discharge via Outfall No. 8. However, the valve can only be opened if the latest lake water monitoring results indicate that water is of an acceptable quality. In normal circumstances, the control valve remains closed and discharge off-site is not possible. All opening/closing of the control valve is logged on site.

If the latest lake water monitoring results indicate that water is not of an acceptable quality, then the valve cannot be opened, the lake water cannot overflow and the Golf Course may begin to flood. This is part of the mitigation design to prevent off-site discharge of water that does not meet the required standard.

The bund that surrounds the site is at least 1.5m high and up to 90,000m³ of floodwater can be retained within the Golf Course in addition to the 20,000m³ lake capacity. In this situation, water samples from the flooded Golf Course will be taken more frequently. Only when water has returned to an acceptable quality will the control valve be opened to allow water to overflow from the lake and into off-site storm drains that discharge via Outfall No. 8, thereby allowing the flood to recede.

The system by which this water control is achieved is shown in **Figure 1-1**.

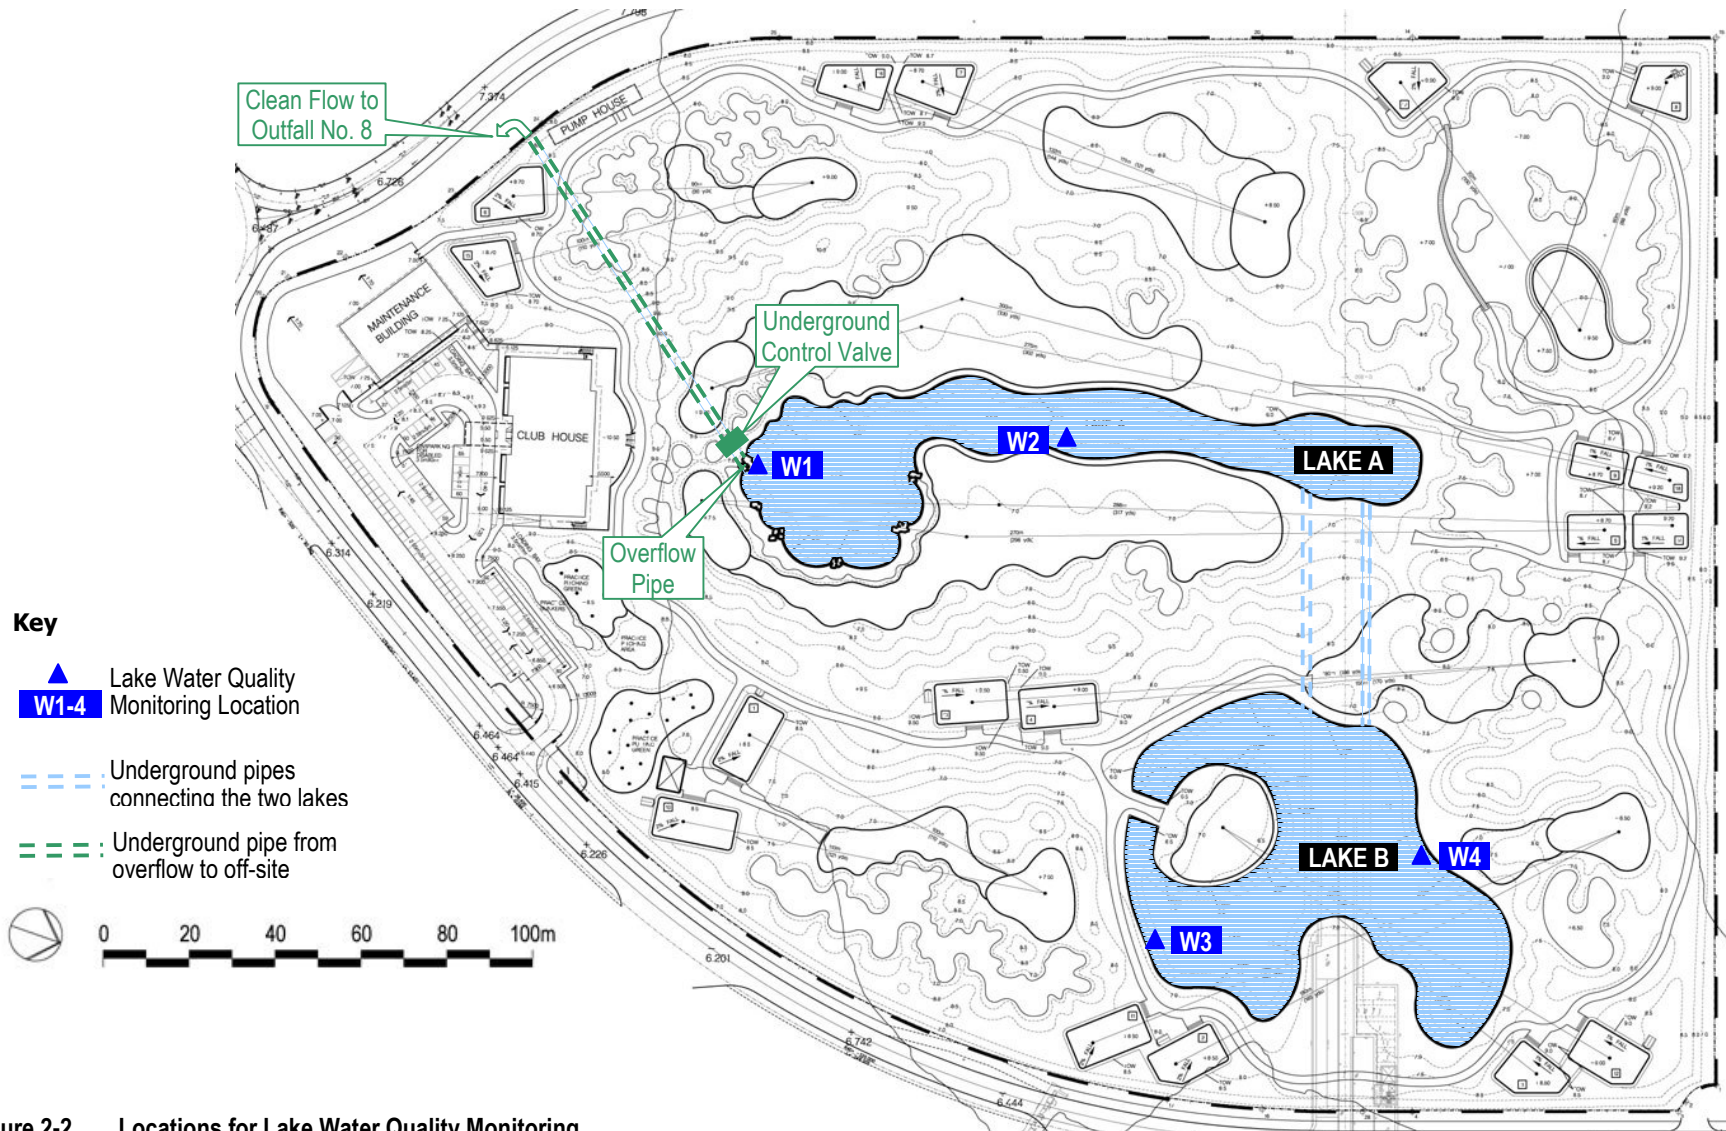
Figure 2-2 Locations for Lake Water Quality Monitoring

Monitoring locations together with grid references are shown in **Figure 2-2**. Monitoring Stations are designated as W1, W2, W3 and W4.

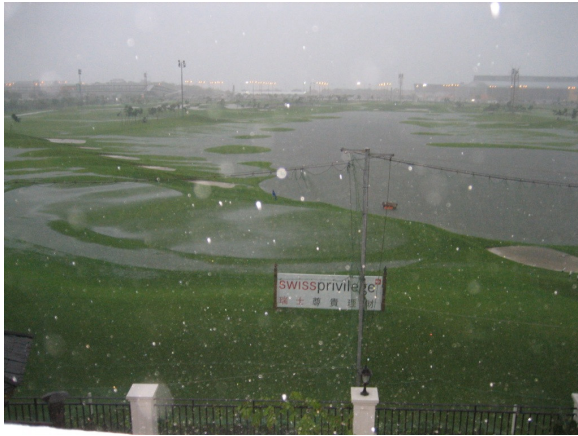
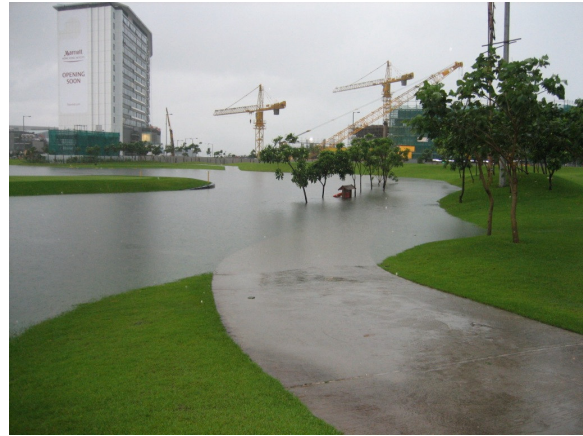
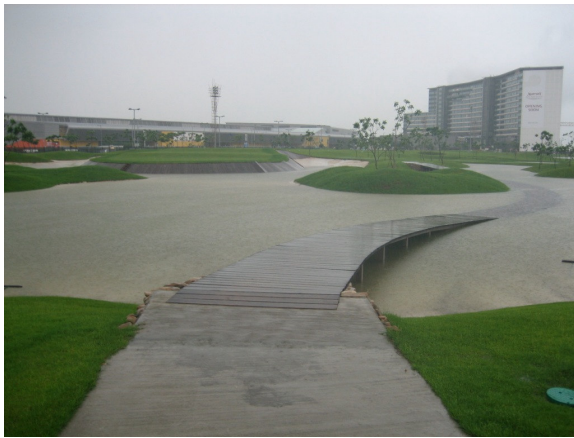
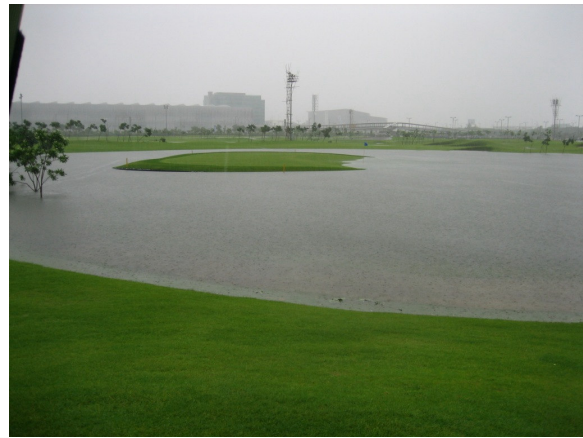
Three occasions of opening of the control valve were recorded in the reporting quarter; on 7 June 2008 when a Black Rainstorm Warning was issued; on 24 and 25 June 2008 when the No. 8 Typhoon Signal was raised; and on 10 July 2008 when an Amber Rainstorm Warning was issued. On these occasions, the SkyCity Nine Eagles Golf Course experienced significant flooding.

Black Rainstorm on 7 June 2008

1. The Golf Facility Supervisor determined that the control valve should be opened to reduce the flooding of the golf course.
2. The most recent lake water quality monitoring results (dated 9 May 2008 and 27 June 2008) indicated that the lake water was of an acceptable standard for discharge.
3. To alleviate the flooding, the Golf Facility Supervisor authorised the opening of the control valve from 6.30am on 7 June to 5.30pm on 7 June; from 3.00pm on 25 June to 5.30pm on 25 June; and from 6.30am on 10 July to 4pm on 10 July. The dates and times of these activities were recorded in the log book, which is kept on site.

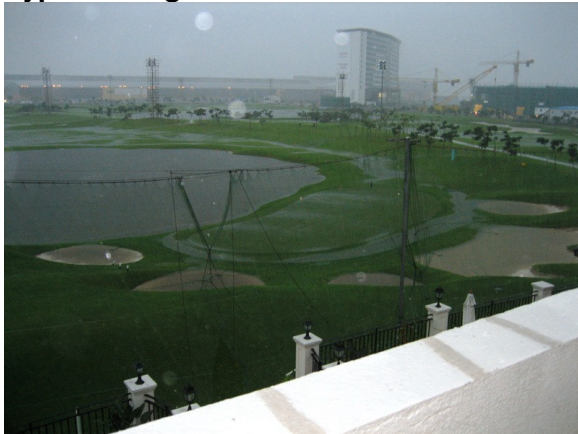
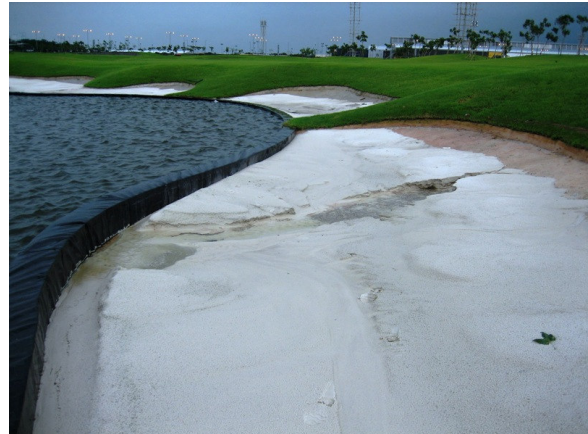
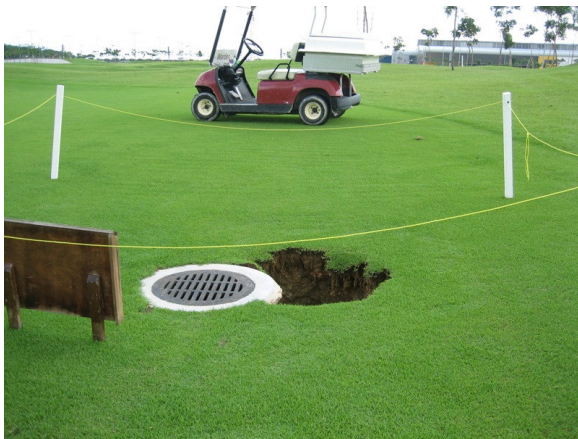
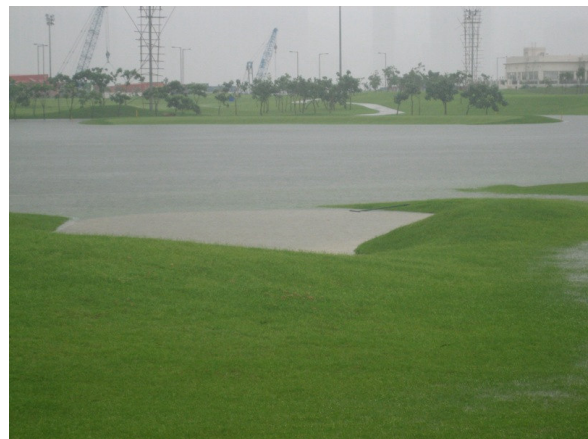
Typhoon Signal No 8 on 25 June 2008

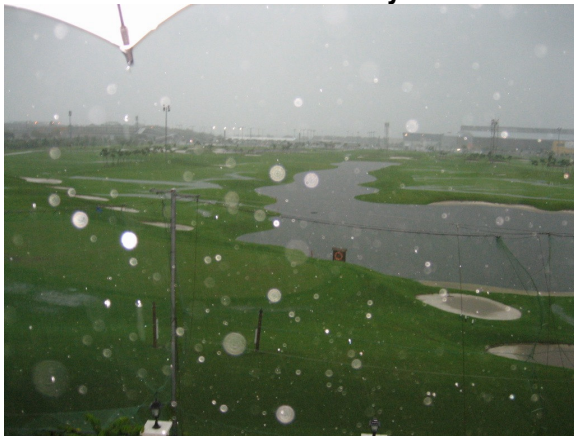
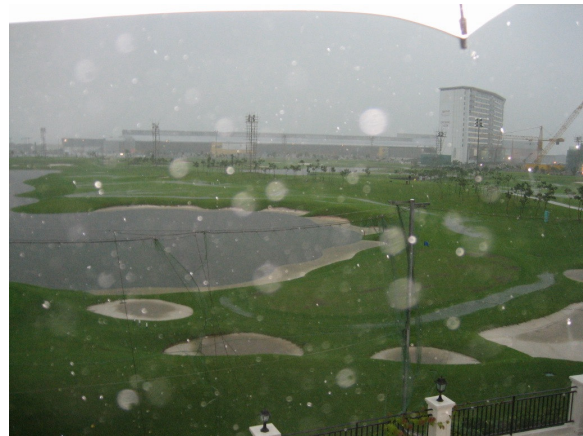
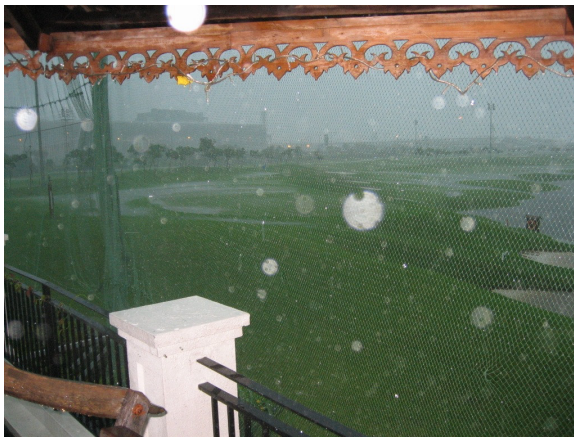
Amber Rainstorm on 11 July 2008
