SkyCity Nine Eagles Golf Course

EM&A Quarterly Compliance Report

August 2009 to October 2009

Report No EB000226-R10-01

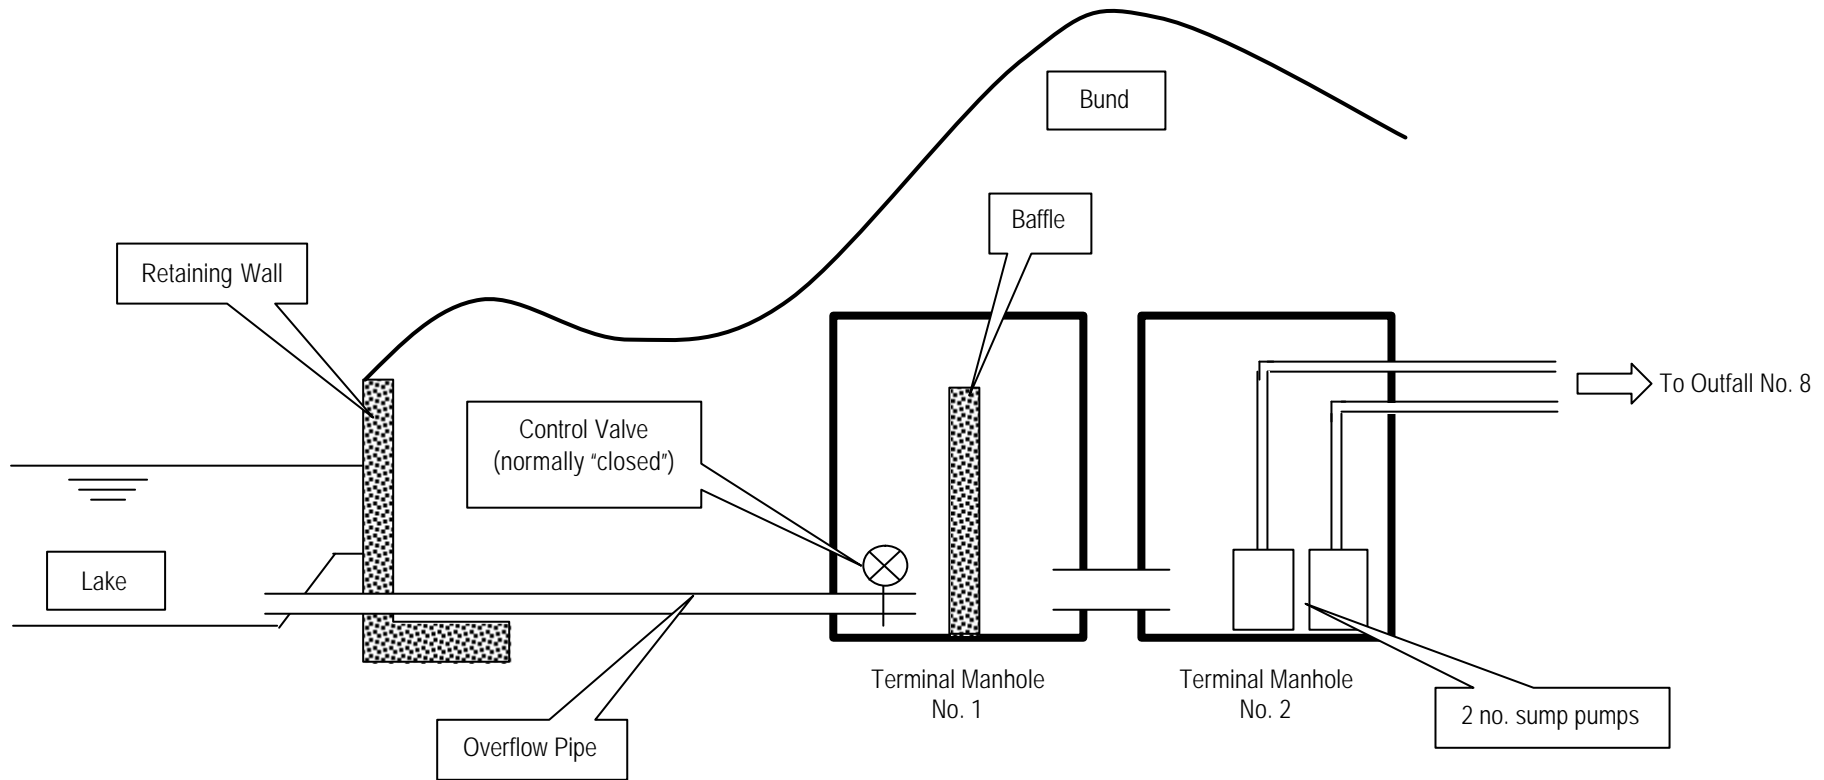
Figure 2-1 Schematic of Lake Water Control System

The Golf Course has been designed to contain water within two artificial lakes, which are linked together by two underwater pipes. Because of the sloping topography of the site, all rainwater collected within the Golf Course will drain into the lakes through a sub-soil drainage system. The lakes provide a source of freshwater for irrigation, from which surplus water will flow back into the lakes.

The lakes are normally maintained at a capacity of 15,000m³. This is not "full" but is the level that provides the required visual appearance. During the winter (dry) months, however, the lake water may fall below this level. The maximum capacity of the lakes is 20,000m³.

If more than 20,000m³ of water flows into the lakes, then the Golf Course may flood. To avoid this, the Golf Course Supervisor can authorise the opening of a control valve to allow the water to overflow from the lake and into off-site storm drains that discharge via Outfall No. 8. However, the valve can only be opened if the latest lake water monitoring results indicate that water is of an acceptable quality. In normal circumstances, the control valve remains closed and discharge off-site is not possible. All opening/closing of the control valve is logged on site.

If the latest lake water monitoring results indicate that water is not of an acceptable quality, then the valve cannot be opened, the lake water cannot overflow and the Golf Course may begin to flood. This is part of the mitigation design to prevent off-site discharge of water that does not meet the required standard.

The bund that surrounds the site is at least 1.5m high and up to 90,000m³ of floodwater can be retained within the Golf Course in addition to the 20,000m³ lake capacity. In this situation, water samples from the flooded Golf Course will be taken more frequently. Only when water has returned to an acceptable quality will the control valve be opened to allow water to overflow from the lake and into off-site storm drains that discharge via Outfall No. 8, thereby allowing the flood to recede.

The system by which this water control is achieved is shown in **Figure 2-1**.

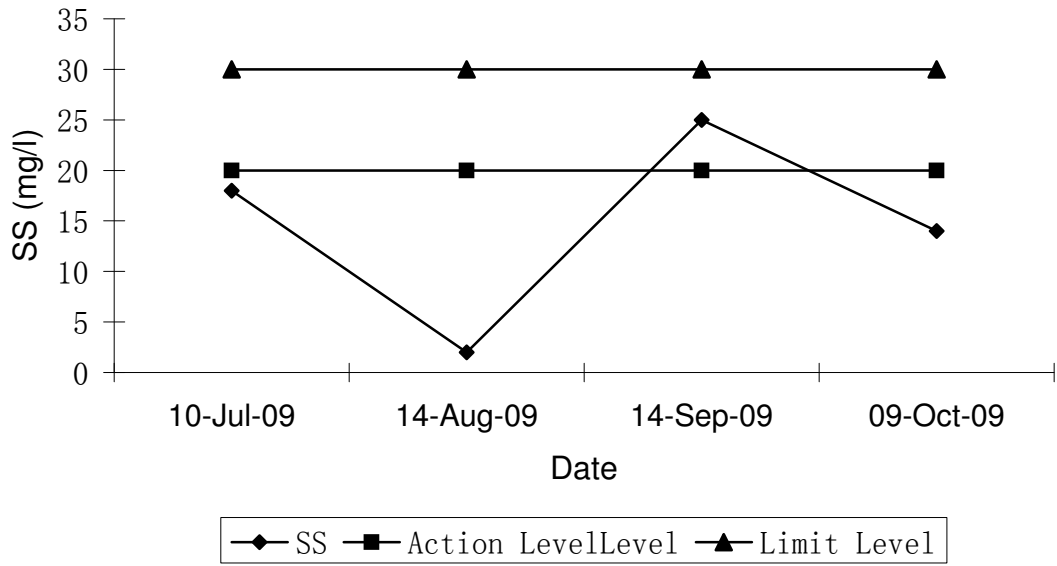
SkyCity Golf Lake Water Quality Monitoring SS at W1

However, there were exceedances of the Action Level for SS at W1 (25mg/l) and W2 (27mg/l) on 14 September 2009. According to the Event Action Plan for Marine Water Quality Monitoring, the source(s) of impact was identified. The exceedances of SS levels at W1 and W2 were mainly due to low water level at Lakes A and B (0.3m during the lake water quality monitoring) caused by the prolonged sunshine and dry weather in August and September 2009, thus leading to excessive evaporation from the lakes. The monitored results indicated that the nutrient levels in the water remained well below the Action Level ((total nitrogen < 3 mg/L & total phosphorus = 0.2 mg/L) and hence the application of nutrient (in Turfgrass Management Plan) was not the cause of excessive algal growth in the lakes in September 2009. Instead, the previously accumulated silts in the lake water in Lake A caused the exceedance of SS Action level. Possible mitigation measures were also discussed with the Operator of the Golf Course. A non-chemical, natural liquid microbial pond clarifier, “Aqua Bio-Trol”, was applied to Lakes A and B on 2 September 2009 to reduce the presence of algae. Besides, more fish (e.g. carps) were added to improve the lake water quality. There was no need for discharge due to low water level (around 0.3m during the water quality monitoring). Hence, it was necessary to carry out the follow-on monitoring.

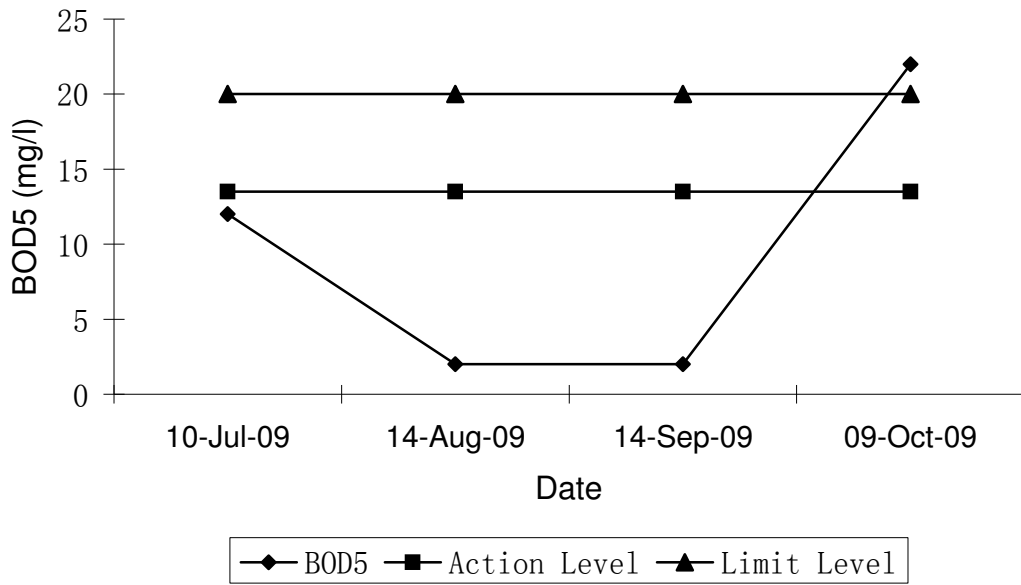
SkyCity Golf Lake Water Quality Monitoring BOD5 at W1

The exceedances of the Limit Level for BOD₅ at W1 (22mg/l) and W2 (32mg/l) were recorded on 9 October 2009. According to the Event Action Plan for Marine Water Quality Monitoring, the source(s) of impact was identified. The relatively high levels of SS recorded at W1 (14mg/l) and W2 (20mg/l) were the reasons accounting for the high levels of BOD₅ recorded at Lake A (W1 and W2). Besides, the aeration of lakes was suspended due to the low water levels (0.2m during the lake water quality monitoring). Hence the exceedances of the Limit Level for BOD₅ were due to previously accumulated silts in the lake water in Lake A and lack of aeration, hence the non-compliance was considered not related to the operation of the project. Possible mitigation measures were also discussed with the Operator of the Golf Course. Second dose of “Aqua Bio-Trol” was applied to the lakes on 23 September 2009 after the first addition on 2 September 2009 to further improve the lake water quality. For the problems of accumulated sand and silts in Lake A, the Operator is now arranging for the pump cleaning system to remove

sand and silts settled in Lake A by late November / early December. Hence the lake water quality will be further improved with the removal of those sand and silts. Considering the low water levels and unnecessary discharge of water at the moment, no follow-on water quality monitoring was required.

ET will keep track of the lake water level and will conduct earlier sampling, if necessary before the lakes are full and ready for discharge. Further details of “Aqua Bio-Trol” are provided in **Appendix 4**.
