SkyCity Nine Eagles Golf Course

EM&A Quarterly Compliance Report

November 2009 to January 2010

Report No EB000226-R11-01

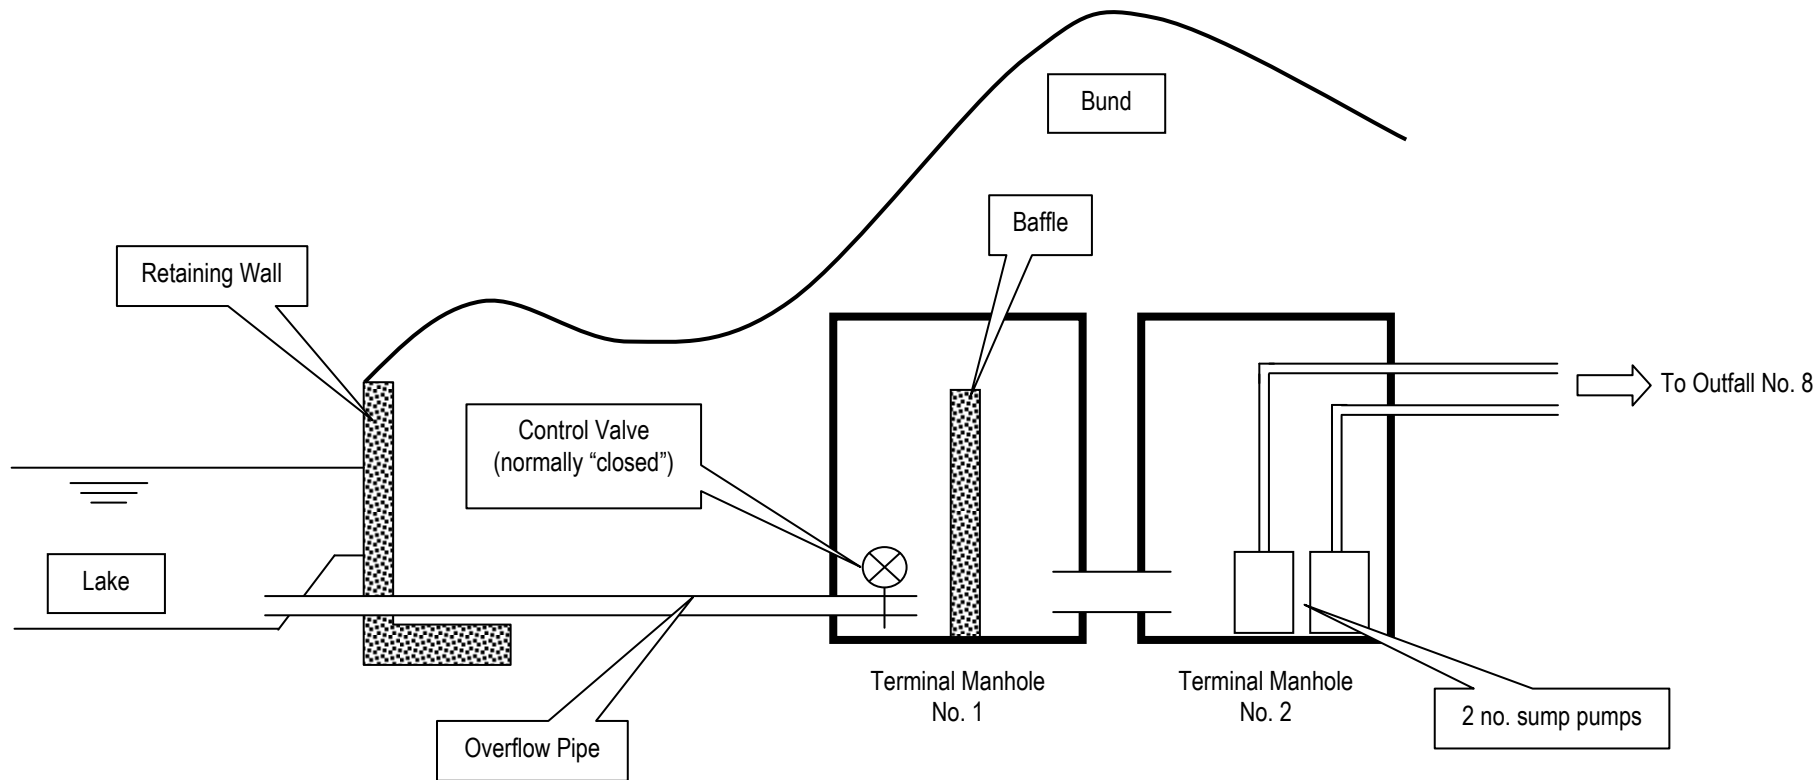
Figure 2-1 Schematic of Lake Water Control System

The Golf Course has been designed to contain water within two artificial lakes, which are linked together by two underwater pipes. Because of the sloping topography of the site, all rainwater collected within the Golf Course will drain into the lakes through a sub-soil drainage system. The lakes provide a source of freshwater for irrigation, from which surplus water will flow back into the lakes.

The lakes are normally maintained at a capacity of 15,000m³. This is not "full" but is the level that provides the required visual appearance. During the winter (dry) months, however, the lake water may fall below this level. The maximum capacity of the lakes is 20,000m³.

If more than 20,000m³ of water flows into the lakes, then the Golf Course may flood. To avoid this, the Golf Course Supervisor can authorise the opening of a control valve to allow the water to overflow from the lake and into off-site storm drains that discharge via Outfall No. 8. However, the valve can only be opened if the latest lake water monitoring results indicate that water is of an acceptable quality. In normal circumstances, the control valve remains closed and discharge off-site is not possible. All opening/closing of the control valve is logged on site.

If the latest lake water monitoring results indicate that water is not of an acceptable quality, then the valve cannot be opened, the lake water cannot overflow and the Golf Course may begin to flood. This is part of the mitigation design to prevent off-site discharge of water that does not meet the required standard.

The bund that surrounds the site is at least 1.5m high and up to 90,000m³ of floodwater can be retained within the Golf Course in addition to the 20,000m³ lake capacity. In this situation, water samples from the flooded Golf Course will be taken more frequently. Only when water has returned to an acceptable quality will the control valve be opened to allow water to overflow from the lake and into off-site storm drains that discharge via Outfall No. 8, thereby allowing the flood to recede.

The system by which this water control is achieved is shown in **Figure 2-1**.

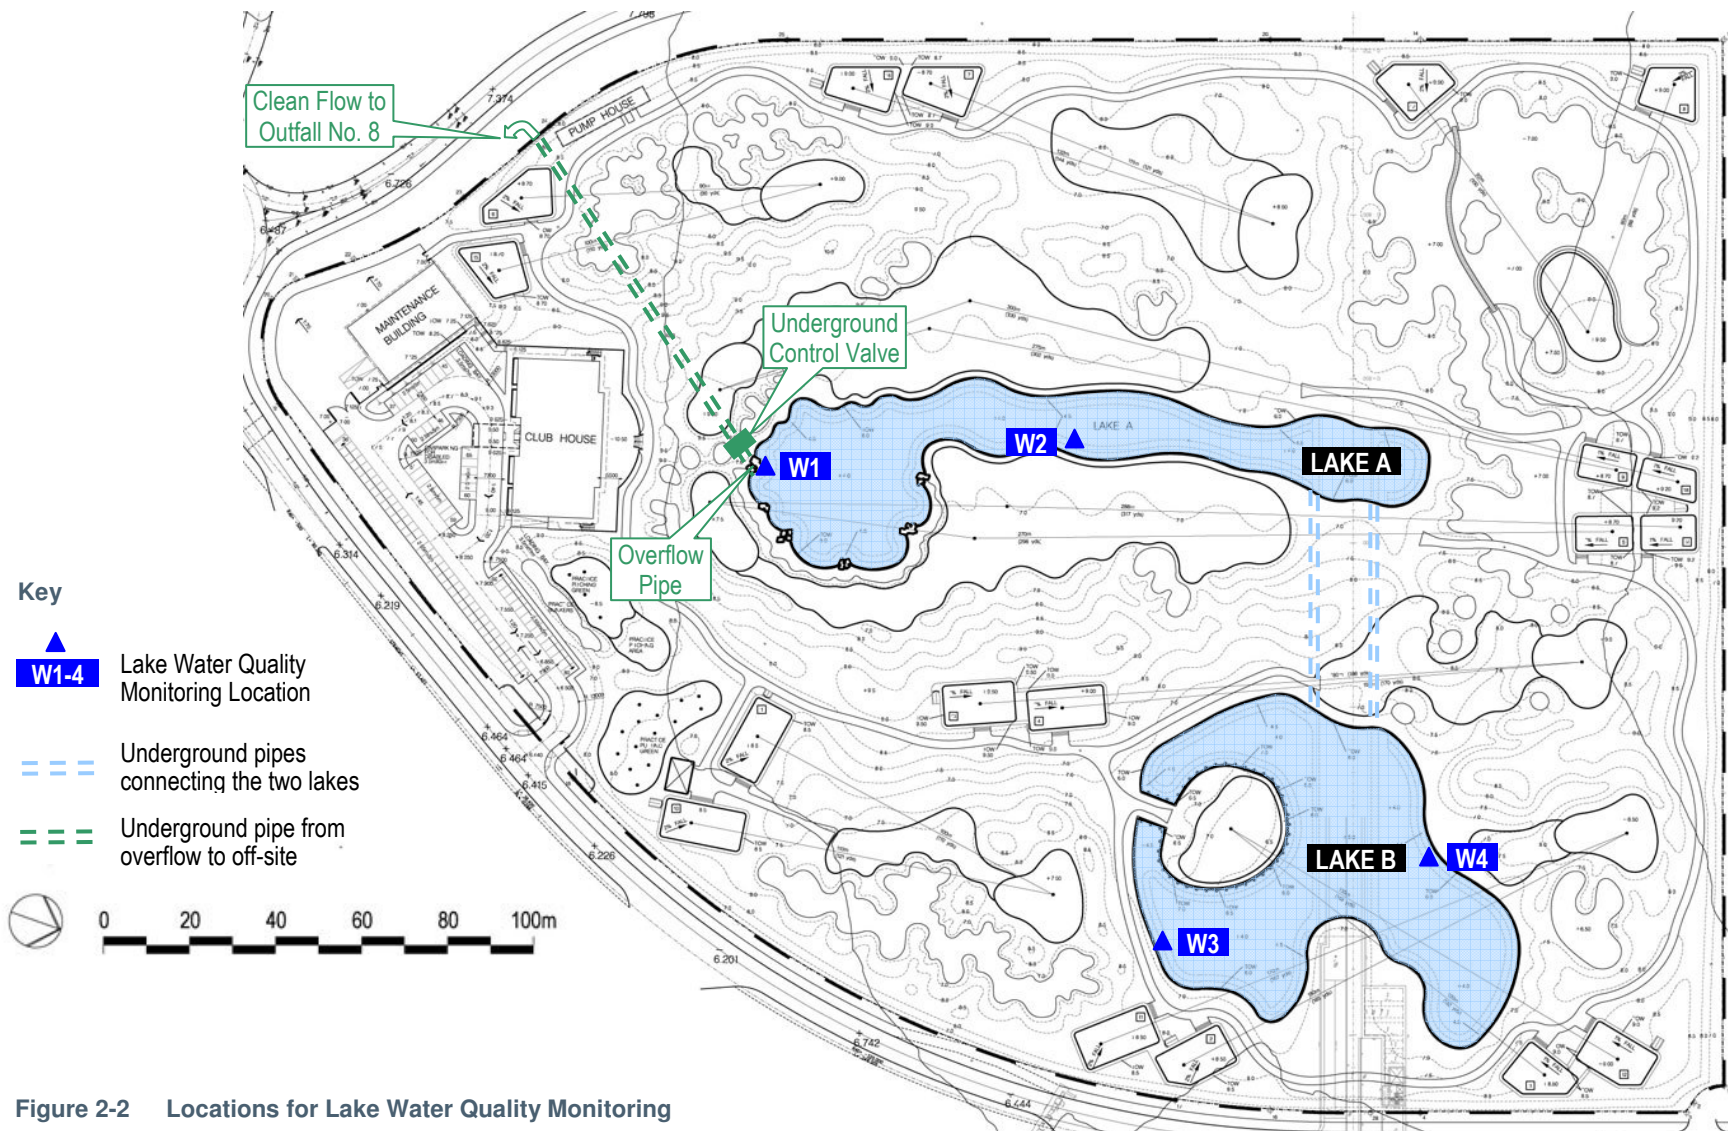
Figure 2-2 Locations for Lake Water Quality Monitoring

Monitoring locations together with grid references are shown in **Figure 2-2**. Monitoring Stations are designated as W1, W2, W3 and W4.
