EM&A Report

SkyCity Nine Eagles Golf Course

Quarterly EM&A Compliance Report

February to April 2011

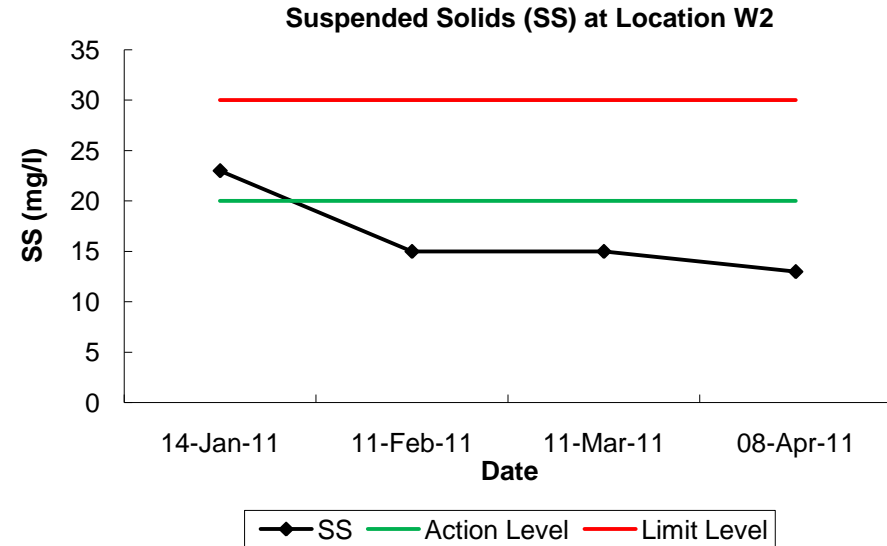
Graphical Plots of Monitoring Data for the Past Four Months

A summary of scheduled lake water monitoring results for the reporting quarter is provided in **Table 3-1**, below. Detailed results are provided in **Appendix 2** and graphical plots since commencement of the second phase of Operation are given in **Appendix 3**.
