EM&A Report

SkyCity Nine Eagles Golf Course

Quarterly EM&A Compliance Report

February– April 2012

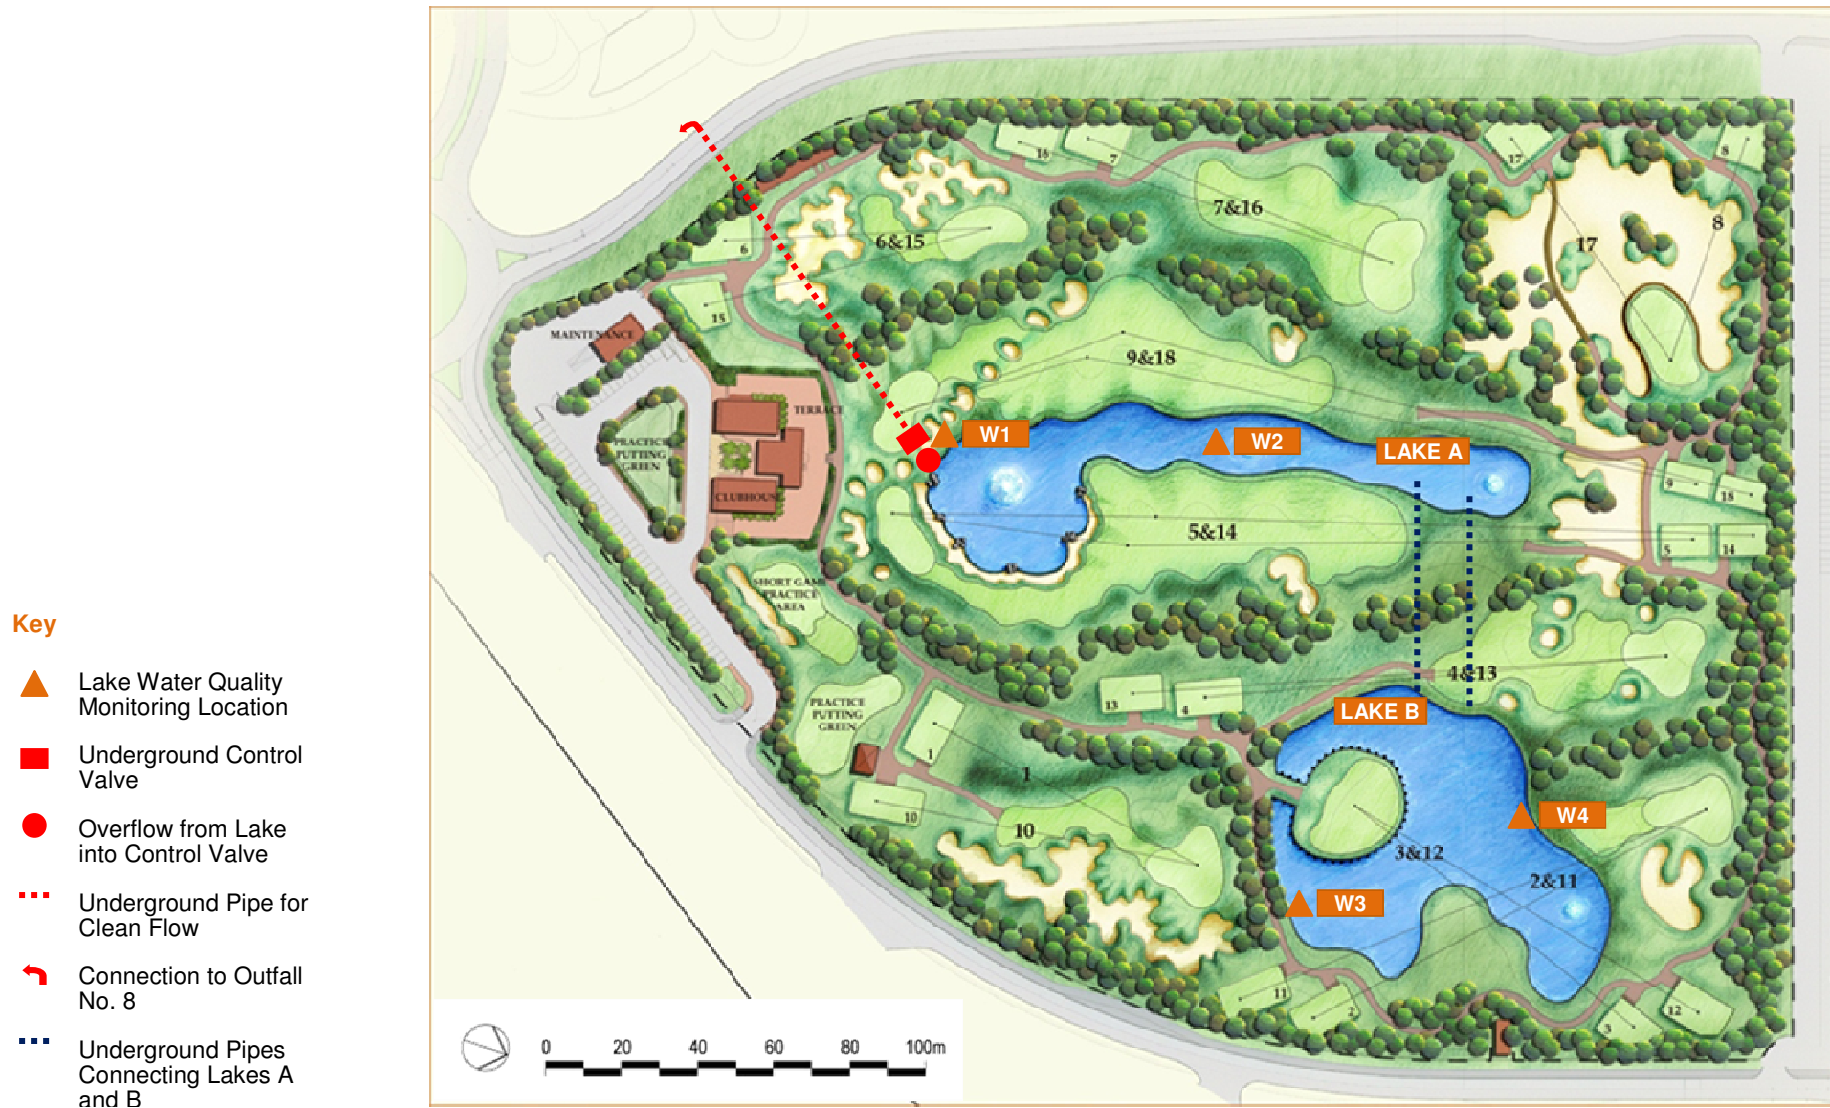
Figure 2-1 Locations for Lake Water Quality Monitoring

Monitoring locations together with grid references are shown in **Figure 2-1**. Monitoring Stations are designated as W1, W2, W3 and W4.
