SkyCity Nine Eagles Golf Course

Quarterly EM&A Compliance Report

May to July 2012

Project/Deliverable Number:	7076024 D01/09
Project Name:	SkyCity Nine Eagles Golf Course
Report Name:	Quarterly EM&A Compliance Report – May to July 2012
Report Date:	August 2012
Report for:	Sky City Nine Eagles Golf Course

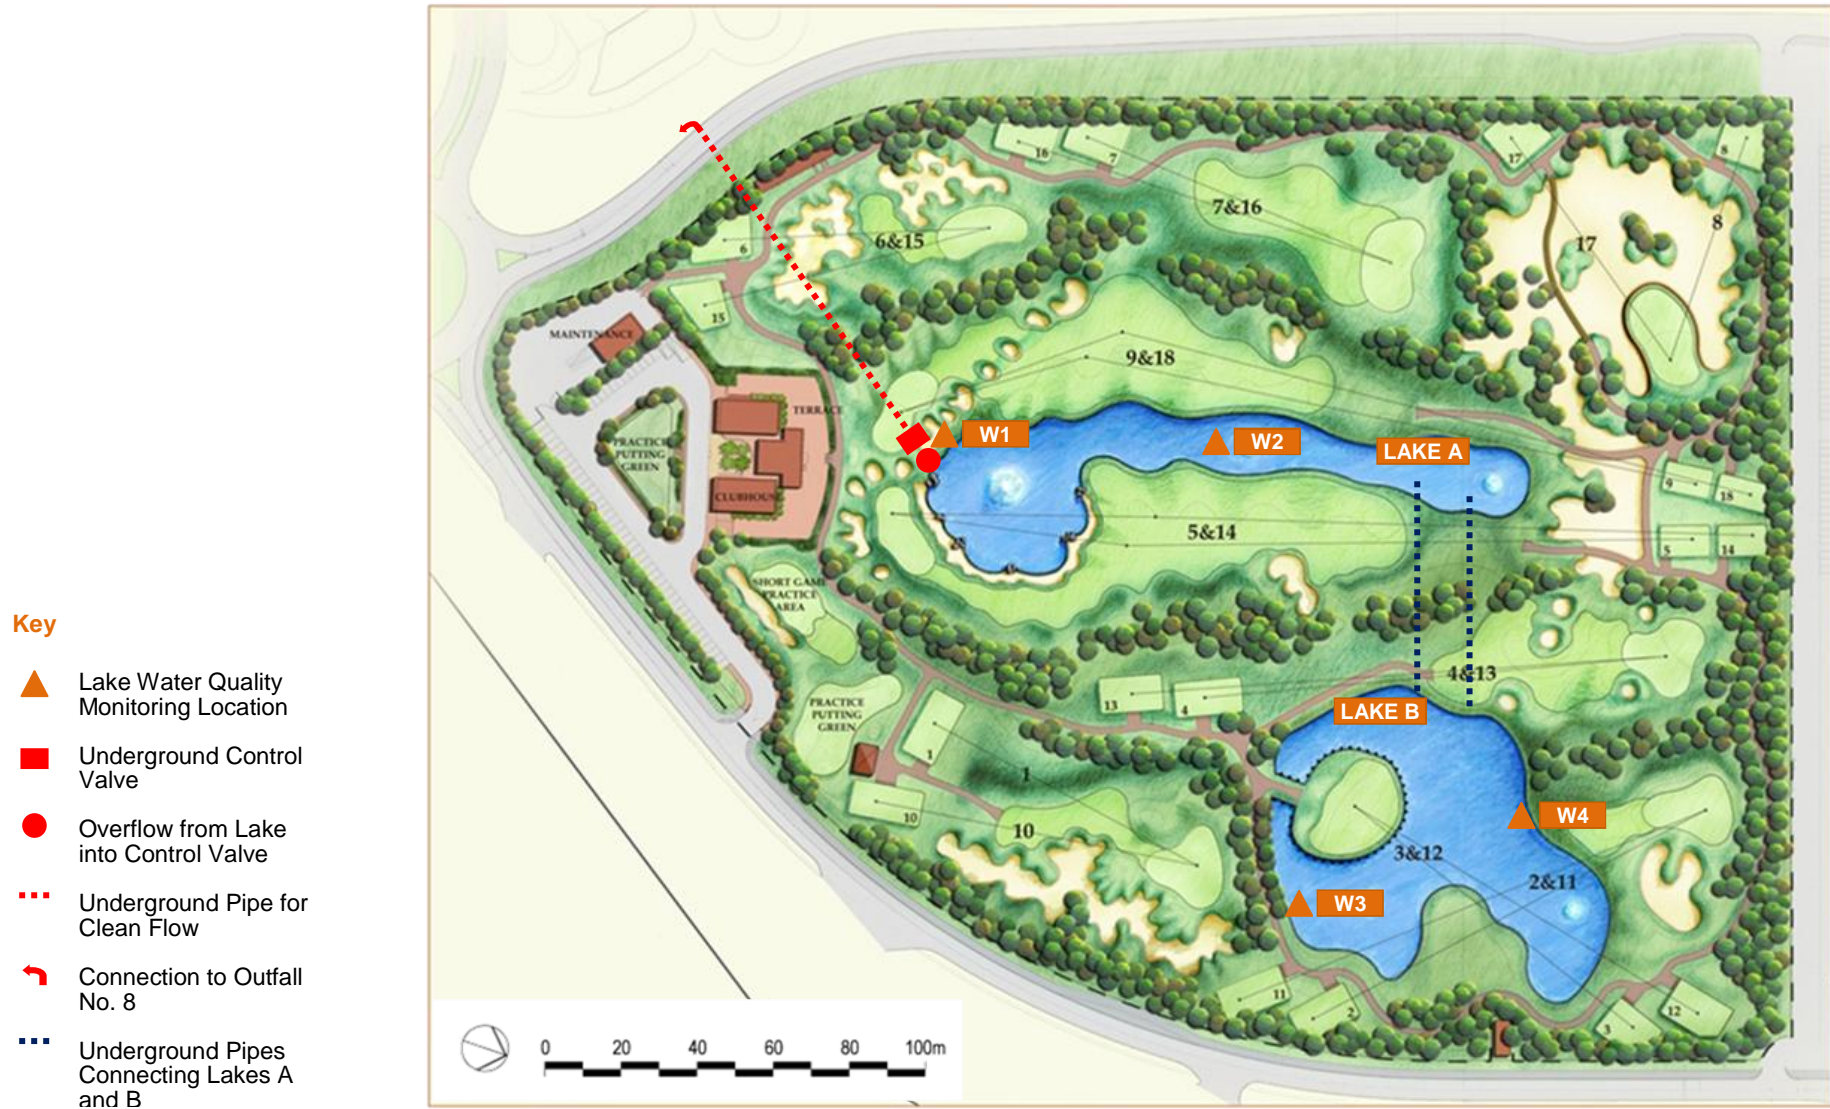
Figure 2-1 Locations for Lake Water Quality Monitoring

Monitoring locations together with grid references are shown in [Figure 2-1](#). Monitoring Stations are designated as W1, W2, W3 and W4.

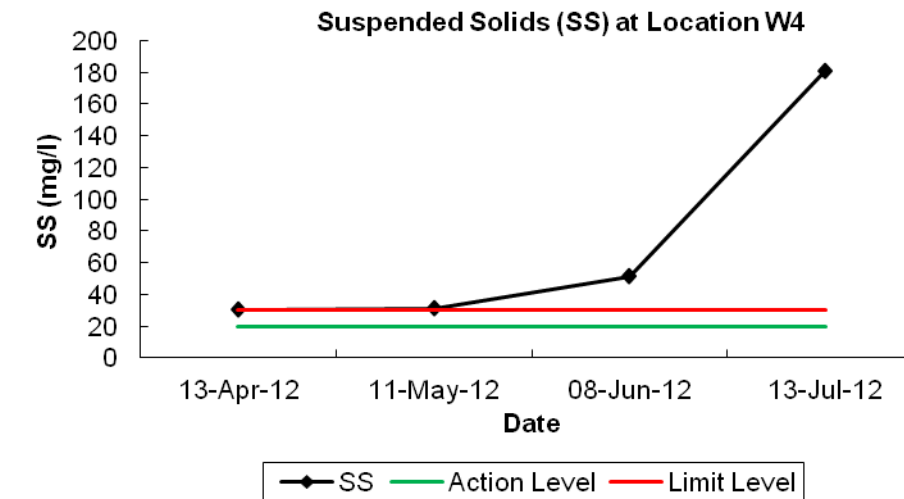
Graphical Plots of Monitoring Data for the Past Four Months

A summary of scheduled lake water monitoring results for the reporting quarter is provided in **Table 3-1**, below. Detailed results are provided in **Appendix 2** and graphical plots since commencement of the second phase of Operation are given in **Appendix 3**.
