Quarterly EM&A Compliance Report

SkyCity Nine Eagles Golf Course

August to October 2012

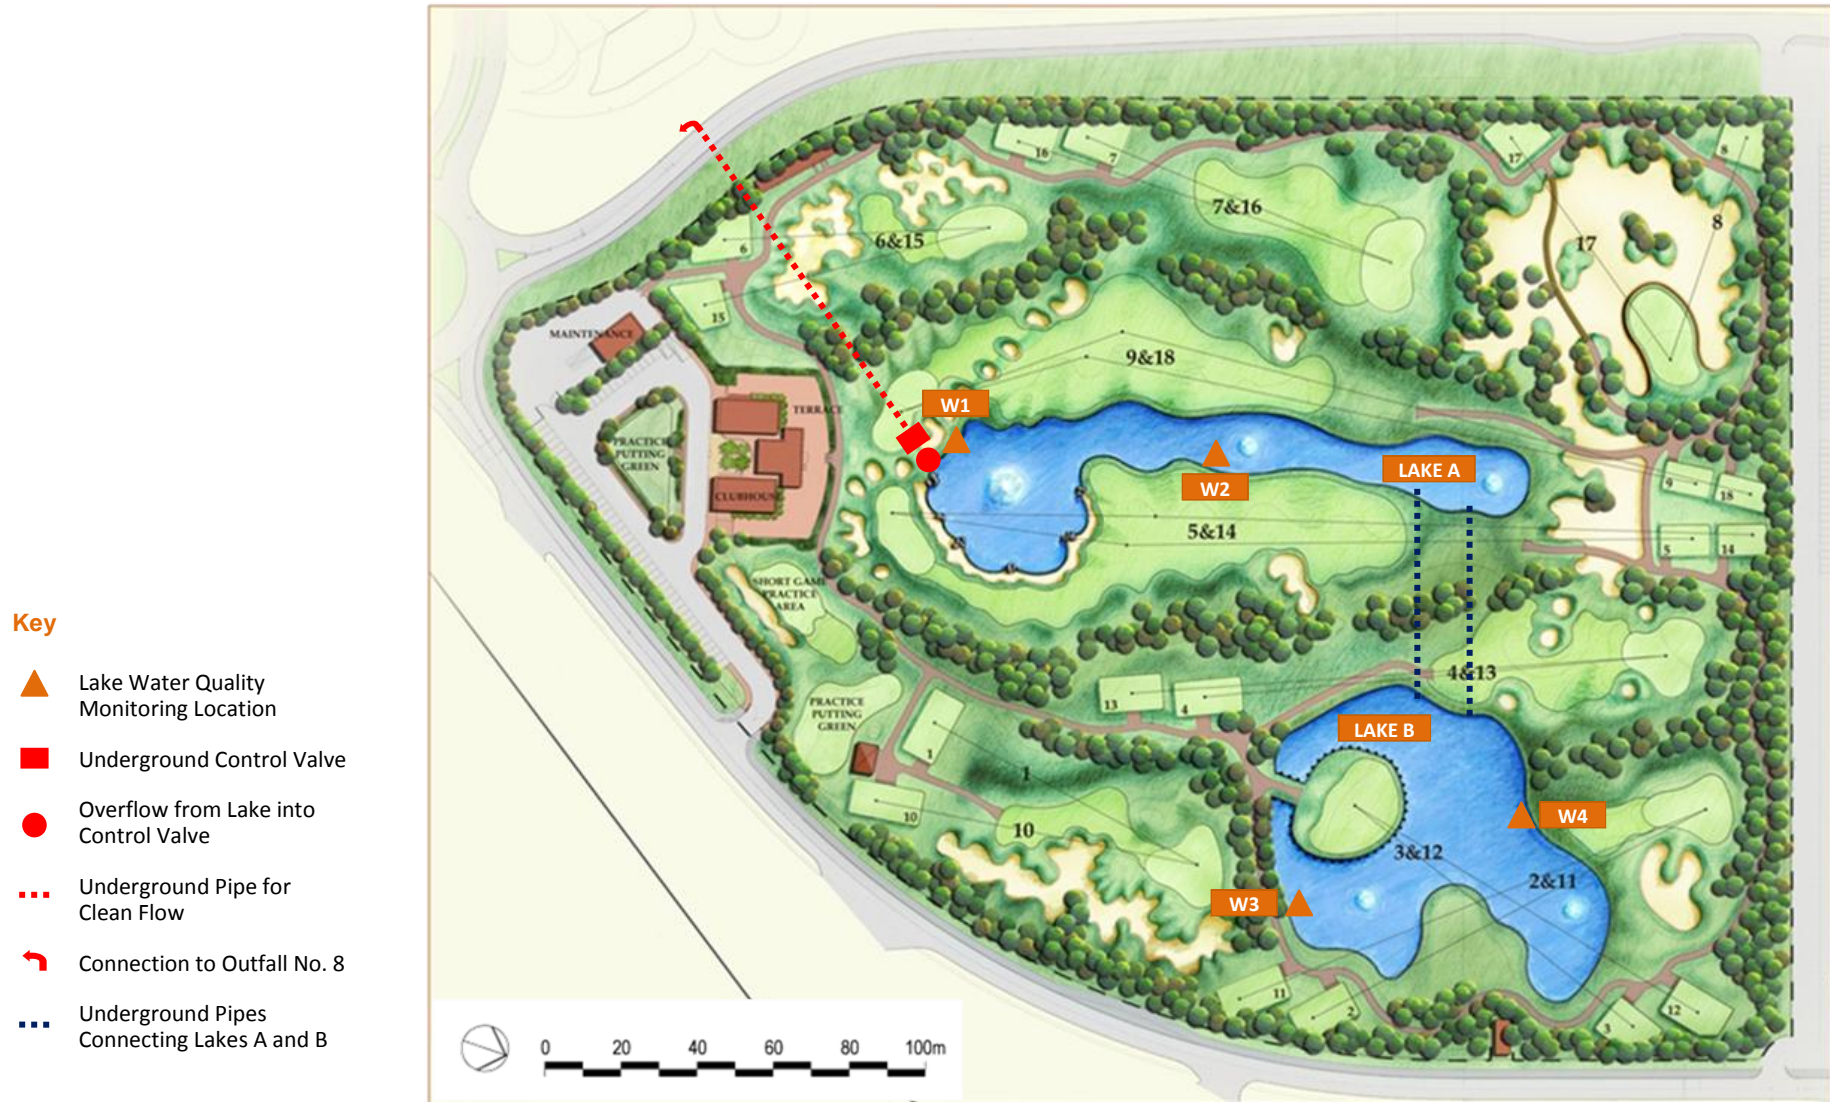
Figure 2-1 **Locations for Lake Water Quality Monitoring**

Monitoring locations together with grid references are shown in [Figure 2-1](#). Monitoring Stations are designated as W1, W2, W3 and W4.
