Quarterly EM&A Compliance Report

SkyCity Nine Eagles Golf Course

November 2012 to January 2013

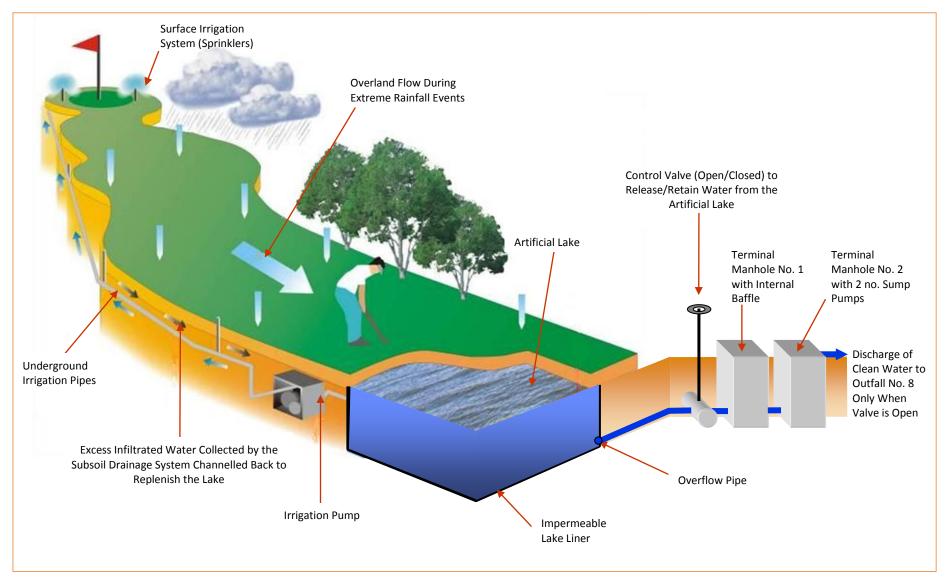
Figure 1-2 Schematic of Lake Water Control System

The Golf Course has been designed to contain water within two artificial lakes, which are linked together by two underwater pipes. The lakes provide a source of freshwater for irrigation. All rainwater and surplus irrigation water collected within the Golf Course will drain back into the lakes for reuse, through a sub-soil drainage system.

The lakes are maintained at a capacity of 15,000m³. This is not "full" but is the level that provides the required visual appearance. During the winter (dry) months, however, the lake water may fall below this level. The maximum capacity of the lakes is 20,000m³.

If the capacity of the lakes exceeds 20,000m³, then the Golf Course may flood. To avoid this, the Golf Course Supervisor can authorise the opening of a control valve to allow the water to overflow from the lakes into storm drains that discharge off-site via Outfall No. 8. However, the valve can only be opened if the lake water monitoring results indicate that water is of an acceptable quality. Under normal circumstances, the control valve remains closed and discharge off-site is not possible. All opening/closing of the control valve is logged on site.

If the latest lake water monitoring results indicate that water is not of an acceptable quality, then the valve cannot be opened, the lake water cannot overflow and the Golf Course may begin to flood. This is part of the mitigation design to prevent off-site discharge of water that does not meet the required standard.

The bund that surrounds the site is at least 1.5m high and up to 90,000m³ of floodwater can be retained within the Golf Course in addition to the 20,000m³ lake capacity. In this situation, water samples from the flooded Golf Course will be taken more frequently. Only when water has returned to an acceptable quality will the control valve be opened to allow water to overflow from the lake and into off-site storm drains that discharge via Outfall No. 8, thereby allowing the flood to recede.

The system by which this water control is achieved is shown in *Figure 1-2*.

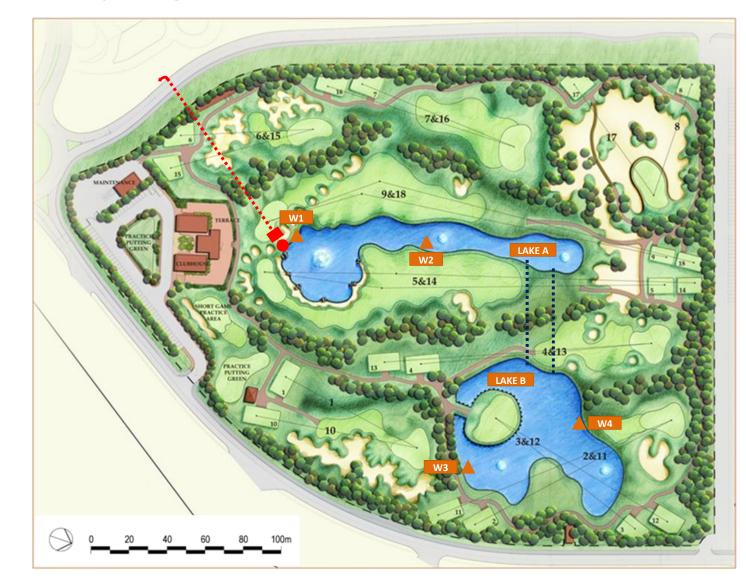
Figure 2-1 Locations for Lake Water Quality Monitoring

Monitoring locations together with grid references are shown in *Figure 2-1*. Monitoring Stations are designated as W1, W2, W3 and W4.

- Underground Pipe for Clean Flow
- Connection to Outfall No. 8
- Underground Pipes Connecting Lakes A and B

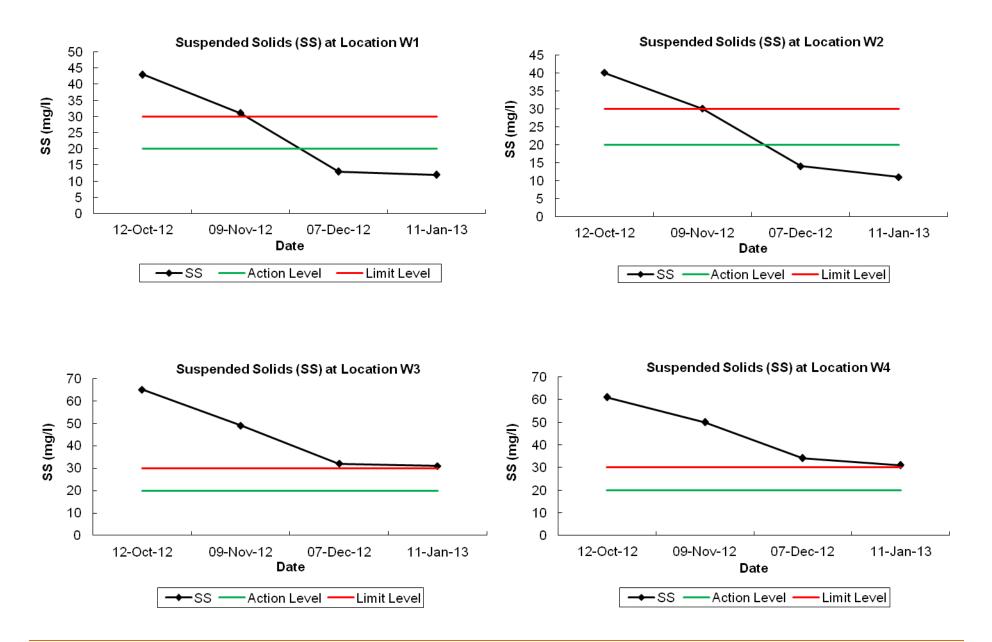
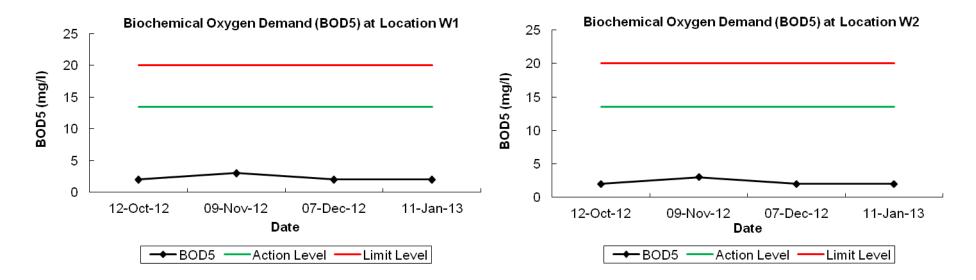
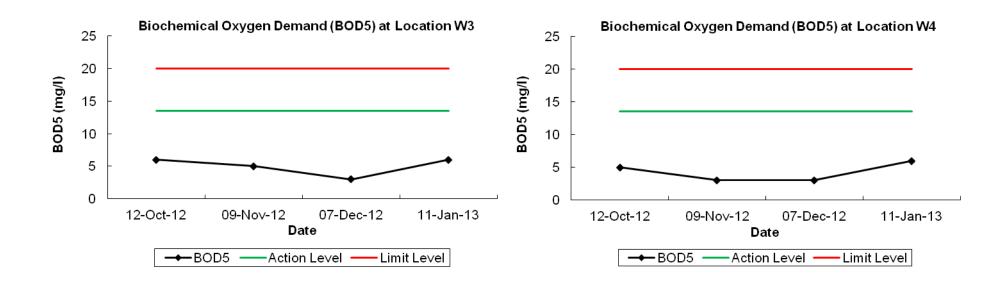
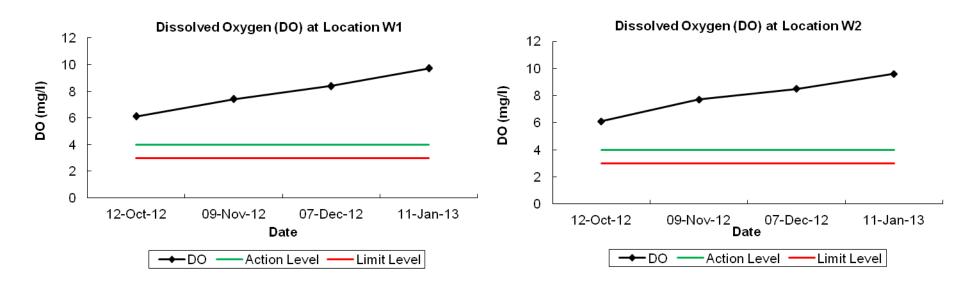
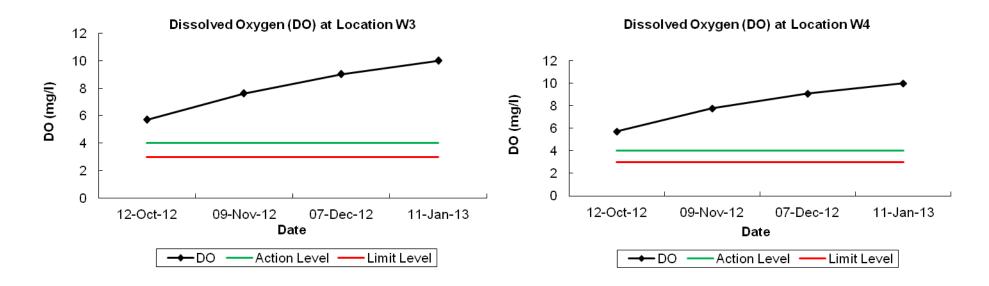
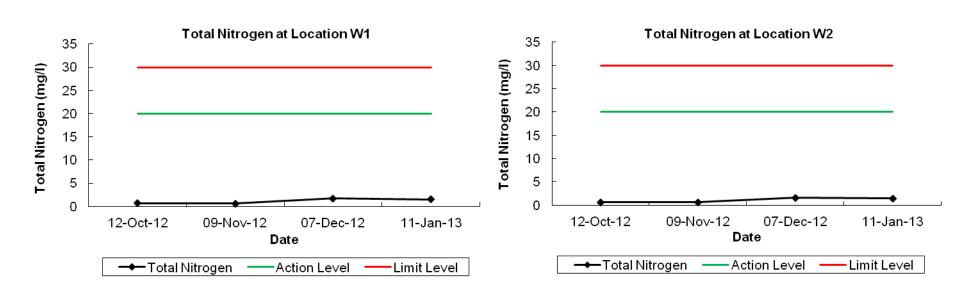
Graphical Plots of Monitoring Data for the Past Four Months

A summary of scheduled lake water monitoring results for the reporting quarter is provided in *Table 3-1*, below. Detailed results are provided in *Appendix 2* and graphical plots since commencement of the second phase of Operation are given in *Appendix 3*.
