Quarterly EM&A Compliance Report

SkyCity Nine Eagles Golf Course

February 2013 to April 2013

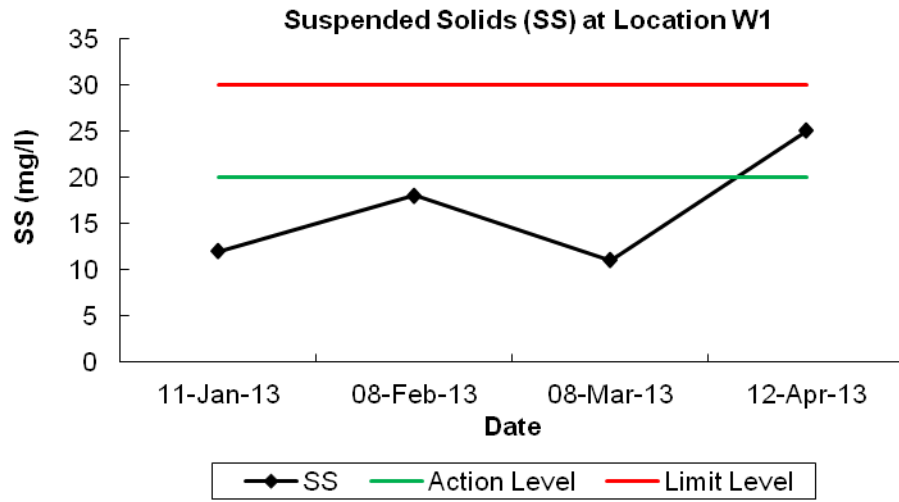
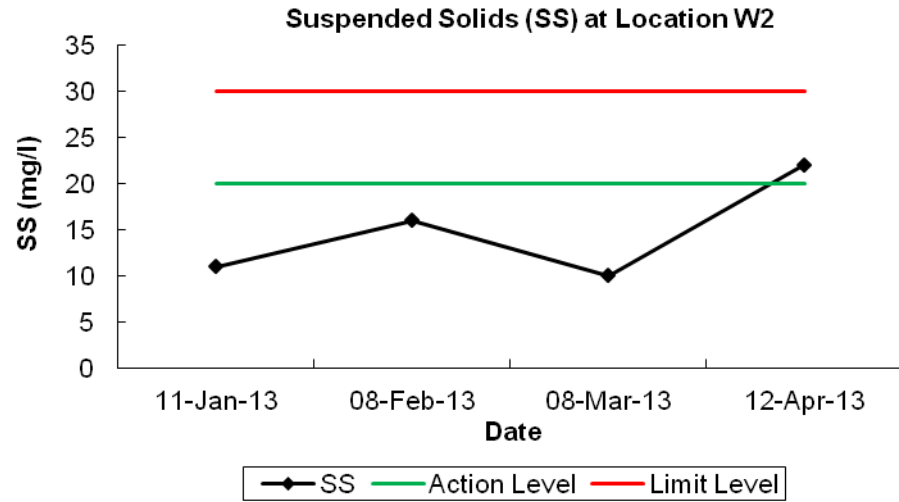
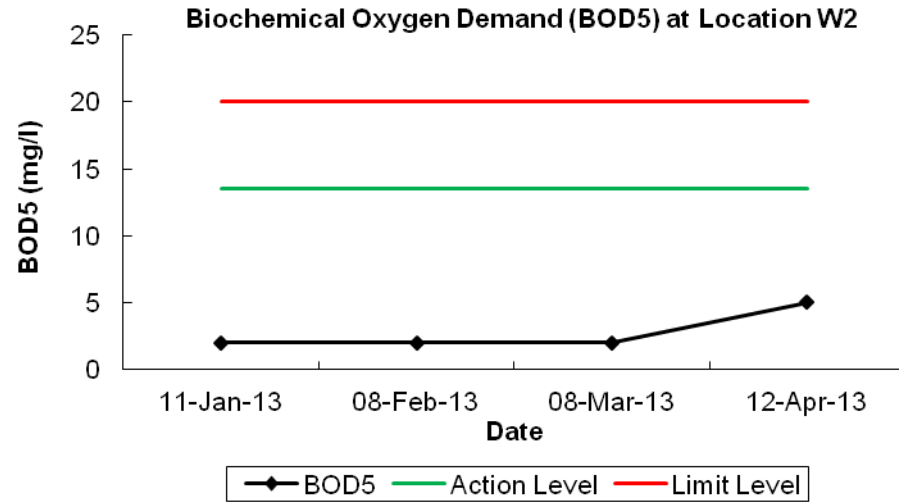
Graphical Plots of Monitoring Data for the Past Four Months

A summary of scheduled lake water monitoring results for the reporting quarter is provided in **Table 3-1**, below. Detailed results are provided in **Appendix 2** and graphical plots since commencement of the second phase of Operation are given in **Appendix 3**.
