Quarterly EM&A Compliance Report

SkyCity Nine Eagles Golf Course

February to April 2014

Project/ Deliverable No.:	7076024 D01/16 Revision No 1
Project Name:	SkyCity Nine Eagles Golf Course
Report Name:	Quarterly EM&A Compliance Report – February to April 2014
Report Date:	May 2014
Report for:	Sky City Nine Eagles Golf Course

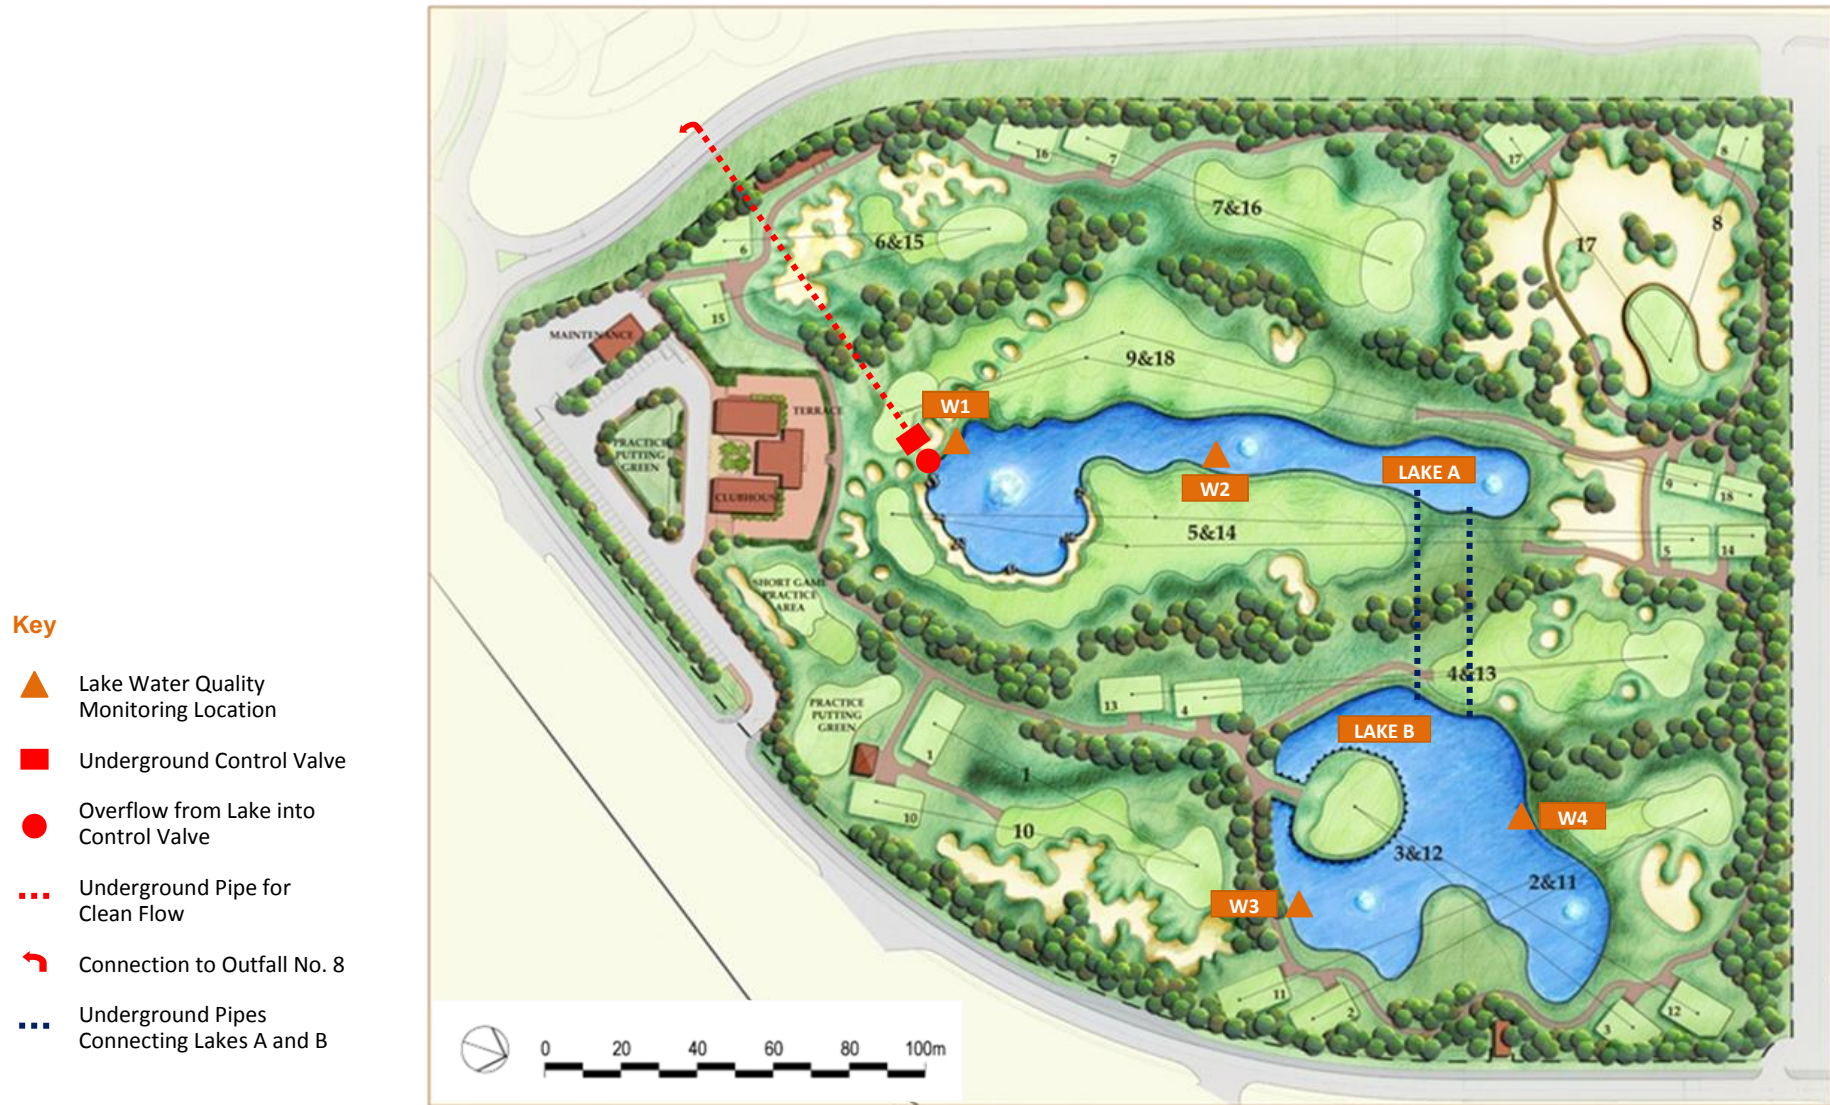
Figure 2-1 **Locations for Lake Water Quality Monitoring**

Monitoring locations together with grid references are shown in [Figure 2-1](#). Monitoring Stations are designated as W1, W2, W3 and W4.
