Quarterly EM&A Compliance Report

SkyCity Nine Eagles Golf Course

May to July 2014

Project Deliverable No.:	7076024 D01/16 – Revision No 1
Project Name:	SkyCity Nine Eagles Golf Course
Report Name:	Quarterly EM&A Compliance Report – May to July 2014
Report Date:	August 2014
Report for:	Sky City Nine Eagles Golf Course

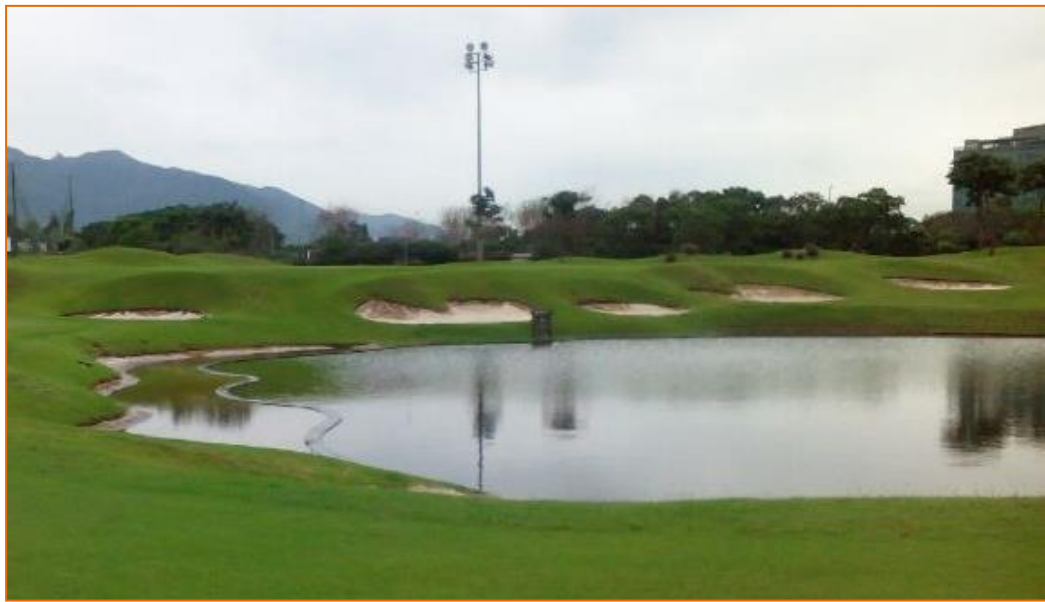
Figure 3-1 High Level of Lake Water in May 2014

Due to heavy rain in early May (more than double normal monthly rainfall), the water level of the lakes was very high, as shown in **Figure 3-1**, below. To prevent flooding, the control valve was opened on 12 May 2014 and an estimated 2,000m³ of clean lake water was discharged off-site via Outfall No. 8 between 6.30am and 4pm. This discharge of clean lake water was permitted under para.2.3.13 of the EM&A Manual.

During the reporting quarter, the control valve could be opened during May if needed because lake water quality was of an acceptable quality for discharge. To prevent flooding, the control valve was opened on 12 May 2014 and an estimated 2,000m³ of clean lake water was discharged off-site via Outfall No. 8 between 6.30am and 4pm.
