Quarterly EM&A Compliance Report

SkyCity Nine Eagles Golf Course

August to October 2014

Project Deliverable No.:	7076024 D01/18 – Revision No 1
Project Name:	SkyCity Nine Eagles Golf Course
Report Name:	Quarterly EM&A Compliance Report – August to October 2014
Report Date:	November 2014
Report for:	Sky City Nine Eagles Golf Course

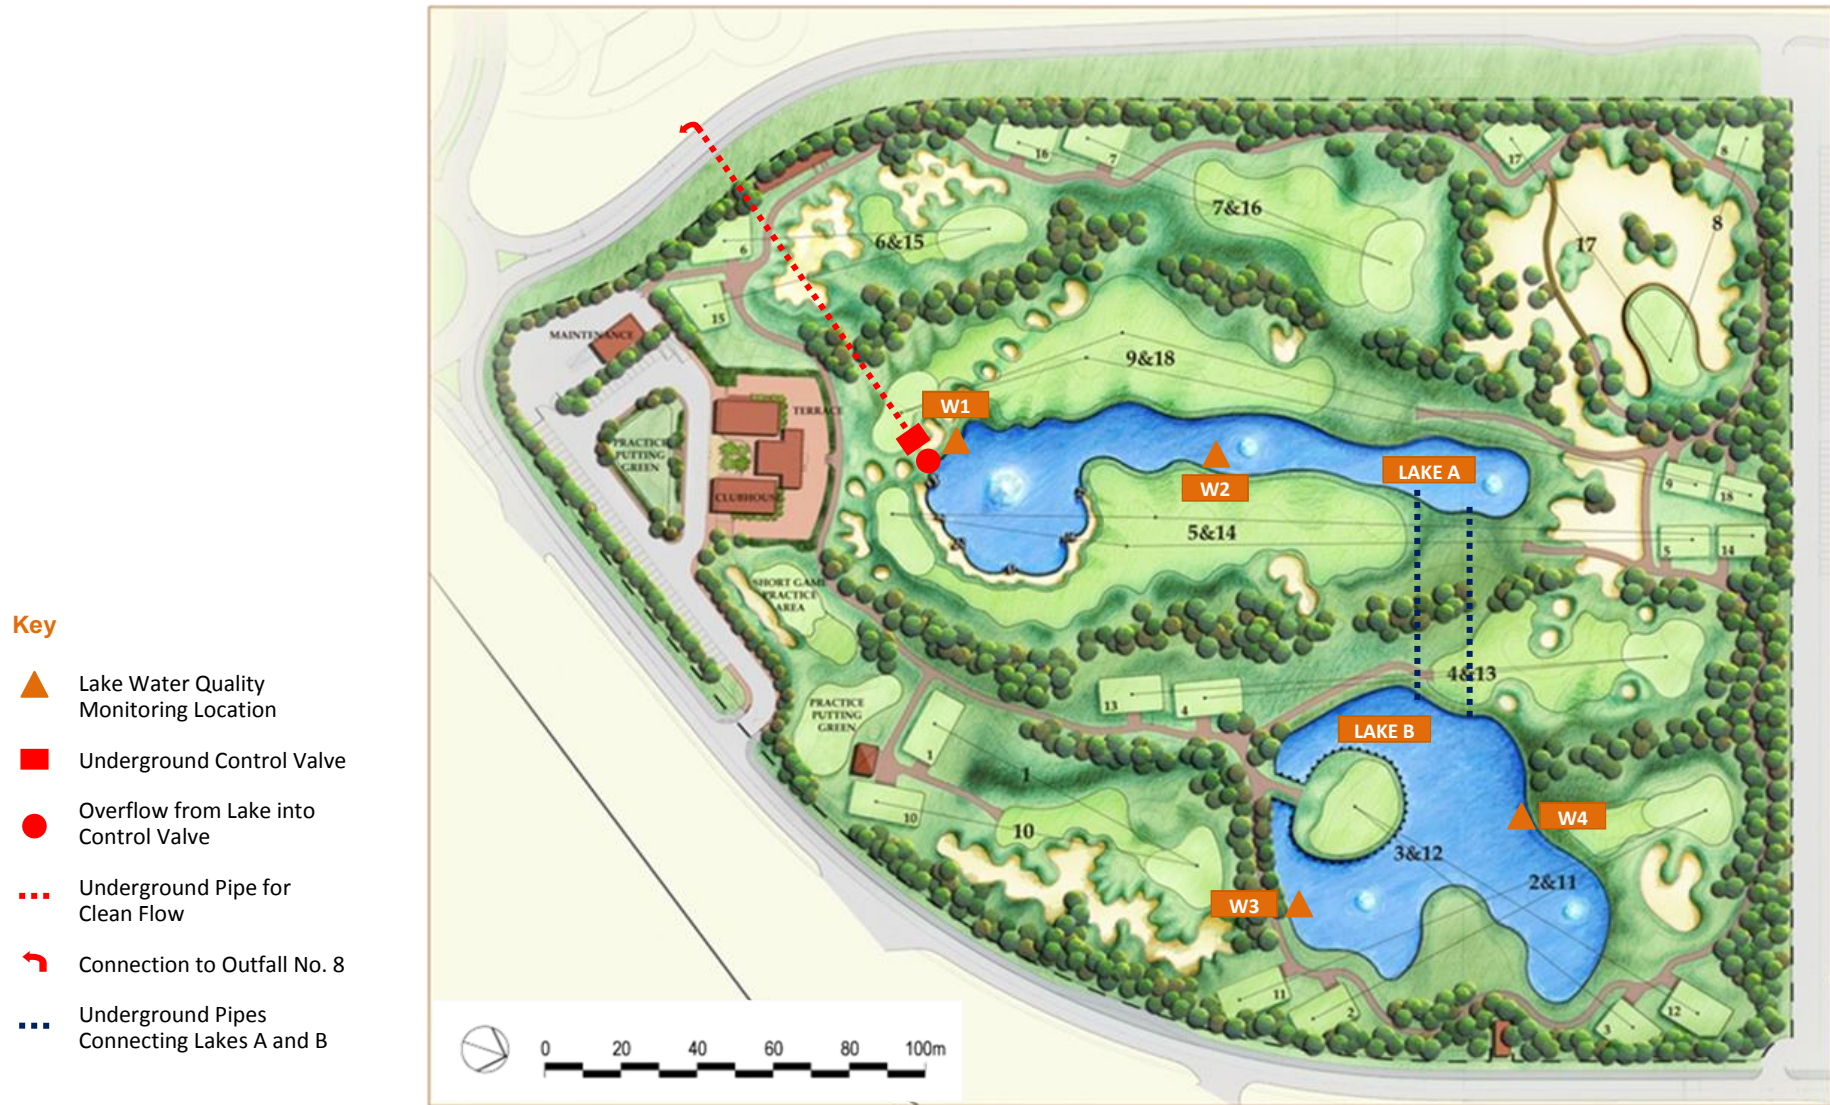
Figure 2-1 **Locations for Lake Water Quality Monitoring**

Monitoring locations together with grid references are shown in [Figure 2-1](#). Monitoring Stations are designated as W1, W2, W3 and W4.

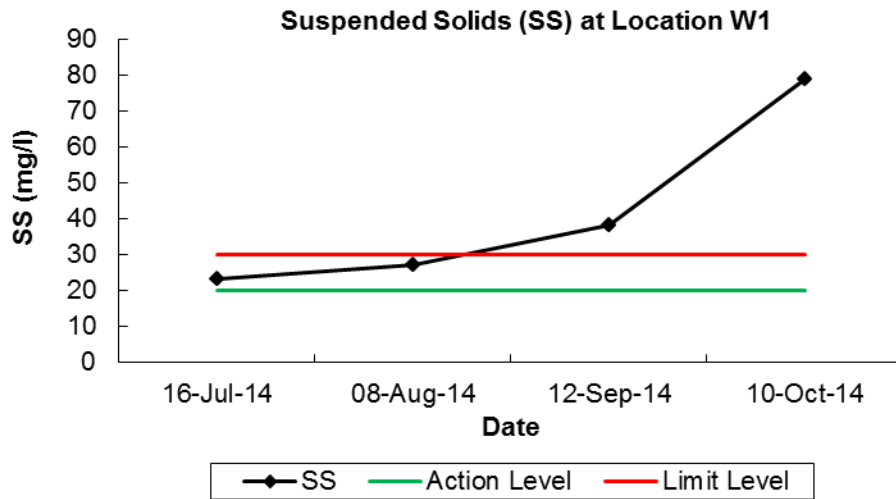
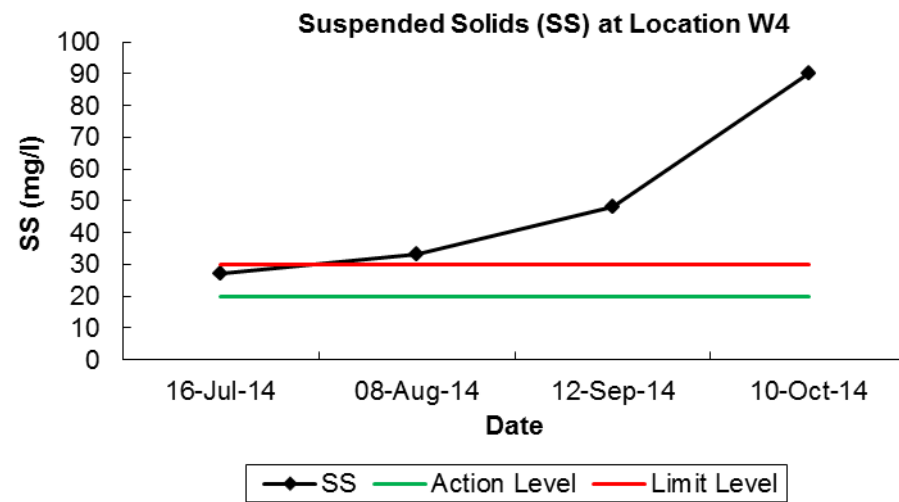
Graphical Plots of Monitoring Data for the Past Four Months

A summary of scheduled lake water monitoring results for the reporting quarter is provided in **Table 3-1**, below. Detailed results are provided in **Appendix 2** and graphical plots since commencement of the second phase of Operation are given in **Appendix 3**.
