TEST REPORT

CONTRACT NO. DC/2007/18
YUNG SHUE WAN AND
SOK KWU WAN VILLAGE SEWERAGE,
STAGE 1 WORKS
MONTHLY IMPACT MONITORING
REPORT NO.8
(JANUARY 2009)

Contract No. DC/2007/18
Yung Shue Wan and Sok Kwu Wan Village Sewerage, Stage 1 Works
Monthly Impact Monitoring Report No. 8

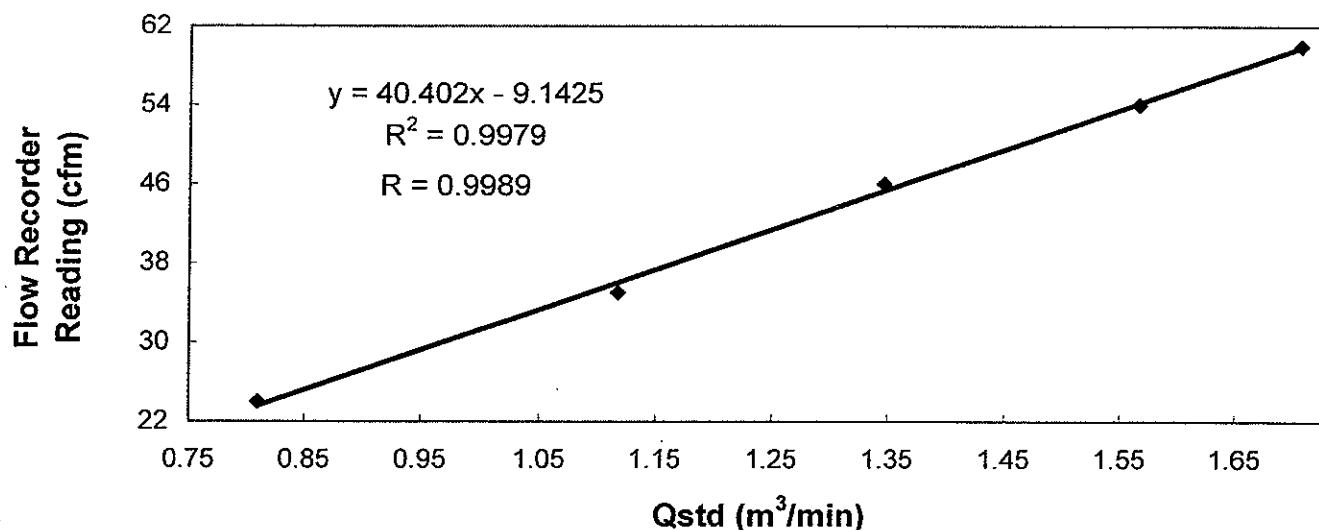
Sampler 1173 Calibration Curve
Site: Sok Kwu Wan (AM-1)

Results	Flow recorder reading (cfm)	60	54	46	35	24
	Qstd (Actual flow rate, m ³ /min)	1.71	1.57	1.35	1.12	0.81
	Pressure : 761.31 mmHg	Temp. : 290 K

Acceptance Criteria : Correlation coefficient (r) of the calibration curve greater than 0.990 after 5-point calibration

The high volume sampler complies* / ~~does not comply*~~ with the specified requirements and is deemed acceptable* / unacceptable* for use.

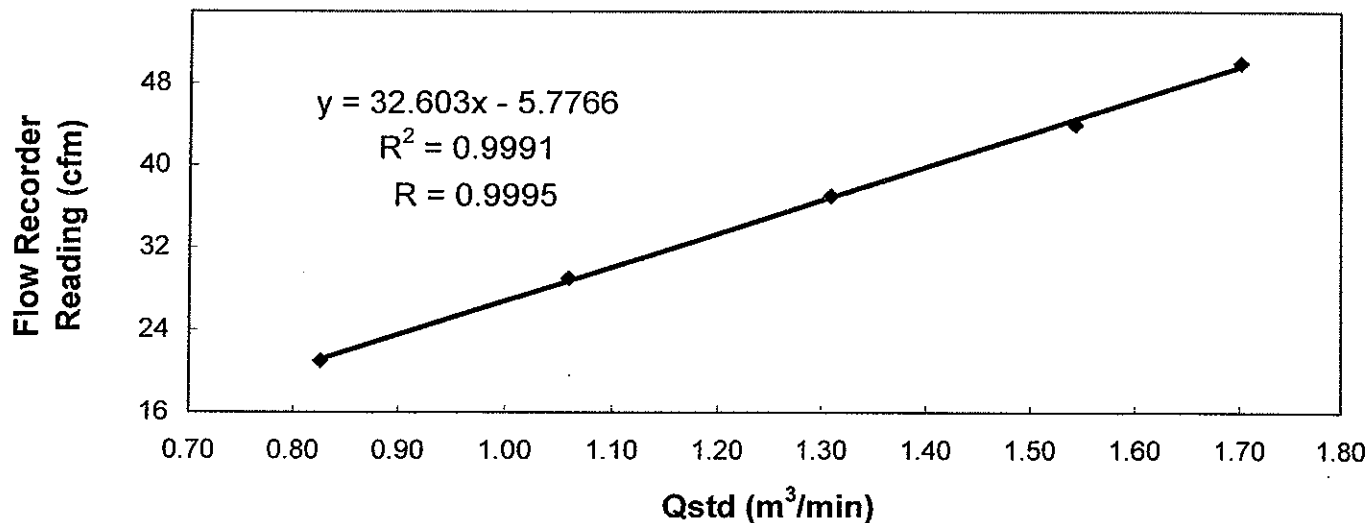
Sampler 9865 Calibration Curve
Site: Sok Kwu Wan (AM-2)

Results	Flow recorder reading (cfm)	50	44	37	29	21
	Qstd (Actual flow rate, m ³ /min)	1.70	1.54	1.31	1.06	0.83
	Pressure : 761.31 mm Hg	Temp. : 290 K

Acceptance Criteria : Correlation coefficient (r) of the calibration curve greater than 0.990 after a 5-point calibration

The high volume sampler complies* / ~~does not comply*~~ with the specified requirements and is deemed acceptable* / ~~unacceptable*~~ for use.

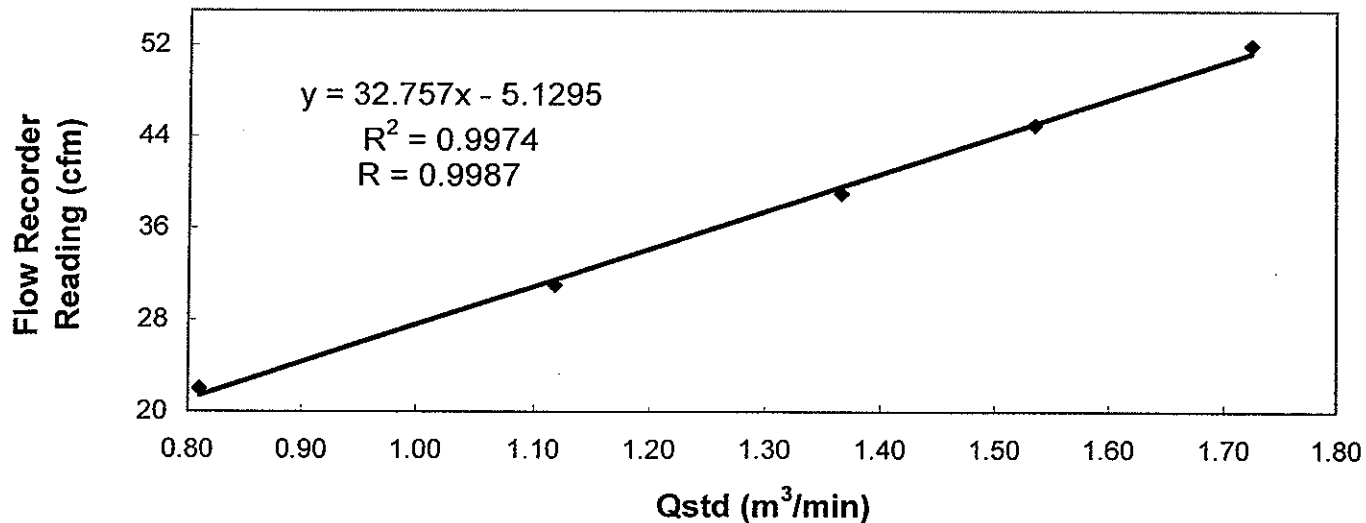
Sampler 9912 Calibration Curve
Site: Sok Kwu Wan (AM-3)

Results	Flow recorder reading (cfm)	52	45	39	31	22
	Qstd (Actual flow rate, m ³ /min)	1.72	1.53	1.37	1.12	0.81
	Pressure :	761.31 mm Hg			Temp. :	290 K

Acceptance Criteria : Correlation coefficient (r) of the calibration curve greater than 0.990 after a 5-point calibration

The high volume sampler complies* / ~~does not comply*~~ with the specified requirements and is deemed acceptable* / unacceptable* for use.

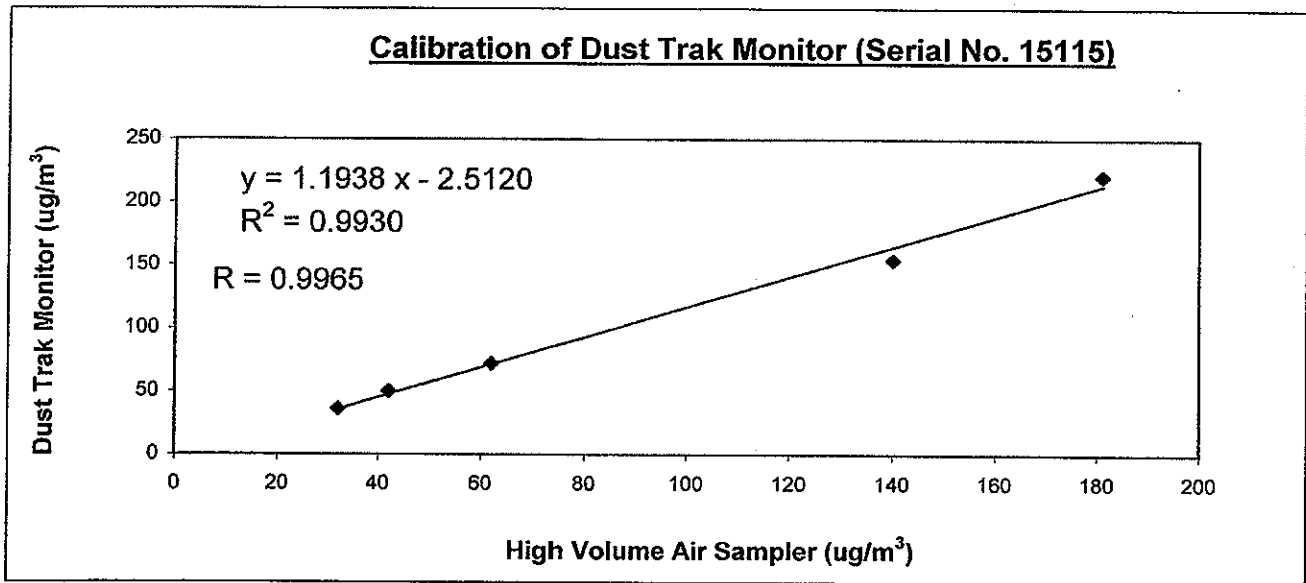
Manufacturer : TSI - 8520 Dust Trak **Date of Calibration** : 14 July 2008
Serial No. : 15115 (ET/EA/001/02) **Calibration Due Date** : 13 January 2009
Method : Parallel measurement (five-point calibration) by placing the Dust Trak Monitor and High Volume Air Sampler together under the same environmental condition

Dust Trak Monitor ($\mu\text{g}/\text{m}^3$)	36	50	72	154	221
High Volume Air Sampler ($\mu\text{g}/\text{m}^3$)	32	42	62	140	181
Serial No of High Volume Air Sampler : 1178			Calibration Date: 01 September 2008

Correlation coefficient (r) of the calibration curve greater than 0.990 after a five point calibration

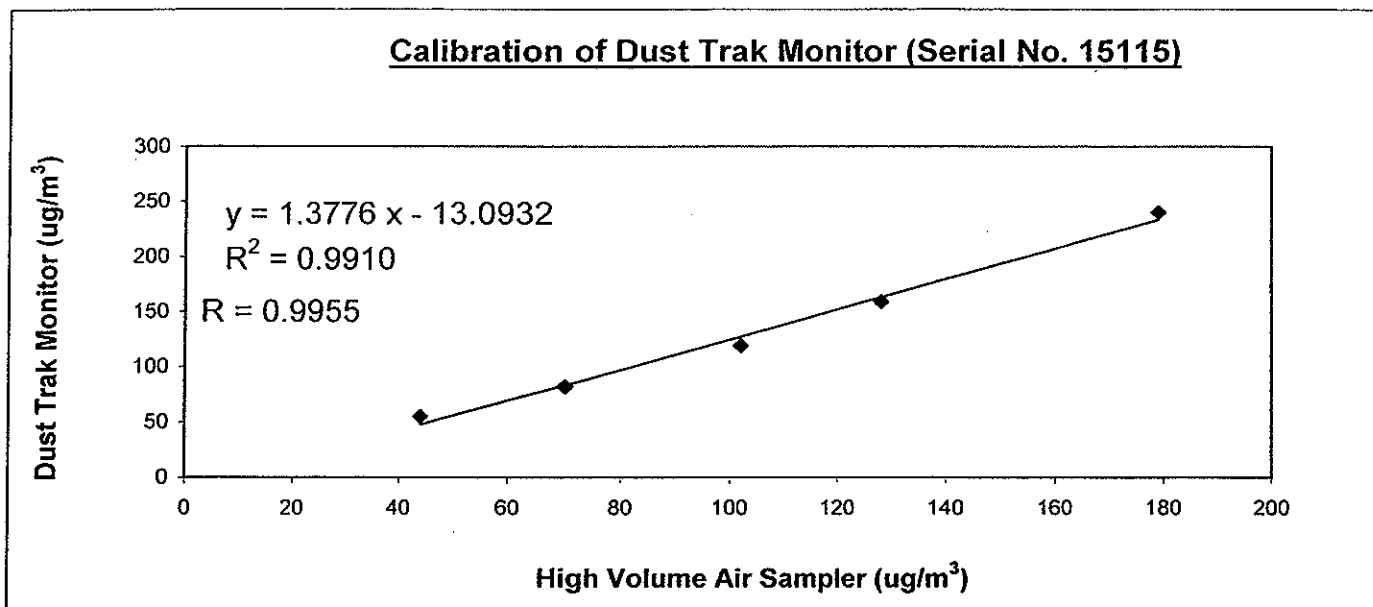
Manufacturer : TSI - 8520 Dust Trak Date of Calibration : 13 January 2009
Serial No. : 15115 (ET/EA/001/02) Calibration Due Date : 12 July 2009
Method : Parallel measurement (five-point calibration) by placing the Dust Trak Monitor and High Volume Air Samper together under the same environmental condition

Dust Trak Monitor ($\mu\text{g}/\text{m}^3$)	55	82	119	159	240
High Volume Air Sampler ($\mu\text{g}/\text{m}^3$)	44	70	102	128	179
Serail No of High Volume Air Sampler : 1178			Calibration Date: 01 March 2009

Correlation coefficient (r) of the calibration curve greater than 0.990 after a five point calibration

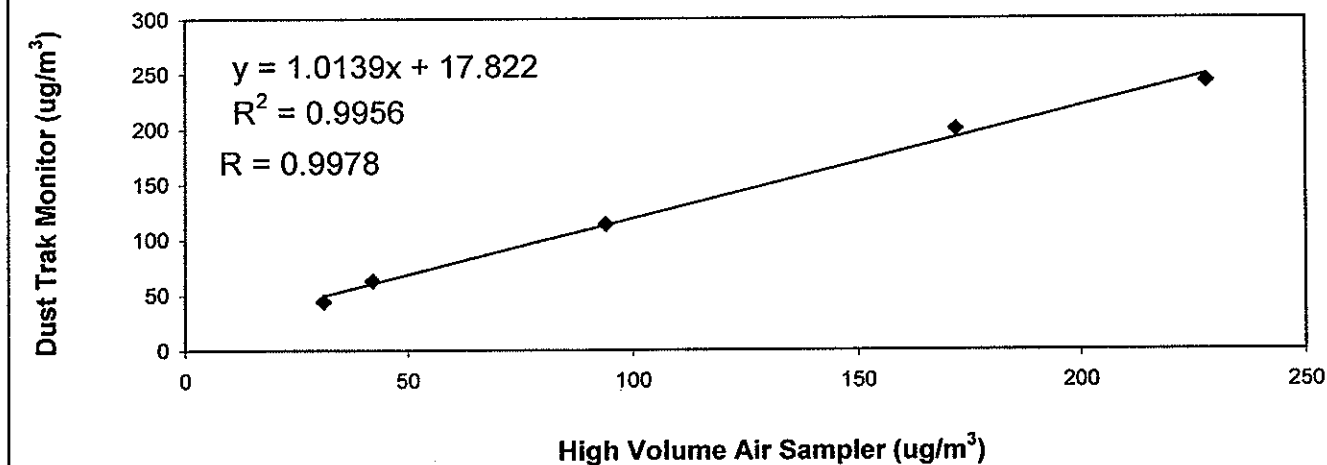
Calibration of Dust Trak Monitor (Serial No. 14230)

Manufacturer : TSI - 8520 Dust Trak **Date of Calibration** : 12 July 2008
Serial No. : 14230 (ET/EA/001/04) **Due Date** : 11 January 2009
Method : Parallel measurement (five-point calibration) by placing the Dust Trak Monitor and High Volume Air Sampler together under the same environmental condition

Dust Trak Monitor ($\mu\text{g}/\text{m}^3$)	44	63	114	200	243
High Volume Air Sampler ($\mu\text{g}/\text{m}^3$)	31	42	94	172	228
High Volume Air Sampler Serial No.: 1178			Calibration Due Date: 01 September 2008

Acceptance Criteria : Correlation coefficient (r) of the calibration curve greater than 0.990 after a five point calibration

The Dust Trak Monitor complies * / ~~does not comply~~ * with the internal calibration procedures and is deemed acceptable * / unacceptable * for use.

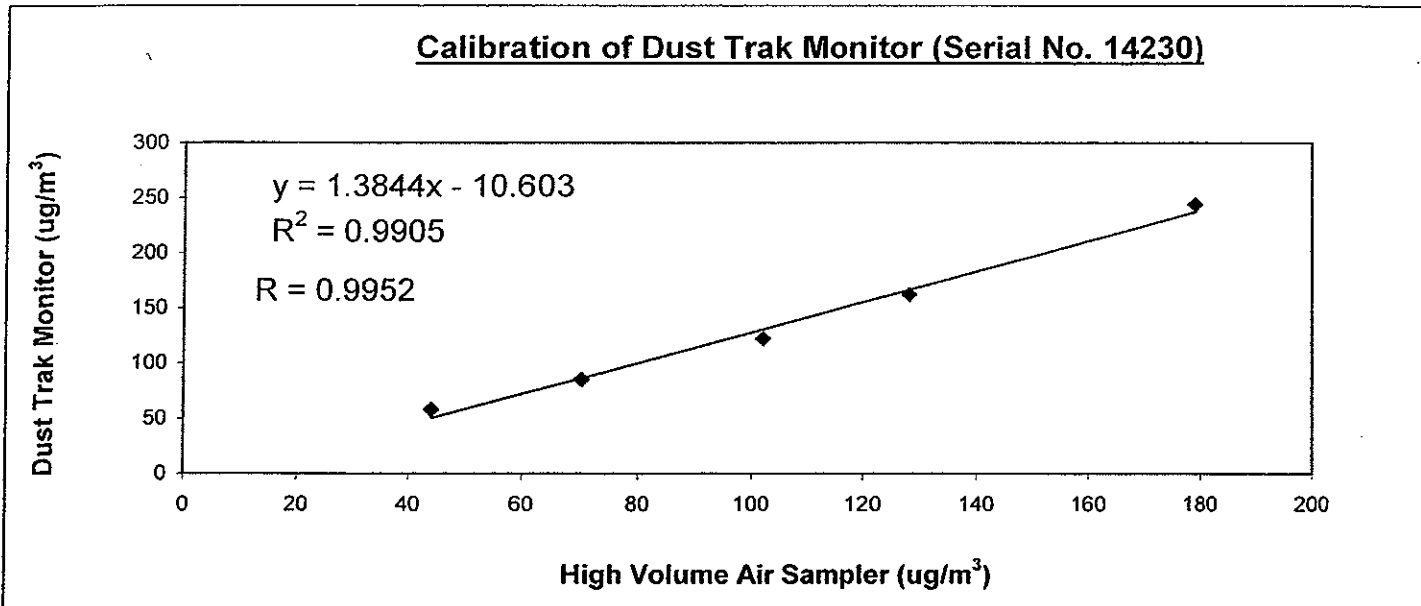
Manufacturer : TSI - 8520 Dust Trak **Date of Calibration** : 13 January 2009
Serial No. : 14230 (ET/EA/001/04) **Due Date** : 12 July 2009
Method : Parallel measurement (five-point calibration) by placing the Dust Trak Monitor and High Volume Air Sampler together under the same environmental condition

Dust Trak Monitor ($\mu\text{g}/\text{m}^3$)	58	85	155	162	244
High Volume Air Sampler ($\mu\text{g}/\text{m}^3$)	44	70	102	128	179
High Volume Air Sampler Serial No.: 1178		Calibration Due Date: 01 March 2009

Acceptance Criteria : Correlation coefficient (r) of the calibration curve greater than 0.990 after a five point calibration

The Dust Trak Monitor complies * / does not comply * with the internal calibration procedures and is deemed acceptable * / unacceptable * for use.
