**DSD CONTRACT NO. DC/2009/13
CONSTRUCTION OF SEWAGE TREATMENT WORKS AT
YUNG SHUE WAN AND SOK KWU WAN**

**YUNG SHUE WAN PORTION AREA
MONTHLY ENVIRONMENTAL MONITORING AND AUDIT
(EM&A) REPORT (No.16) – DECEMBER 2011**

PREPARED FOR
LEADER CIVIL ENGINEERING CORPORATION LIMITED

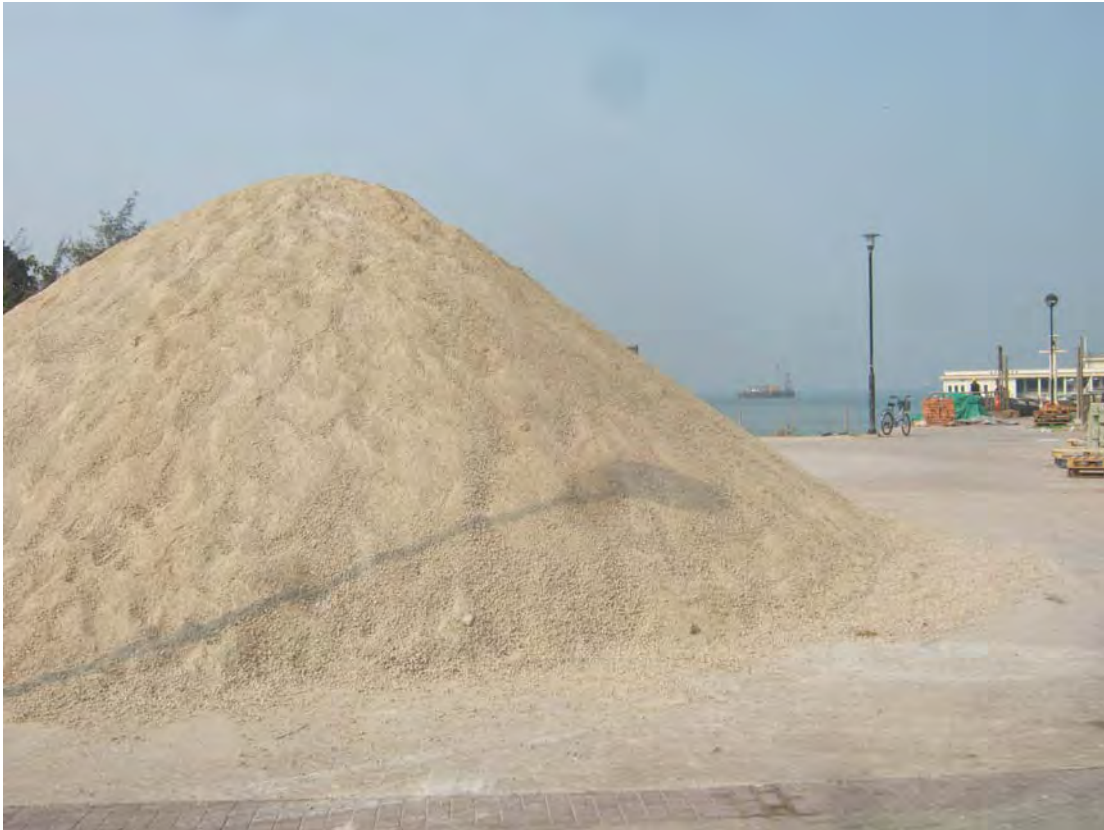
Photo 1 (taken on 13 December 2011)

piled since 12 December 2011 at the open area near the public pier which was about 30m from the High Volume Samplers under the Project. As a result, considerable fugitive dust and TSP caused the recorded exceedance during dry and windy conditions of the dry season.

Photos of Sand Stockpiles

4.04 According to the construction information provided by the Contractor, major construction activities undertaken during the captioned exceedance included concrete repairing work; preparation works for concreting; formwork erection; rebar bending and fixing; removal of scaffolding; plastering work and general site tidying. With full implementation of the required environmental mitigation measures, in particular construction dust suppression measures including water sprays for haul roads as well as wheel washing facilities provided at the exit/entrance of the site, these construction activities are not anticipated to create adverse construction dust impacts as shown by the TSP monitoring results of the previous construction period.

- 4.06 Since the exceedance was confirmed after the monitoring due to the time required for the laboratory analysis of TSP, no increase of monitoring frequency was possible to be implemented by the ET, as the no exceedance was recorded in the subsequent monitoring event on 19 December 2011. In addition, no complaint was received during the exceedance, indicating the occasional exceedance bore only short term impacts. It is concluded that the exceedances were not related to the work under the Project and no remedial actions are required.
- 4.07 The detailed investigation report for the cause of exceedance and photo record are presented in [Appendix N](#).
- 4.08 The meteorological information during the impact monitoring days are summarized in [Appendix I](#).

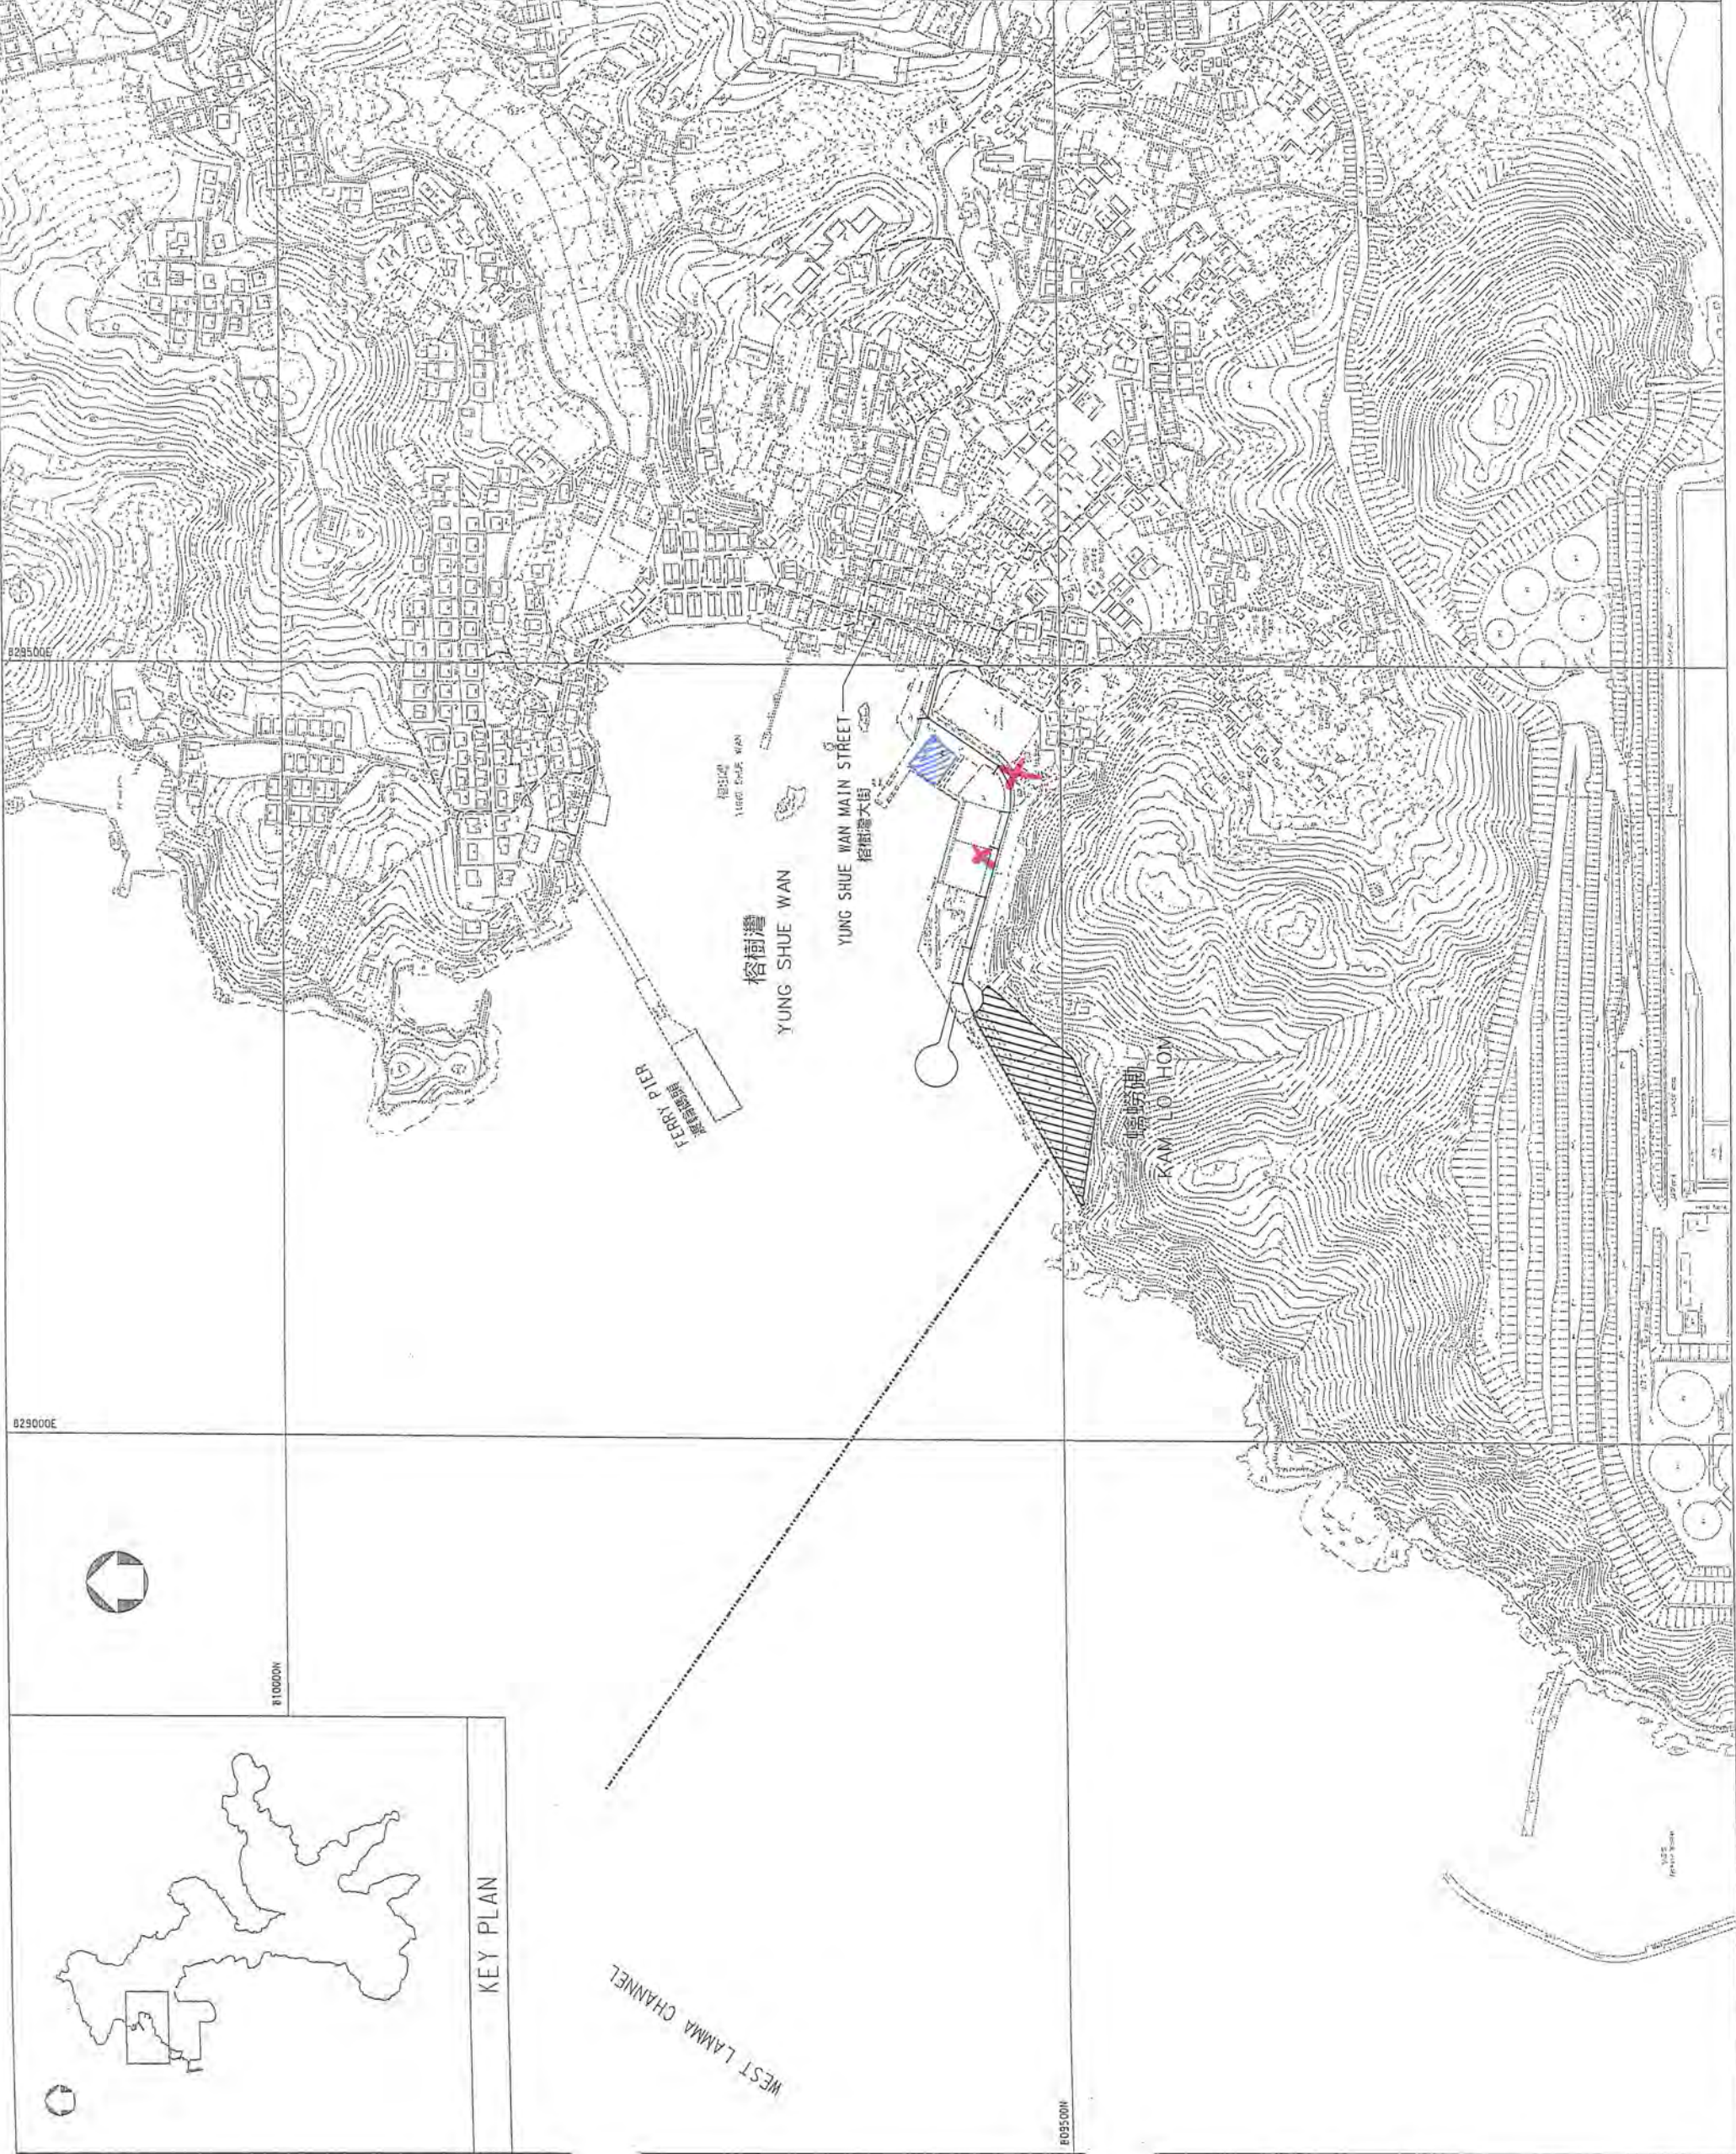
Location of AC04c and AC02b

Stackpiling of sand & rock fines by others
