PROJECT No.: TCS/00512/09

DSD CONTRACT No. DC/2009/13 CONSTRUCTION OF SEWAGE TREATMENT WORKS AT YUNG SHUE WAN AND SOK KWU WAN

YUNG SHUE WAN PORTION AREA MONTHLY ENVIRONMENTAL MONITORING AND AUDIT (EM&A) REPORT (NO.22) – JUNE 2012

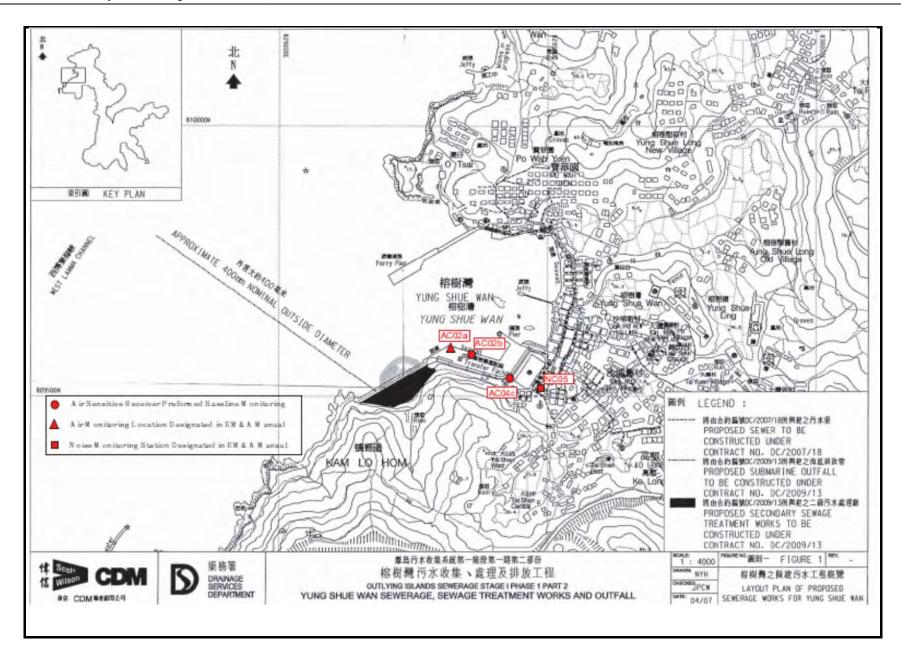
Location of Monitoring Stations (Air Quality / Construction Noise / Water Quality / Dive Surveys of Coral)

- 3.04 Two designated monitoring stations, AC02a located at Yung Shue Wan Refuse Transfer Station and AC04 located at residential area nearby Yung Shue Wan football pitch, were recommended in the *EM&A Manual Section 2.5*. In order to identify and seek for the access of the air monitoring locations designated in the EM&A Manual, site visit was conducted by Leader and ET.

3.06 According to *EM&A Manual Section 3.4*, one noise sensitive receivers (NC05) designated for the construction noise monitoring was recommended at Yung Shue Wan Portion Area of the Project. The designated monitoring station is identified and successfully granted the premises. The detailed construction noise monitoring station is described in *Table 3-3* and graphical is shown in *Appendix D*.

3.07 Two control stations (CY1 and CY2) and three impact stations (WY1-WY3) were recommended in the *EM&A Manual Section 4.5*. Impact stations WY1-WY3 were identified close to the sensitive receivers (the coral colonies in the vici nity of Yung Shue Wan, and secondary contact recreation subzone). It is proposed to monitor the impacts from the construction of the submarine outfall as well as the ef fluent discharge from the proposed STW on water quality. Two control stations: CY1 and CY2 were recommended at locations representative of the project site in its undisturbed condition and located at upstream and downstream of the works area. The marine water quality monitoring stations to be performed under the Project is described in *Table 3-4* and shown in *Appendix D*.

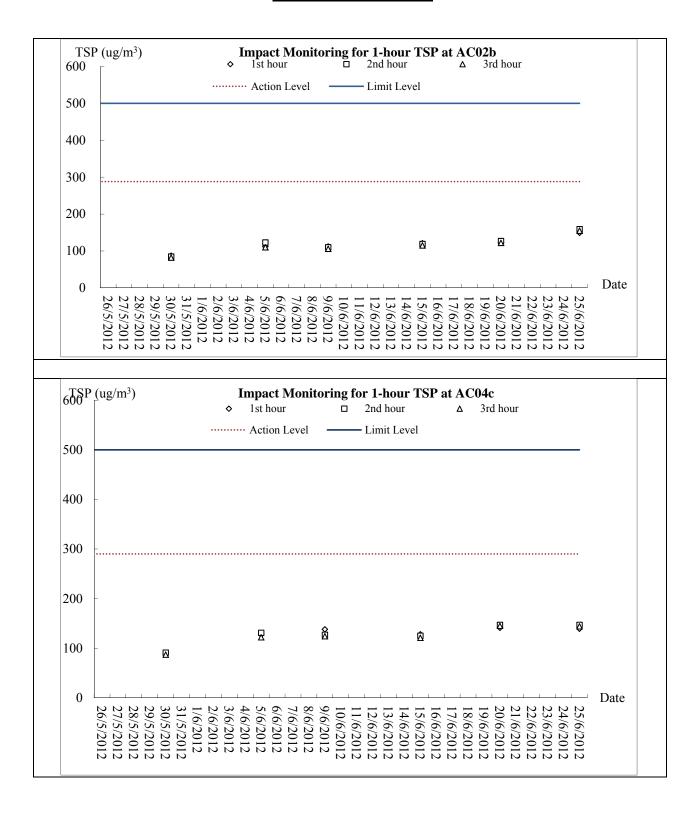
1-hour TSP Monitoring

- 13.03 No 1-hour and 24-h our TSP result was found to b e triggered the Action or Lim it Level in this Reporting Period.
- 13.04 No noise com plaint (an Action Level exceedance) was re ceived and no c onstruction noise measurement results that exceeded the Limit Level were recorded in this Reporting Period.

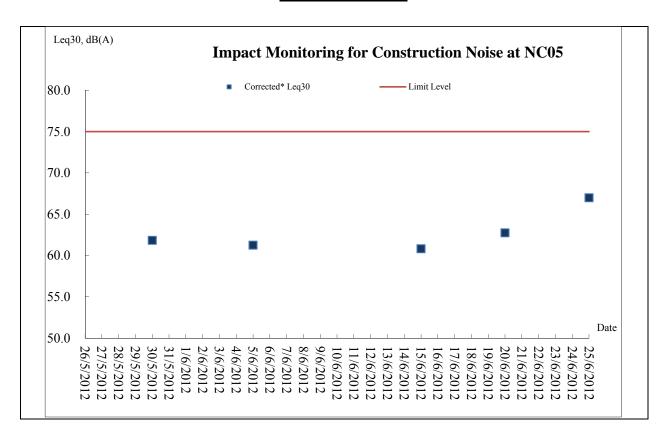
Noise Monitoring

5.03 It was noted that no noise complaint (which is an Action Level exceedance) was received. In view of the results shown in *Table 5-1*, all the values are well below 75dB(A), therefore, no Action or Limit Level exceedance was triggered during this Reporting Period.

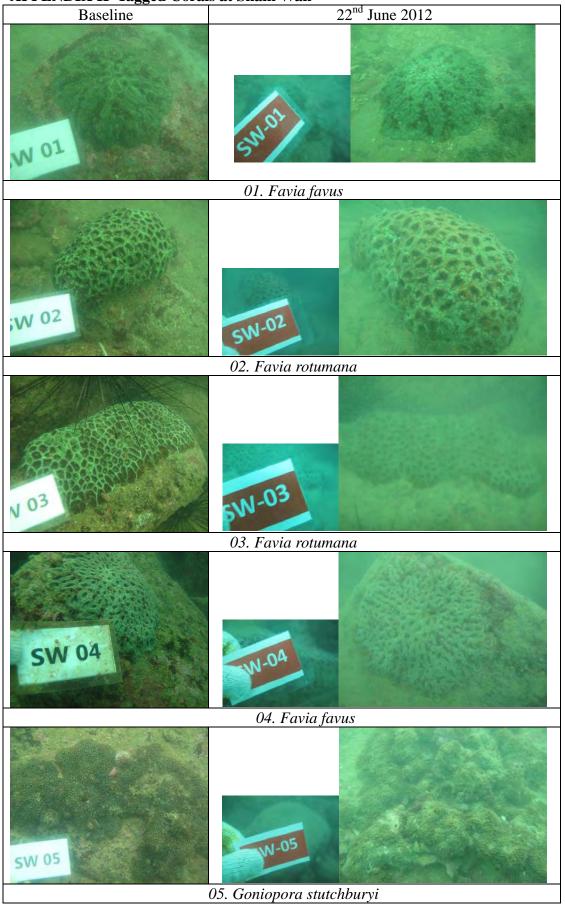
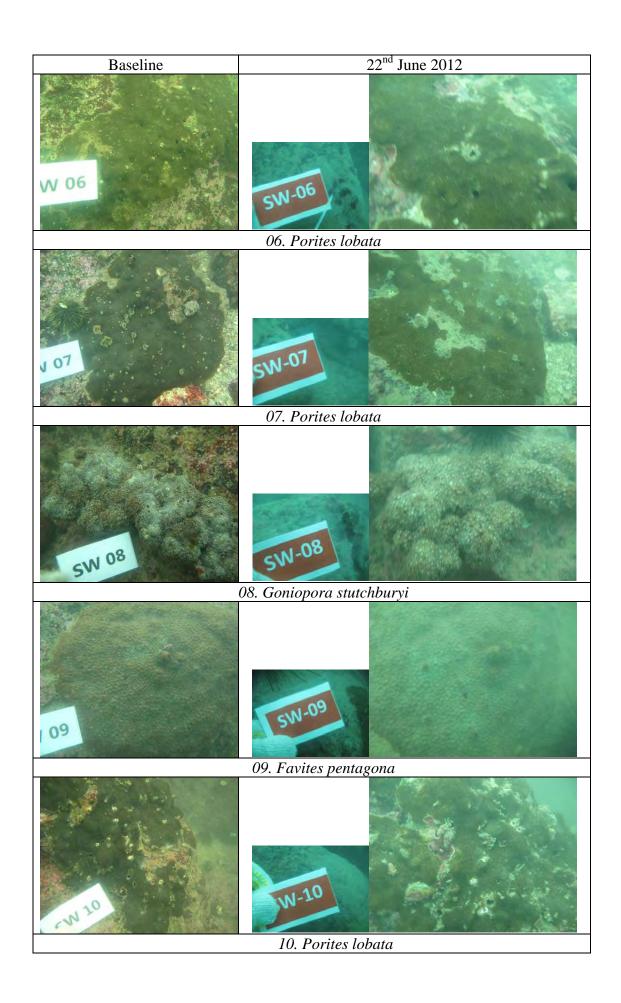
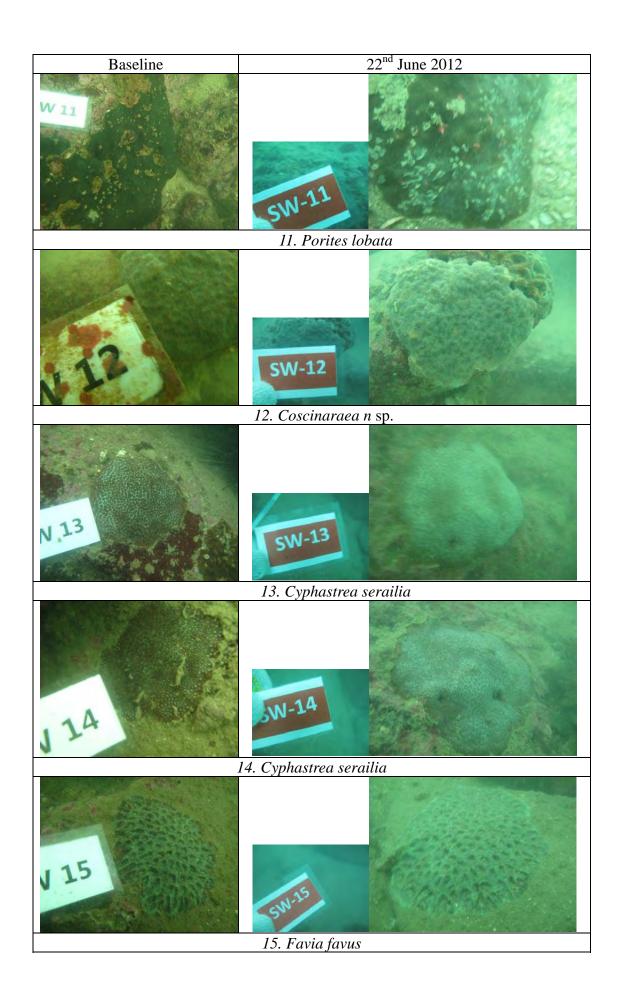
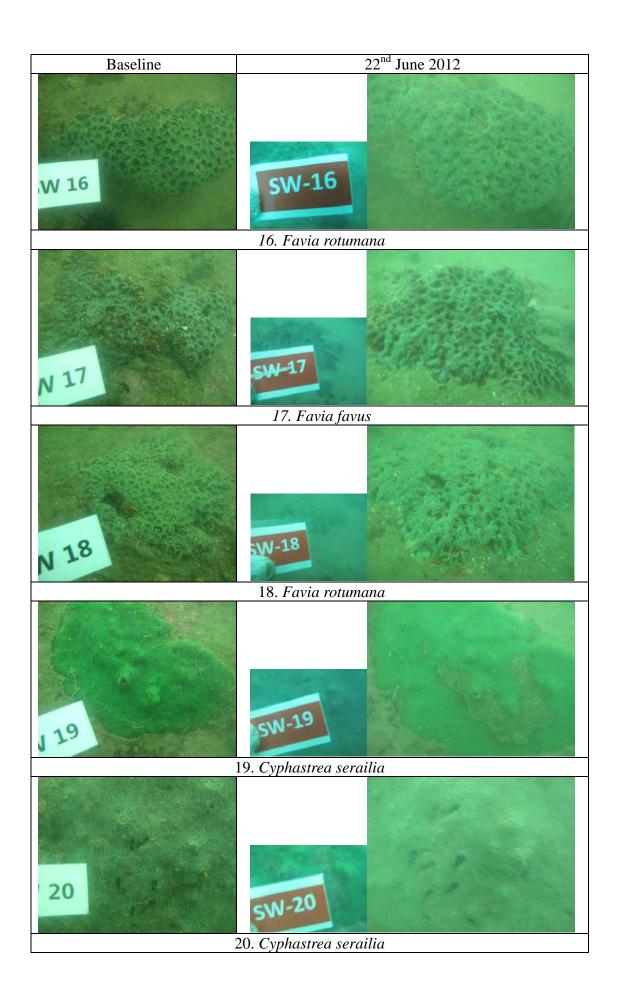
APPENDIX II Tagged Corals at Sham Wan

#7 of Sham Wan. No sediment was recorded during the survey. Other than coral colony #7 in Sham Wan, no beaching or mortality was recorded on both sites during the monitoring period. The coral coverage in both impact site (YSW) and control site (SW) are relatively low when compared with other coral communities in Hong Kong (such as Sharp Island and Hoi Ha Wan). Most of the coral colonies recorded in both site are common species in Hong Kong water.

6.3 Partially mortality on the soft/black corals was not recorded at the monitoring site. No bleaching or deterioration in the general condition of the coral fauna was observed. No adverse deterioration of the coral community was observed in the ecological monitoring results when compared with the baseline ecological monitoring results.
