DSD CONTRACT No. DC/2009/13 CONSTRUCTION OF SEWAGE TREATMENT WORKS AT YUNG SHUE WAN AND SOK KWU WAN

YUNG SHUE WAN PORTION AREA MONTHLY ENVIRONMENTAL MONITORING AND AUDIT (EM&A) REPORT (No.23) – JULY 2012

Monthly Environmental Monitoring and Audit (EM&A) Report No. 23 (July 2012)

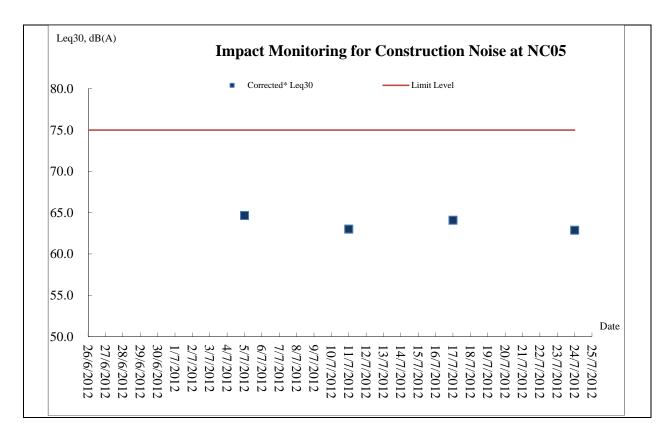
Noise Monitoring

5.03 It was noted that no noise complaint (which is an Action Level exceedance) was received. In view of the results shown in *Table 5-1*, all the values are well below 75dB(A), therefore, no Action or Limit Level exceedance was triggered during this Reporting Period.
