**DSD CONTRACT NO. DC/2009/13  
CONSTRUCTION OF SEWAGE TREATMENT WORKS AT  
YUNG SHUE WAN AND SOK KWU WAN**

**YUNG SHUE WAN PORTION AREA  
MONTHLY ENVIRONMENTAL MONITORING AND AUDIT  
(EM&A) REPORT (No.25) – SEPTEMBER 2012**

PREPARED FOR  
**LEADER CIVIL ENGINEERING CORPORATION LIMITED**

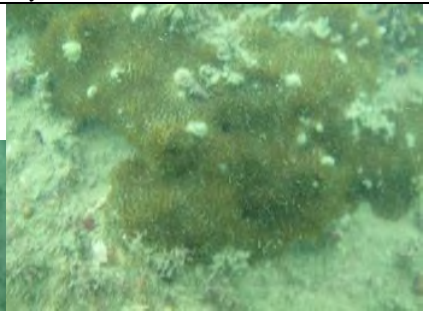
<i>14. Porites lobata</i>

5.3 On 6<sup>th</sup> September, coral colonies #14 and #15 were recorded to have 1% and 2% sediment respectively. Tags of coral #8, #19 and #20 were missing during the monitoring on 6<sup>th</sup> and were retagged on 28<sup>th</sup>. On 28<sup>th</sup> September, coral colony #14 was recorded to have 2% sediment. No sediment was recorded in other coral colonies during the survey. No bleaching or mortality was recorded during the monitoring survey on the monitoring dates. Photos of each tagged corals were shown in **Appendix II**.

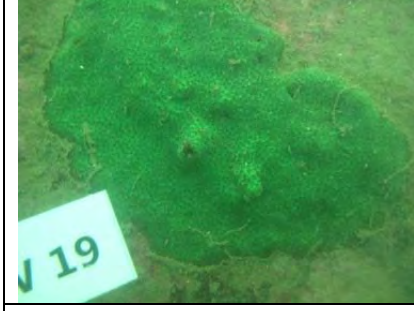
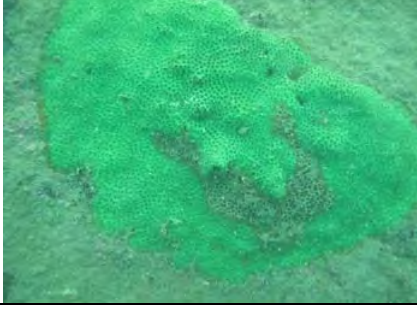
<i>19. Cyphastrea serailia</i>

- 5.6 On 6<sup>th</sup> September, coral colony #19 was recorded to have 15% mortality and all tags were missing during the monitoring period. No sediment was recorded during the survey. No bleaching or mortality was recorded in other tagged coral colonies during the monitoring survey on the monitoring dates. Corals were retagged on 28<sup>th</sup> monitoring. Photos of each tagged corals were shown in **Appendix II**.
