PROJECT NO.: TCS/00512/09

**DSD CONTRACT NO. DC/2009/13
CONSTRUCTION OF SEWAGE TREATMENT WORKS AT
YUNG SHUE WAN AND SOK KWU WAN**

**YUNG SHUE WAN PORTION AREA
MONTHLY ENVIRONMENTAL MONITORING AND AUDIT
(EM&A) REPORT (No.27) – NOVEMBER 2012**

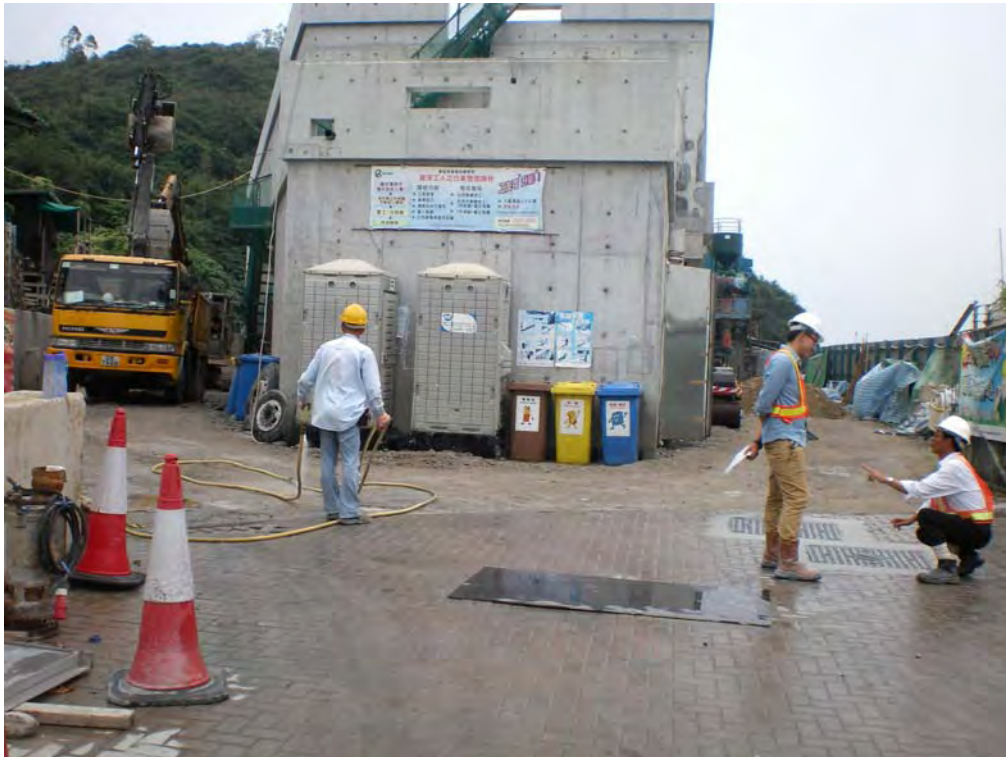
Photo B1: Photo record for mitigation measures provided by the Contractor

- It is concluded that the exceedance was not related to the works under the Project. As no consecutive e exceedances were recorded on the next monitoring, no remedial actions are required. Nevertheless, full implementation of the recommended environmental mitigation measures, in particular construction dust suppression measures during dusty construction activities including vehicle and construction plant movement, is strongly recommended under dry and windy conditions.

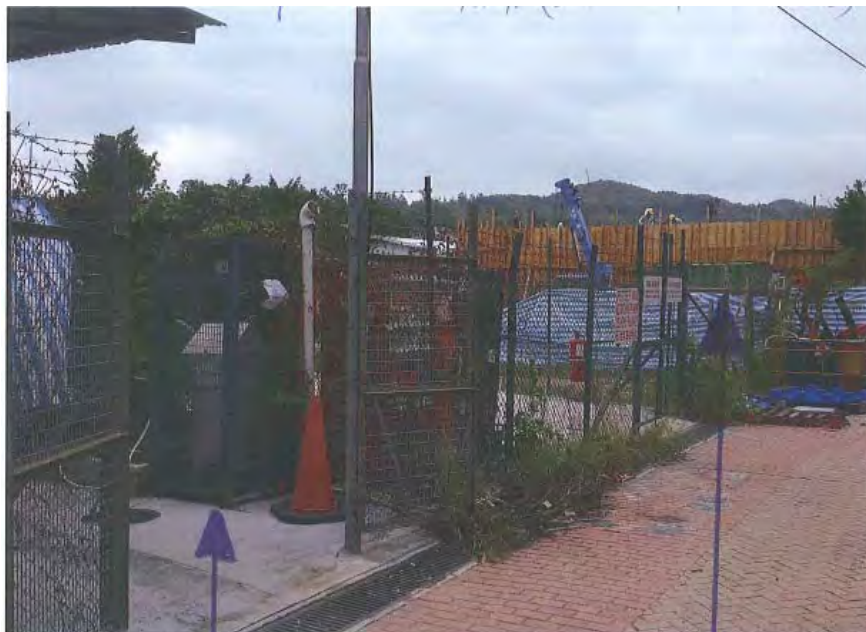
Photo B2: Photo record for the location of ASD's work site and AC02b

- Other the other hand, it is found that a concurrent construction project, R.C. construction for new police station, was in progress in the Architectural Service Department's (ASD) work site which is about 25m adjacent to monitoring location AC02b. It was considered as one of the source attributable to the 24-hour TSP exceedance.

Monitoring
Location AC02b

ASD Work Site
for new police station

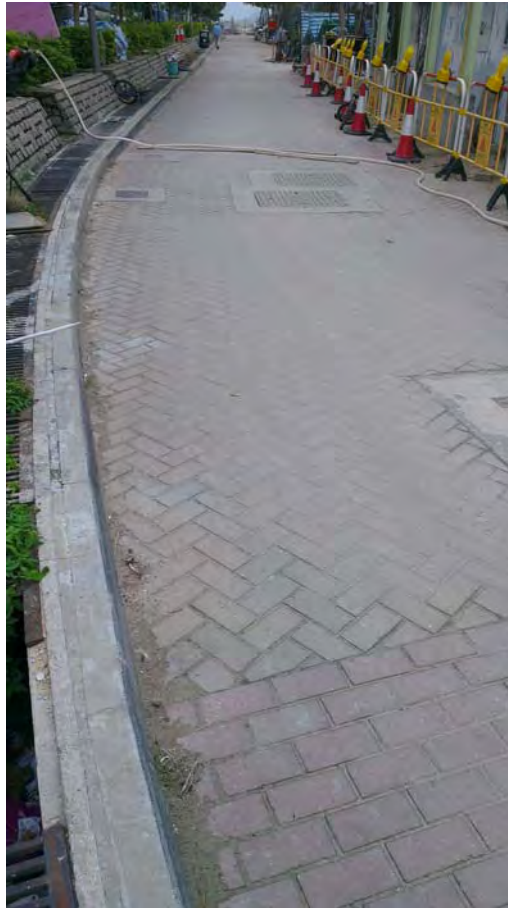
Photo B3: Photo record for dusty road outside ASD's work site

- Dusty public road which leads to the current construction site was observed. The dusty road is highly possibly brought from the ASD's site during transportation of the material and stockpiles. The dusty road would be another source attributable to the exceedance.
